# Flowline and Final Reclamation Inspection

June 27, 2017

Operator: ANADARKO E&P ONSHORE LLC - 2800

Inspection Photos  
Location Name: BELLMORE #9-66-15-5H  
API: 05-123-33865

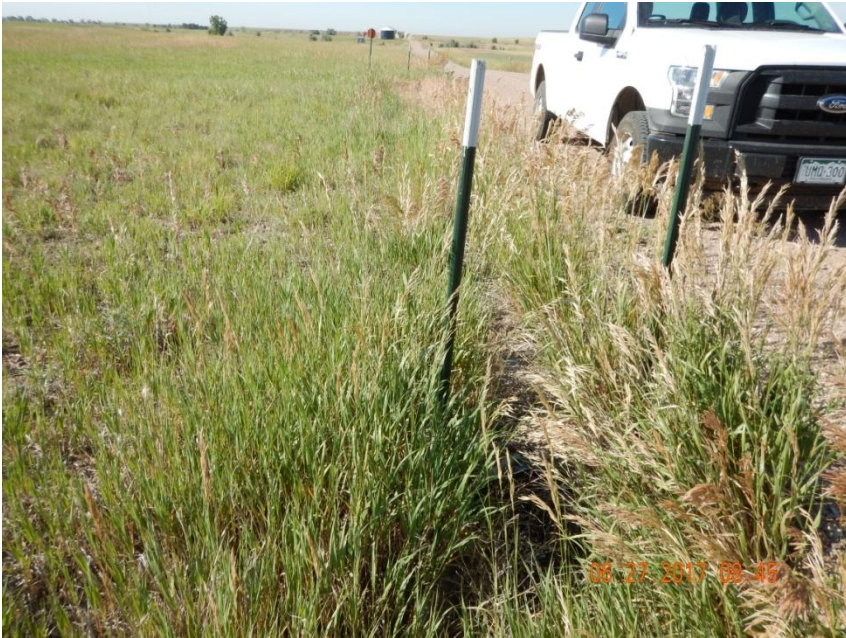
**Photo 1.** Photo taken from the entrance of the location, facing south. T-posts and culvert remain and needs to be removed per Rule 1004.

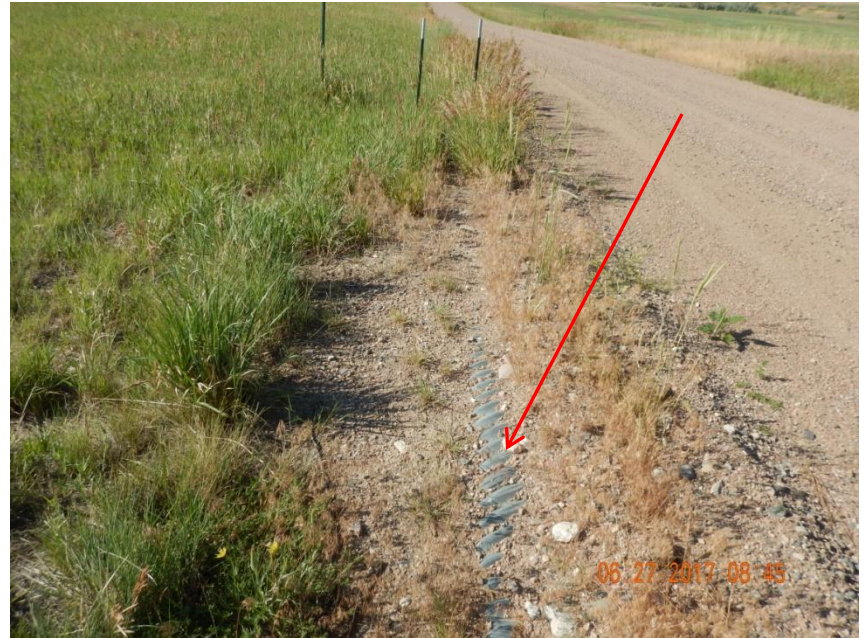
**Photo 2.** Photo taken of the culvert at the entrance of the location, facing South.

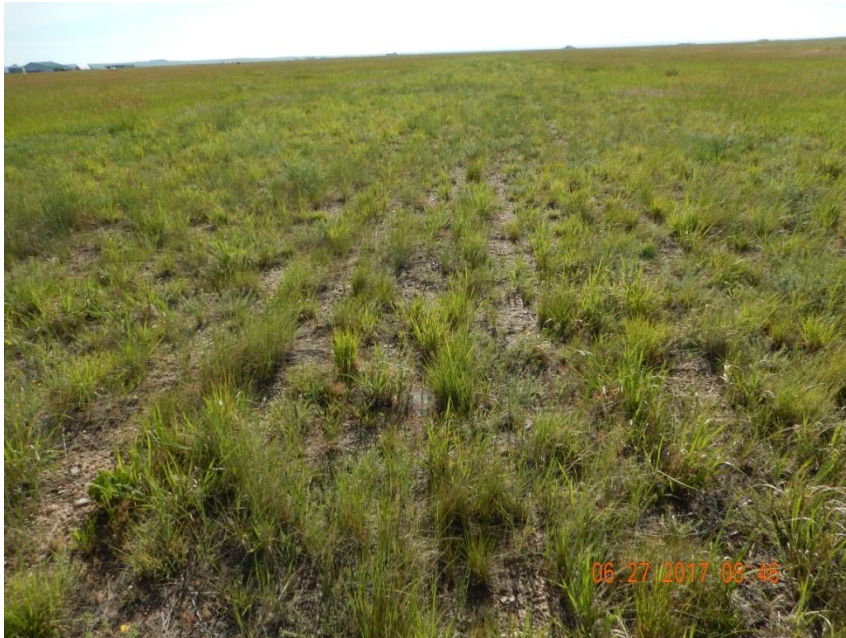
**Photo 3.** Photo taken from a portion of the access road, facing East. Disturbance areas appear reflective of reference area vegetative conditions.

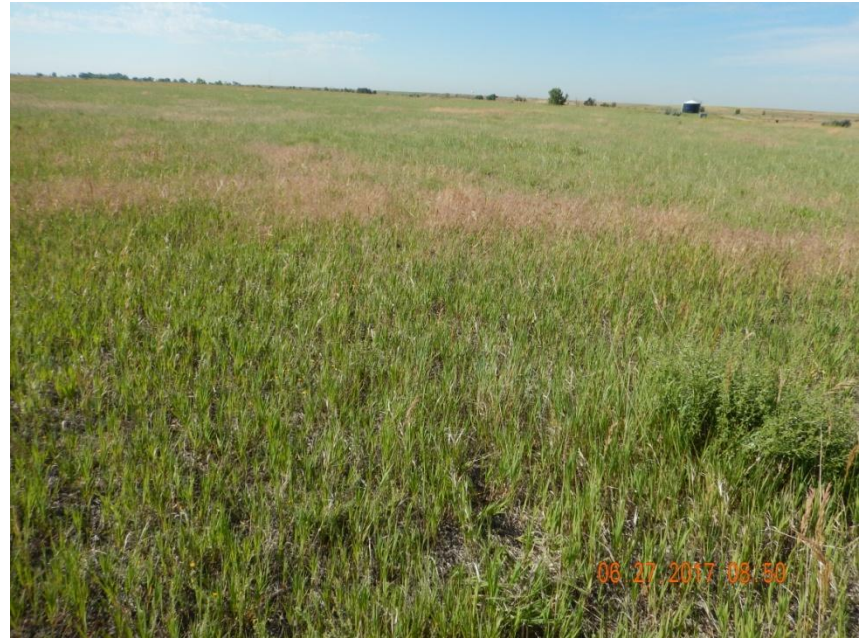
**Photo 4.** Photo taken from the approximate center of the location, facing South. Disturbance areas appear reflective of reference area vegetative conditions.
