# Flowline and Final Reclamation Inspection

June 27, 2017

Operator: PDC ENERGY INC - 69175

API: 05-123-10803

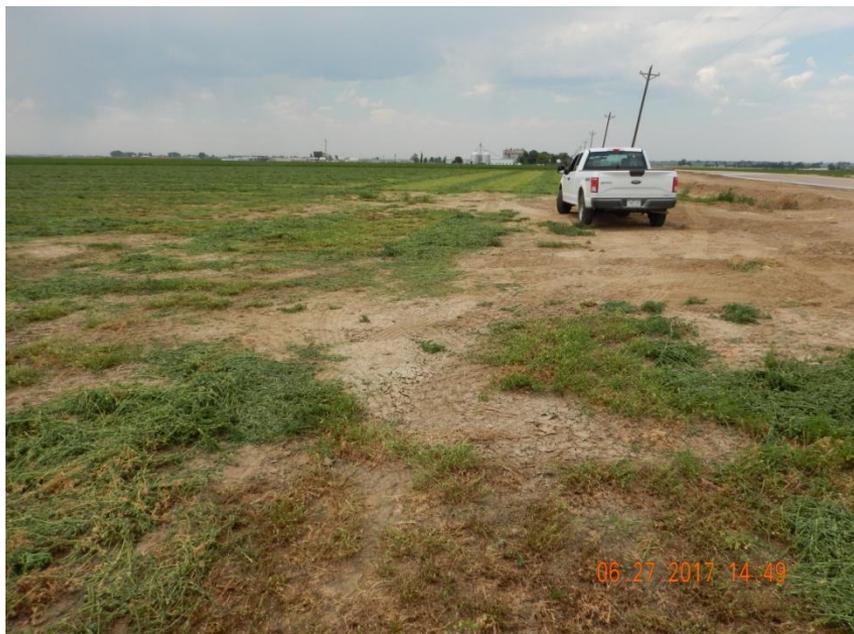
**Photo 1.** Photo taken from the entrance of the southern battery location, facing North. Battery location is not reflective of reference area vegetative conditions.

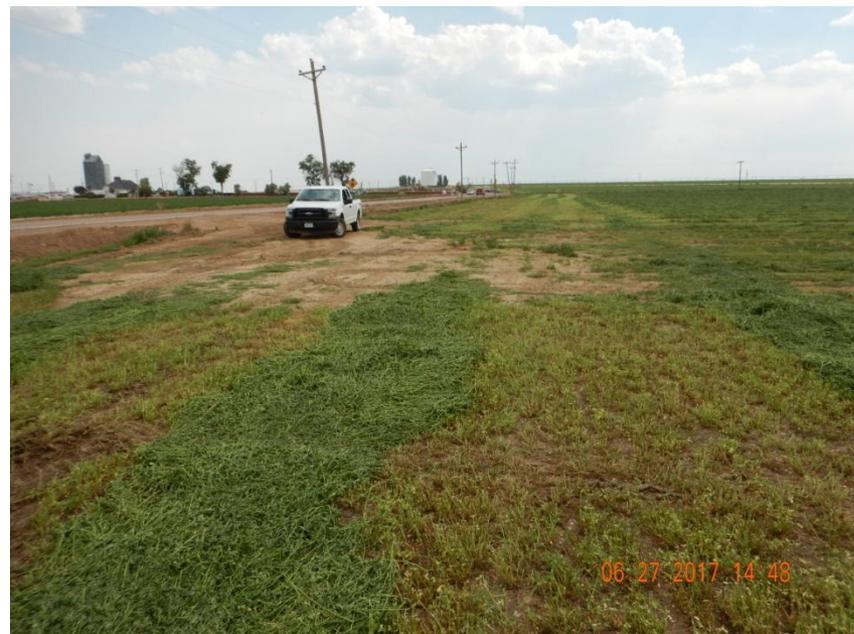
**Photo 2.** Photo taken from the entrance of the northern battery location, facing South. Battery location is not reflective of reference area vegetative conditions.

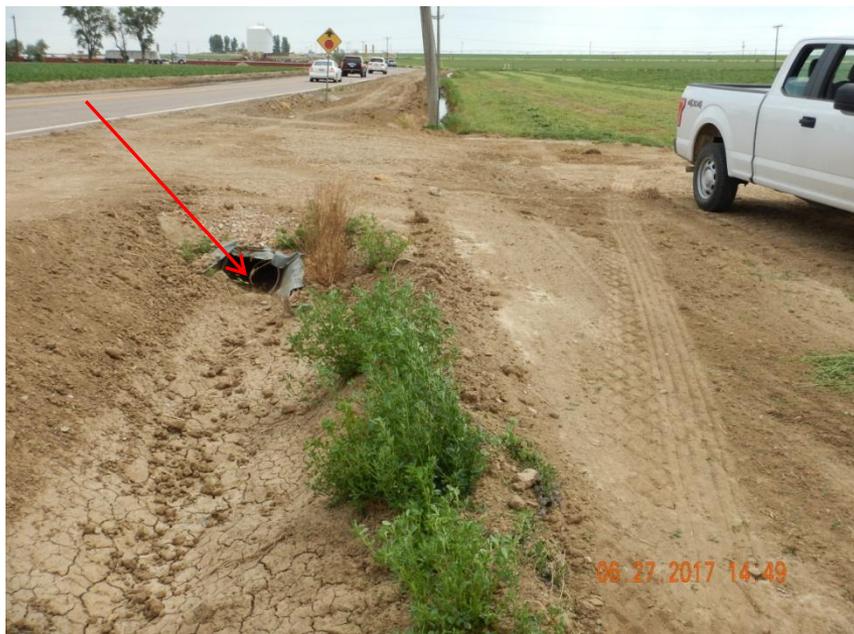
**Photo 3.** Photo taken from the entrance of the location, facing South. Culvert remains and needs to be removed per Rule 1004.
