NOAV# 401245081
Doc# 2227121
Date: 05/31/2017**Re: COGCC NOAV 401245081**

TOP Operating Co. (TOP) has received an NOAV referenced above for the Hays 1 well (API=05-123-11229-00). One of the alleged violations is of Rule 906.a Spills and Release - General.

<div>COGCC DOC # 410268923</div> <div>Date: 5/9/2017</div>	<div>Detailed Site Map Hays #1 Weld County, Colorado NWNW 32 5N65W 6 PM</div>	<div>

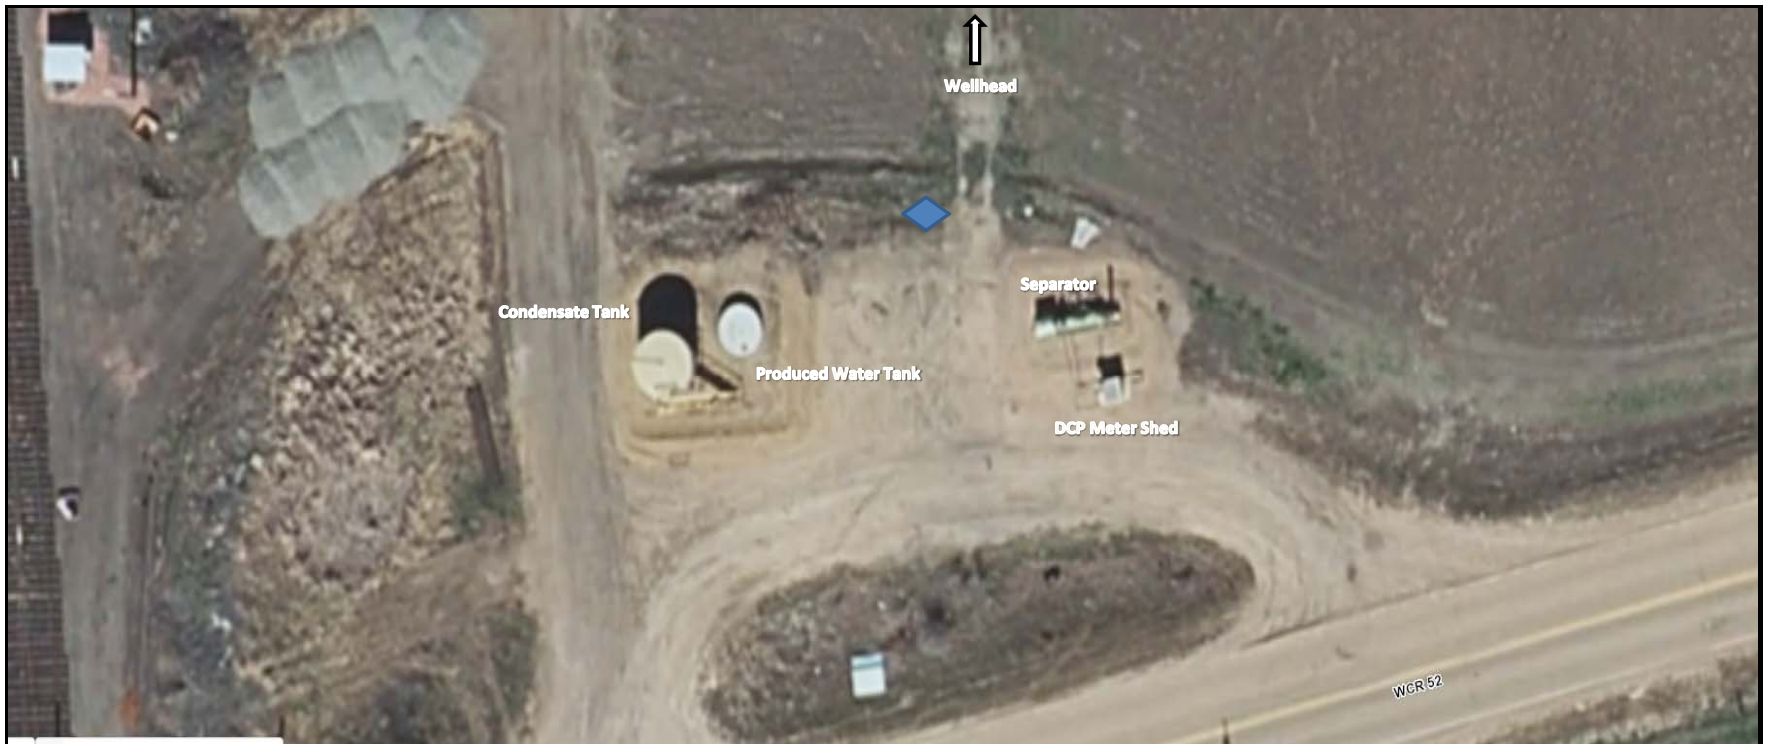
Soil Sample Location</div> <div>

Wellhead (~295 feet from Separator)</div>		<p>DISCLAIMER : This Geographic Information System (GIS) and its components are designed as a source of reference for answering inquiries, for planning and for modeling. GIS is not intended, nor does it replace legal description information in the chain of title and other information contained in official government records such as the County Clerk and Records office or the courts. In addition, the representations of locations in this GIS cannot be substituted for actual legal surveys.</p>

Operator shall properly treat or dispose of oily waste in accordance with Rule 907.e. Submit an eForm 27 with disposal documentation and confirmation sample results verifying compliance with Table 910-1. Attach disposal documents, sample location diagram, summary table with sample results compared to Table 910-1 standards and laboratory report to eForm 27.

My suggestion is to complete the required corrective actions as soon as possible. This might require one or two loads of waste that would need to be loaded, transported and disposed at an approved, licensed disposal facility. Collect confirmation soil samples from the area after the oily waste is removed to verify compliance with Table 910-1. Analyze the samples for TPH - GRO, DRO & ORO and BTEX. Provide the disposal documentation, sample location diagram, summary table and lab report via supplemental eForm 27. Last, restore the surface where the waste is removed.
