# Inspection Photos

Operator: NOBLE ENERGY INC - 100322

Location ID: 408094

Inspection Doc. Number: 682502474

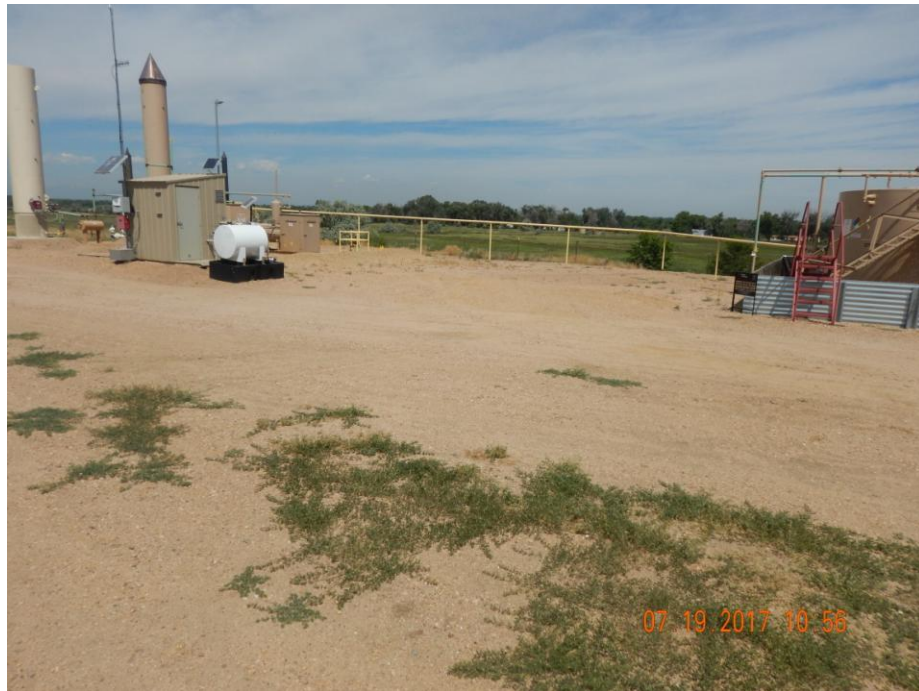
**Photo 1:** Photo taken from the well location, facing southwest. Photo shows the Dickens F-32 tank battery has been constructed at the well location.

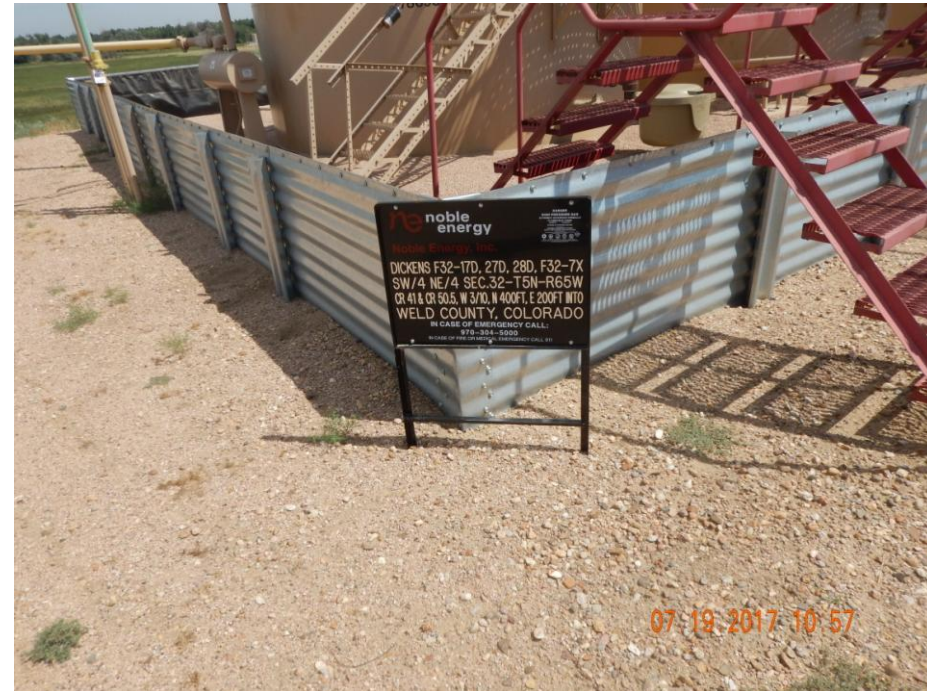
**Photo 2:** Photo taken from the Dickens F-32 tank battery.

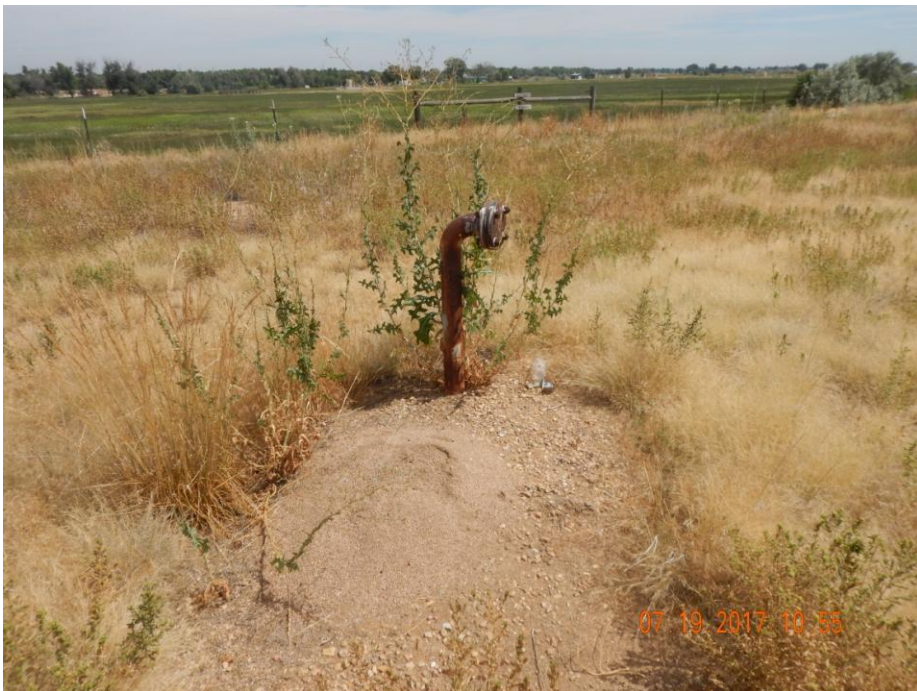
**Photo 3:** Photo taken from the former battery location. Photo shows riser remaining at location. COGCC rule 1004.a requires operator to remove all debris, abandoned gathering line risers, and flowline risers, and equipment within three months of plugging the associated facility. All work should have been conducted by 7/1/2008.

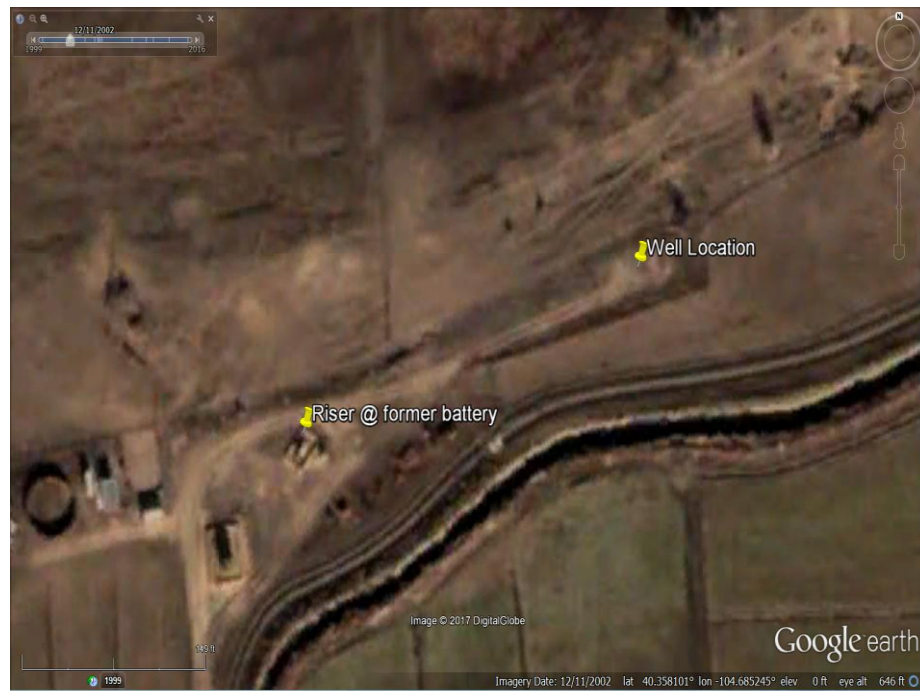
**Photo 4:** 2002 Aerial imagery showing the riser's location at the former battery, and the well location.
