Final Reclamation Inspection

Operator: PUBLIC SERVICE COMPANY OF COLORADO - 72400

Location ID: 384125

Inspection Photos
Location Name: LEYDEN STORAGE #31
Location ID: 384125

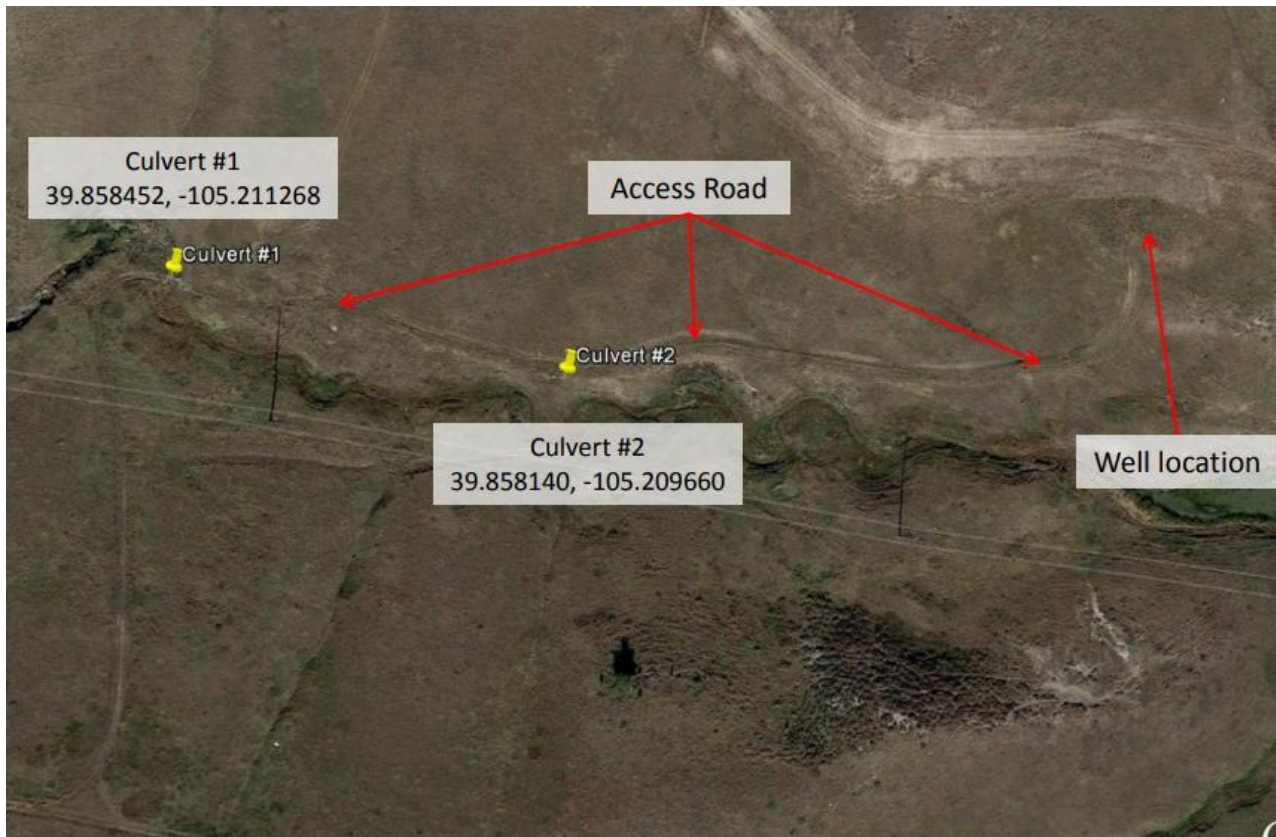
Google Earth aerial imagery taken 10/9/2015 illustrating area of interest. Appears the Colorado List B noxious weed, Diffuse knapweed (*Centaurea diffusa*), has been controlled from Culvert #1 to the well location. Culverts #1 and #2 have been removed from the access road.

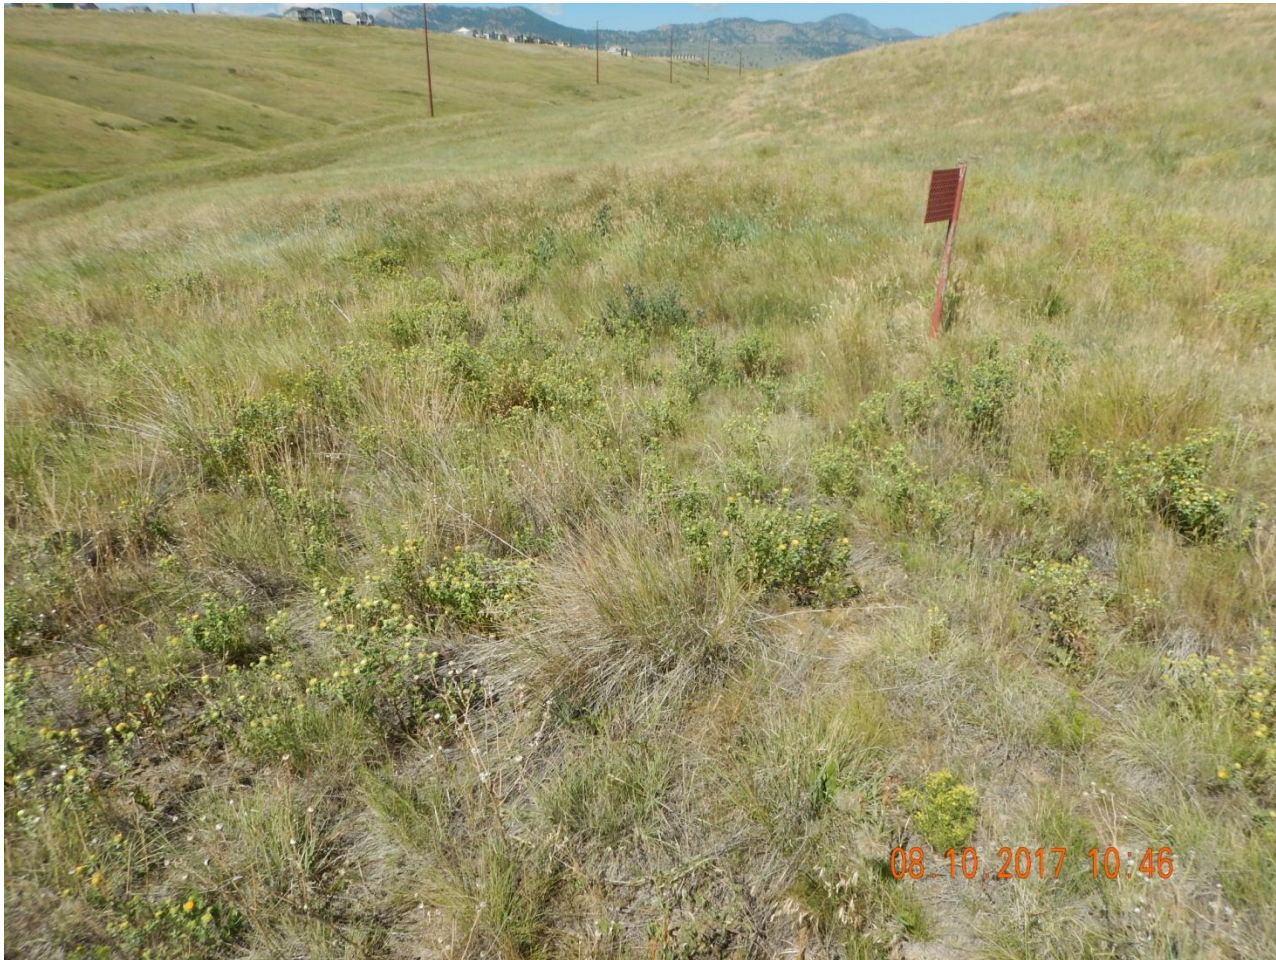
Photo 1. Photo taken from approximate center of location, facing West. Perennial vegetation has established at location and did not observe any Diffuse knapweed (*Centaurea diffusa*) at location. Location appears to meet Rule 1004 standards.

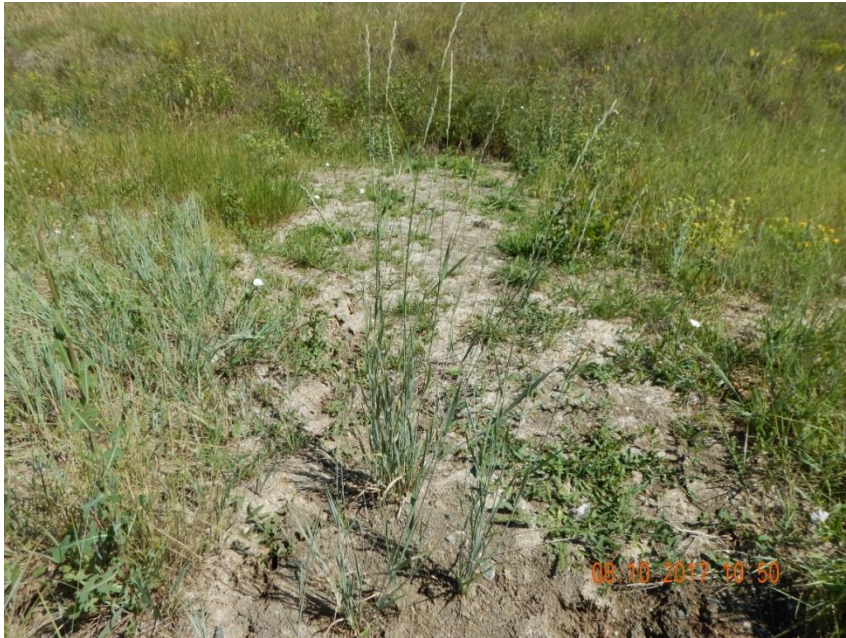
Photo 2. Photo taken from Culvert #2, facing North. Culvert has been removed and disturbance area seeded. No stormwater erosion was observed.

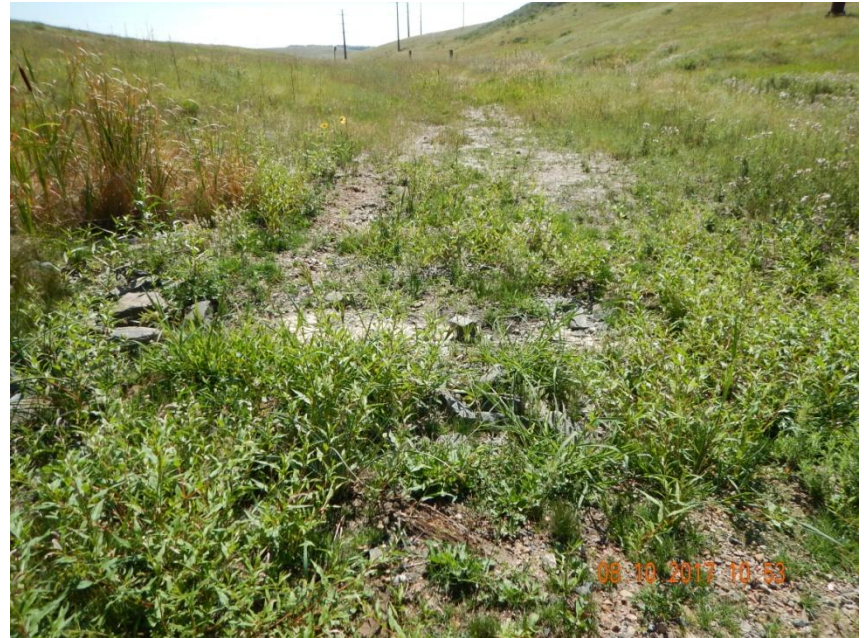
Photo 3. Photo taken from Culvert #1, facing East. Culvert has been removed and no stormwater erosion was observed.
