Inspection Photos

Operator: BONANZA CREEK ENERGY
OPERATING COMPANY LLC - 8960

Location ID: 322877

Inspection Doc. Number: 675103891
Weld County, CO

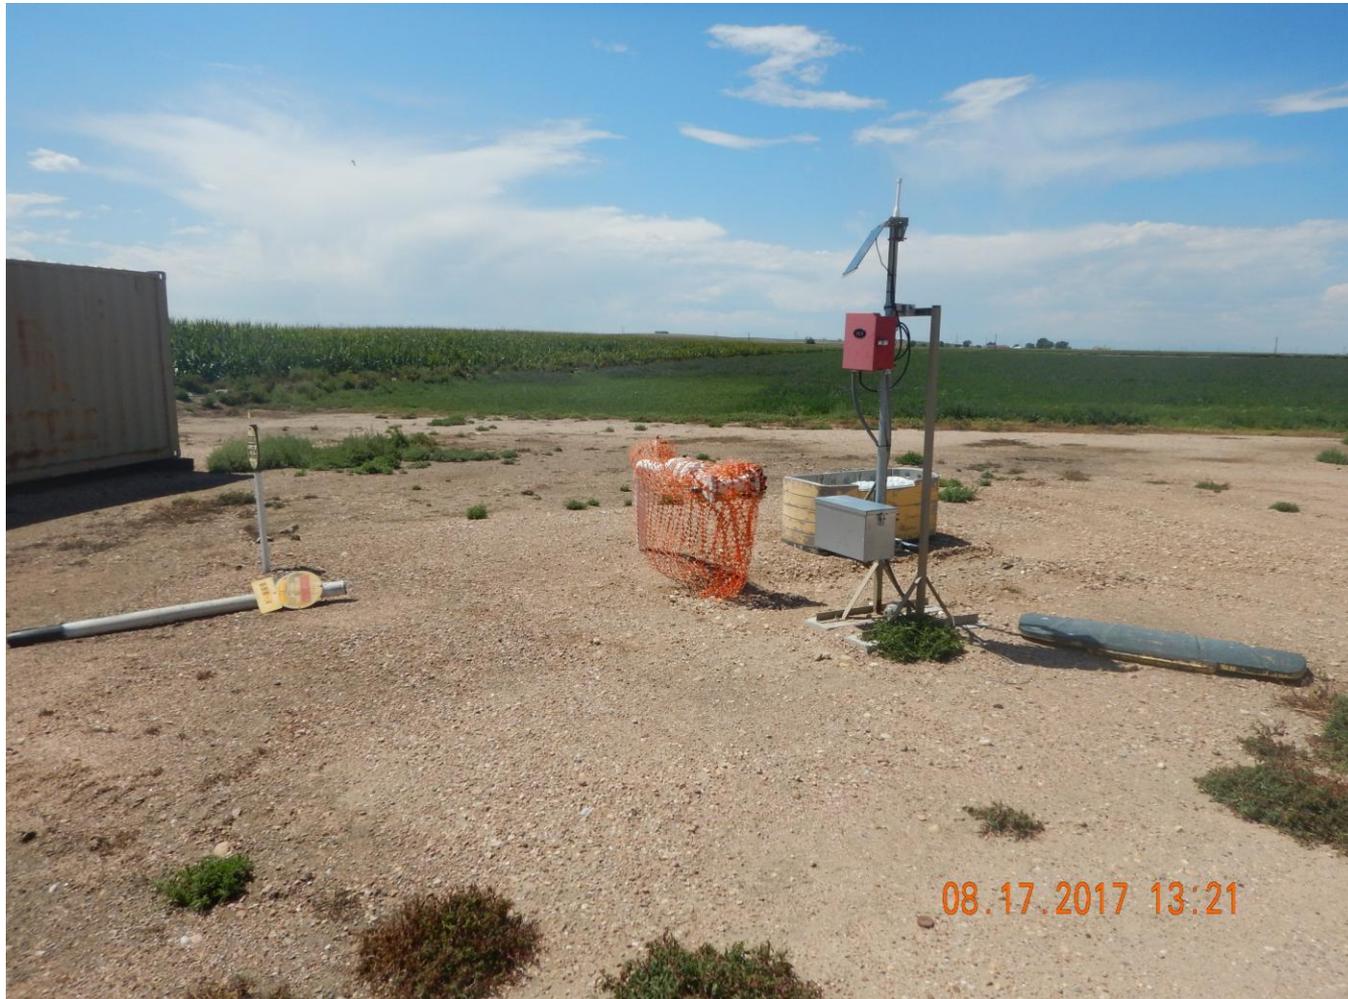
Photo 1: Photo taken from the battery location. Photo shows meter shed has been removed, however pipe equipment associated with the meter shed has not been removed. Photo also shows Battery location remains un-reclaimed
