Inspection Photos

Operator: NOBLE ENERGY INC - 100322

Location ID: 332748

Inspection Doc. Number: 675103899

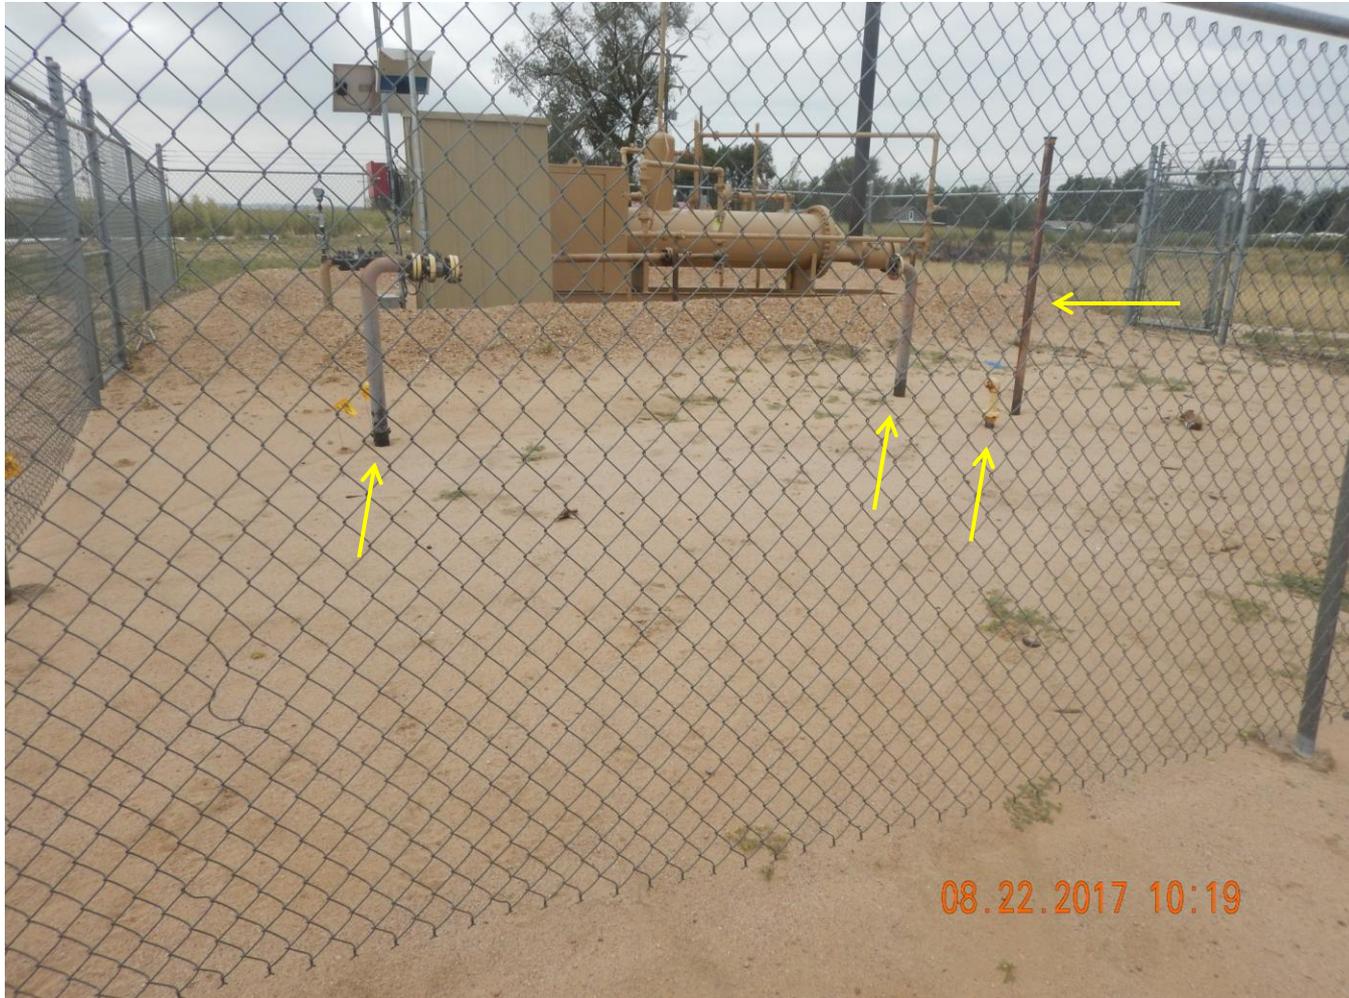
Photo 5: Photo taken from the east end of the battery facility location, facing south. Inspection doc. #682502476 identified four (4) risers at the battery location, and required they be removed in accordance to 1004.a. Photo shows risers have not been removed.
