# Final Reclamation and Stormwater Inspection

September 6, 2017

Operator: PDC ENERGY INC - 69175

Inspection Photos  
Location Name: FEIT BROTHERS #2-27  
Location ID: 319055

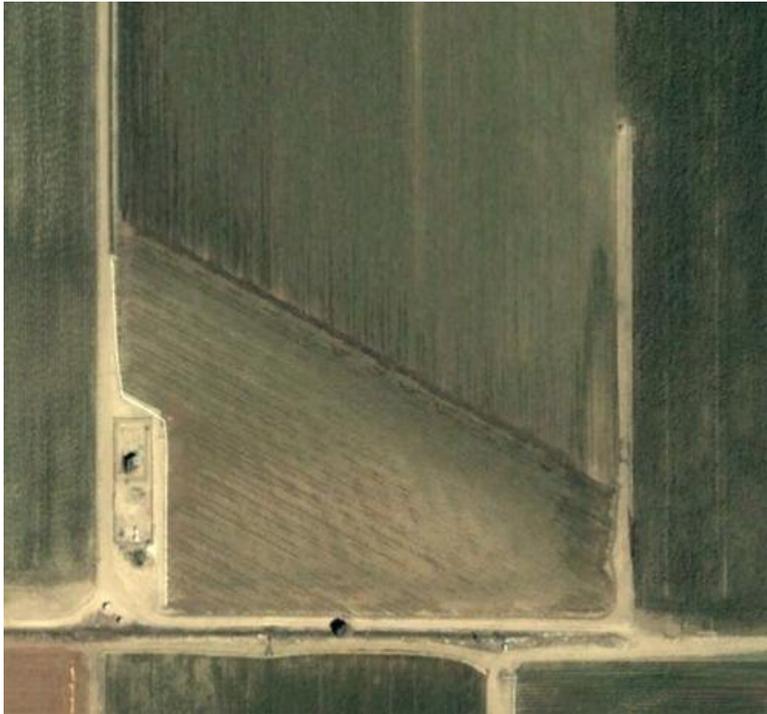
Google Earth aerial imagery taken June 28, 2006 during active operations. Imagery illustrates well location and battery location.

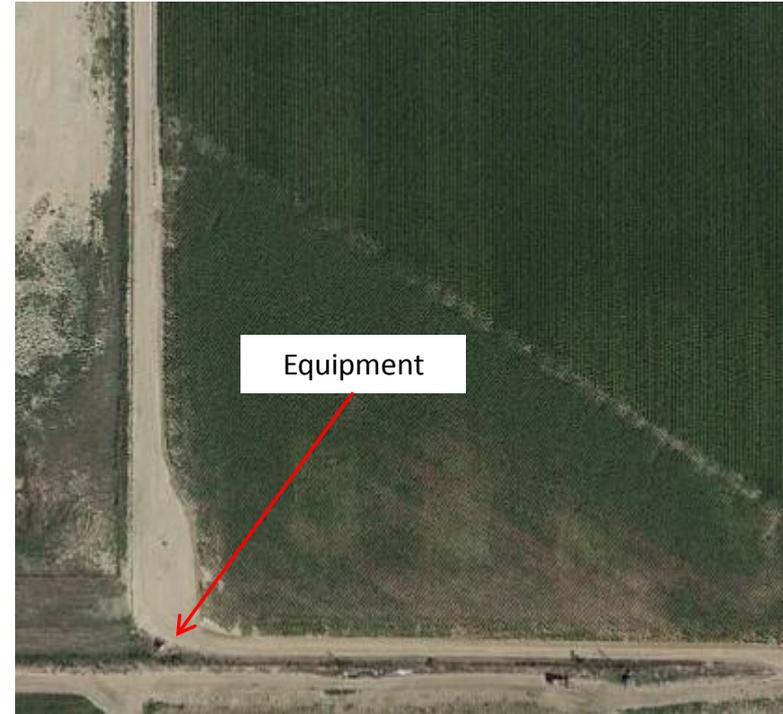
Google Earth aerial imagery taken September 7, 2016. Meter shed with risers (equipment) remain at the battery location. Well location and battery location appear to meet Rule 1004 standards.

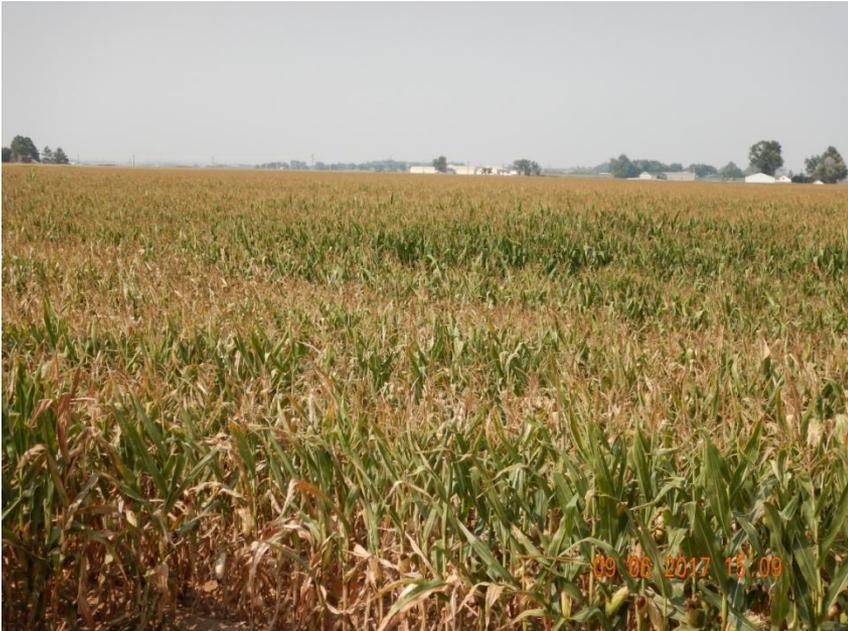
**Photo 1.** Photo taken south of the well location, facing North along the existing access road. Unable to find evidence of oil and gas activities and/or disturbances. Well location and access road appear reflective of reference crop areas.

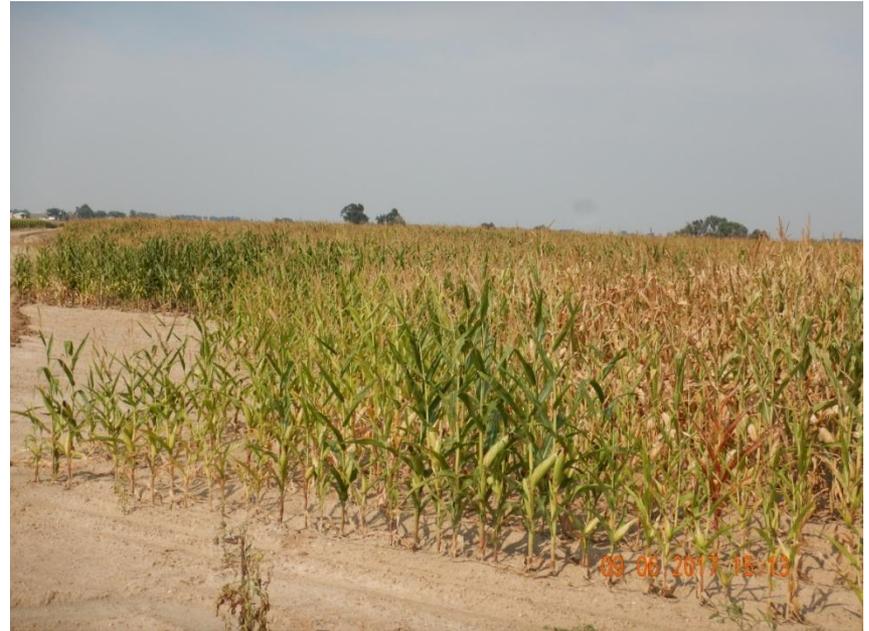
**Photo 2.** Photo taken south of the battery location, facing North. Unable to find evidence of oil and gas activities and/or disturbances. Battery location appears reflective of reference crop areas.

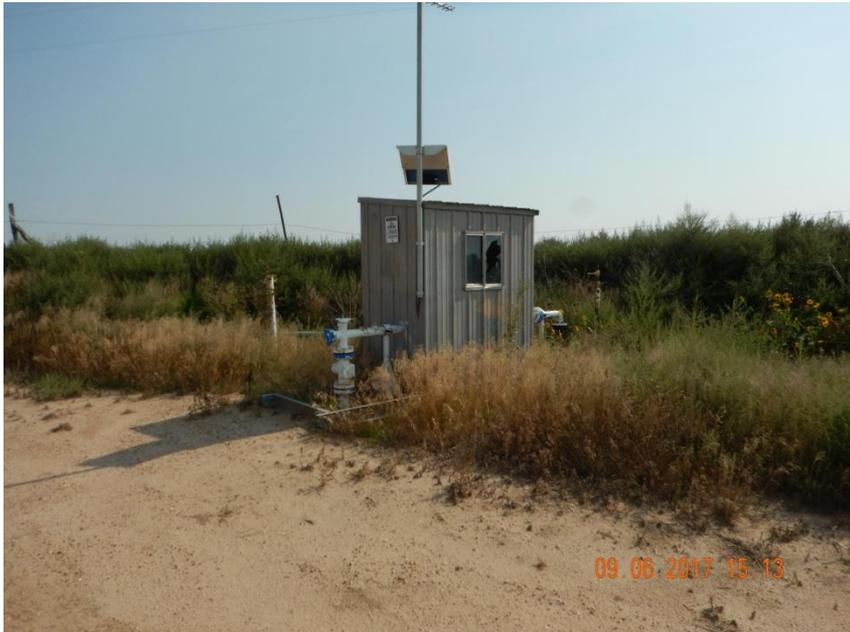
**Photo 3.** Photo taken from the battery location, facing South. Meter shed and risers remain at location. Comply with Rule 1004.a. to remove all equipment by 10/4/2017.

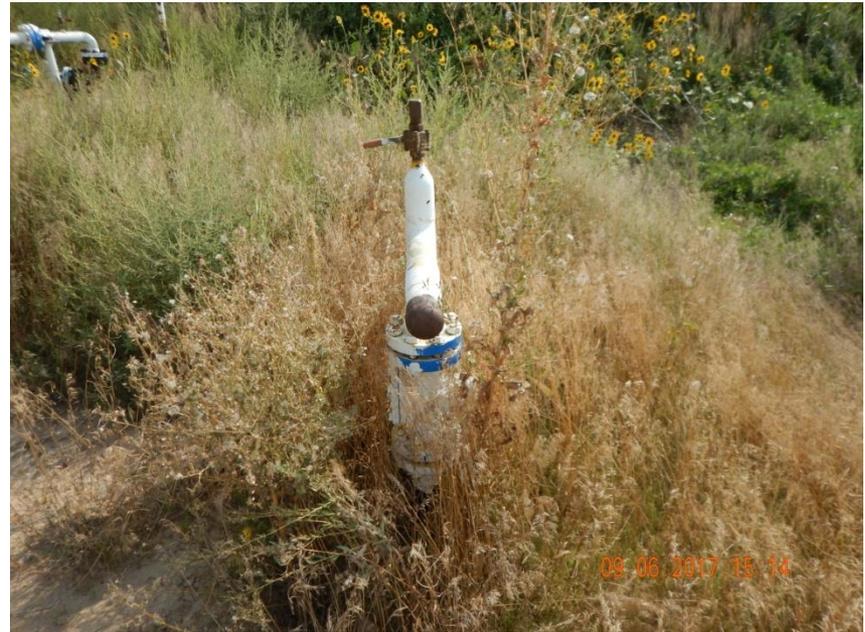
**Photo 4.** Photo taken from the battery location. Risers remain at location. Comply with Rule 1004.a. to remove all equipment by 10/4/2017.

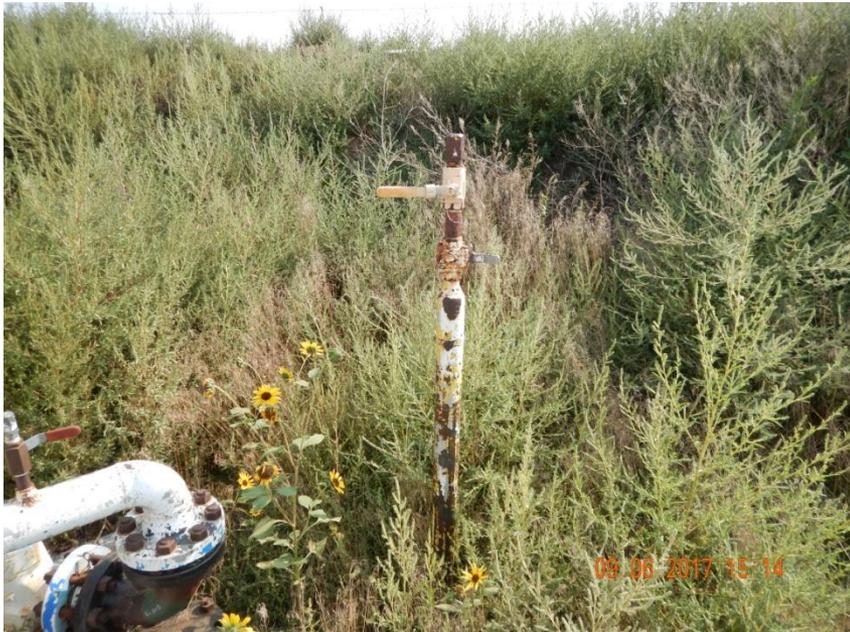
**Photo 5.** Photo taken from the battery location. Risers remain at location. Comply with Rule 1004.a. to remove all equipment by 10/4/2017.

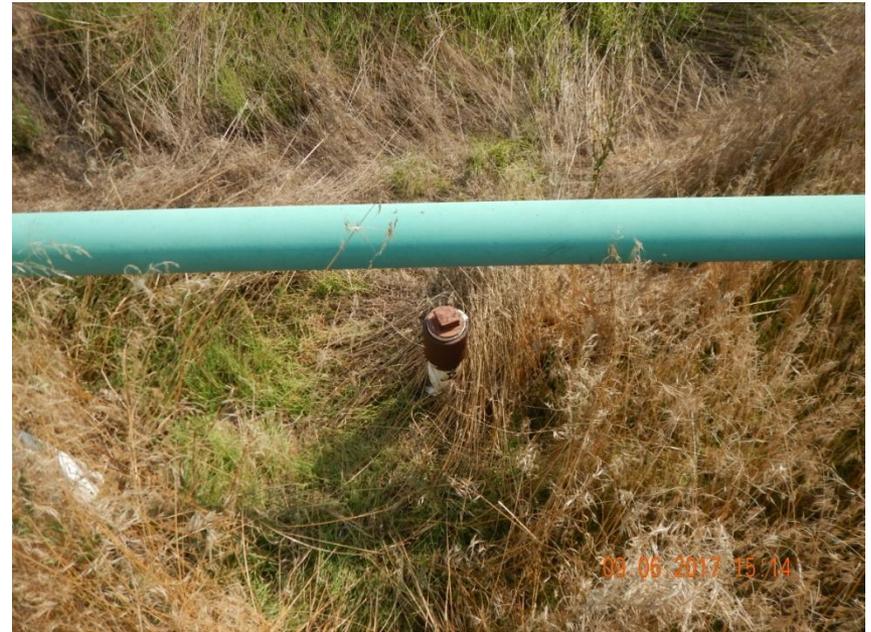
**Photo 6.** Photo taken from the battery location. Risers remain at location. Comply with Rule 1004.a. to remove all equipment by 10/4/2017.
