AC 01-12 API# 05-071-09475

Date: September 14, 2017

Corrective Actions completed regarding COGCC FIR Document # 689900162

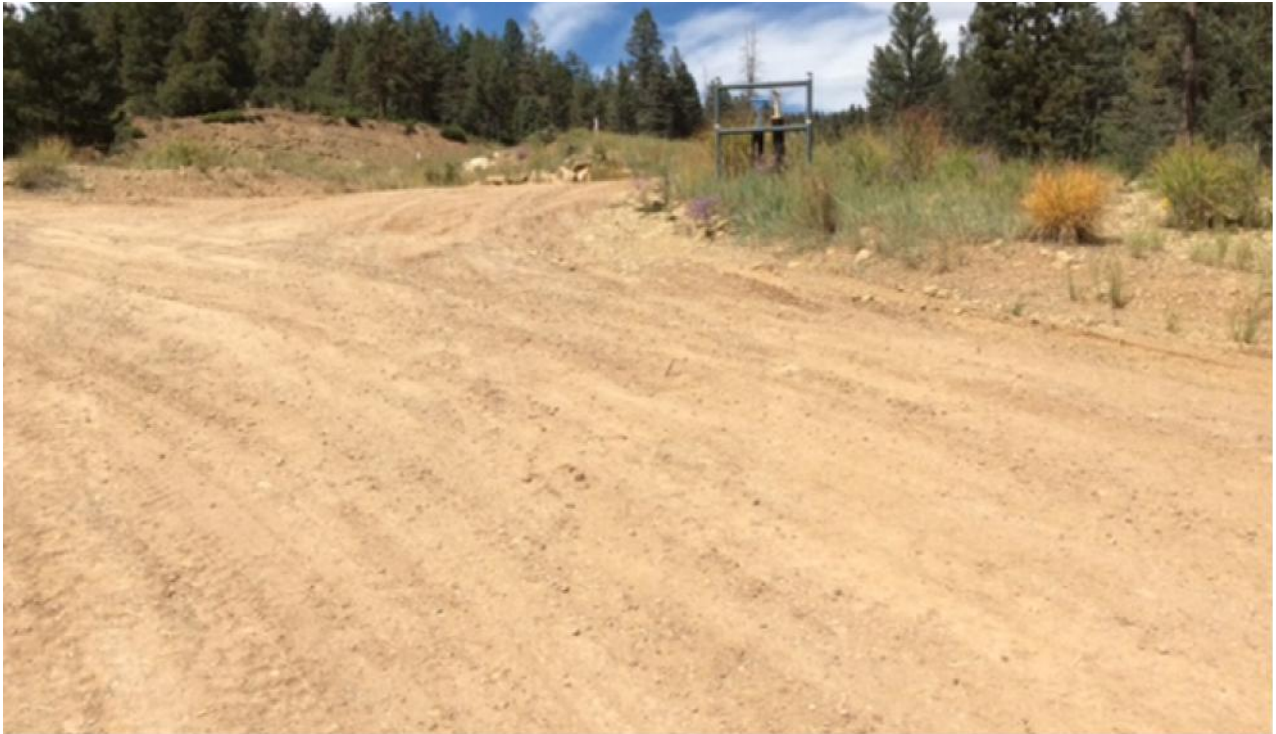
Photo 1: Facing west along the main road. Installed road base and surfaced crowned the driving surface to establish sheet flow.

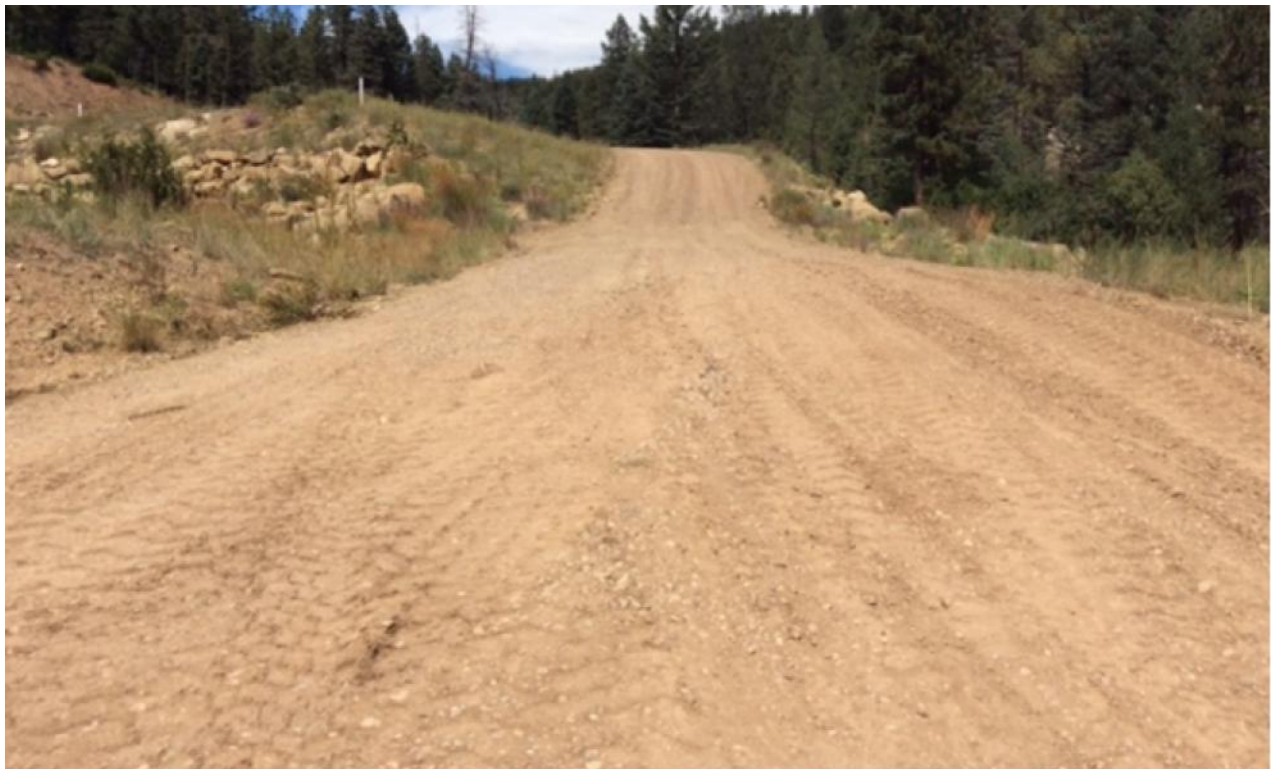
Photo 2: Access road to AC 01-12 well pad. Installed road base and surfaced crowned the driving surface to establish sheet flow.

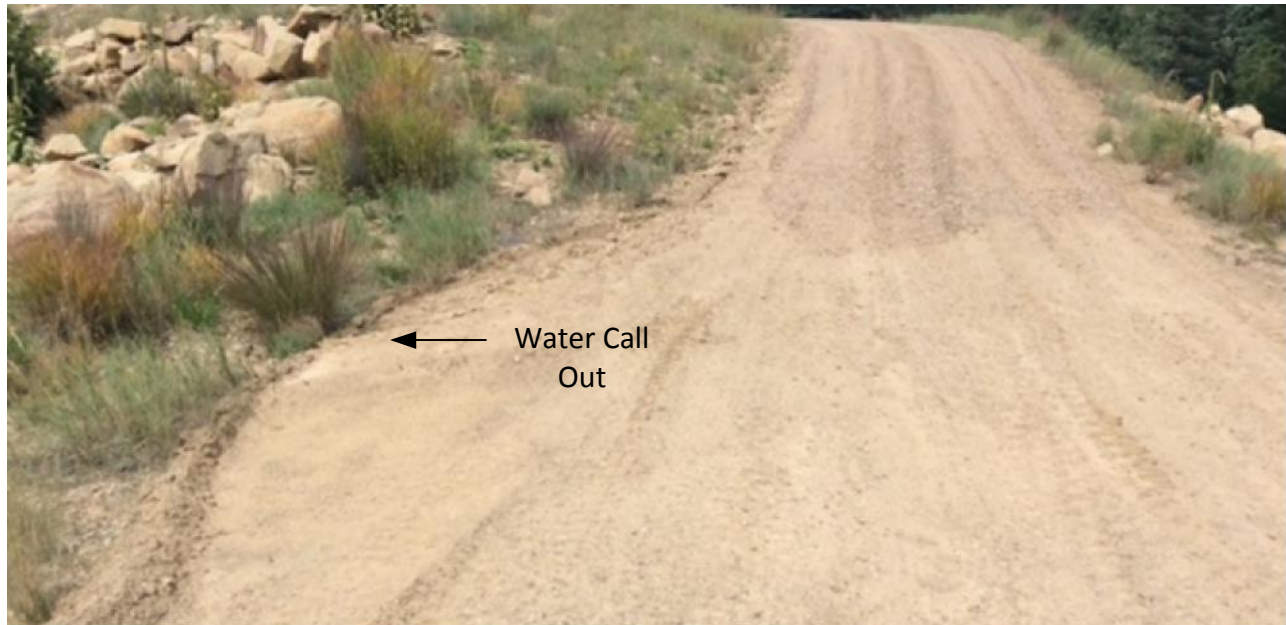
Photo 3: Access road to AC 01-12 well pad. Created a water call out to allow water to drain from the roadway surface to the west side of access road.

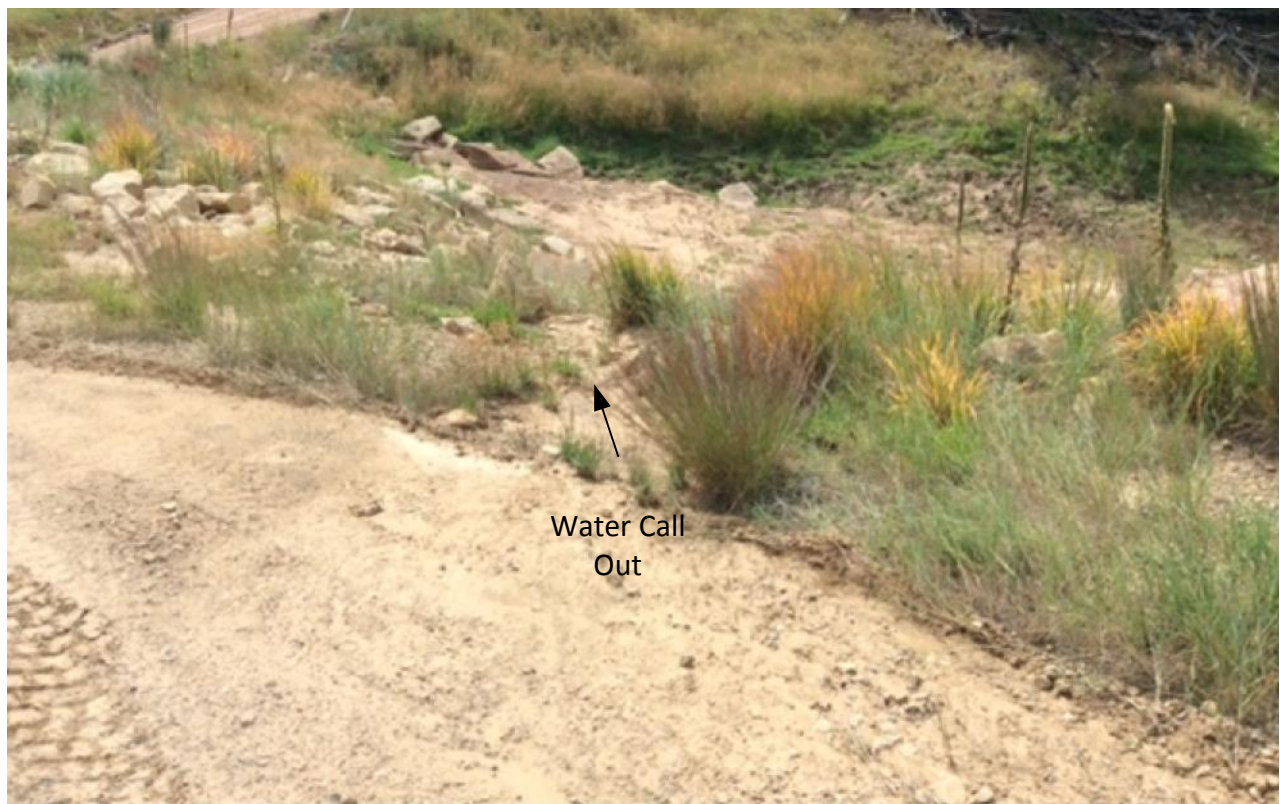
Photo 4: Access road to AC 01-12 well pad. Run off is diverted to an armored swell toward the culvert inlet.

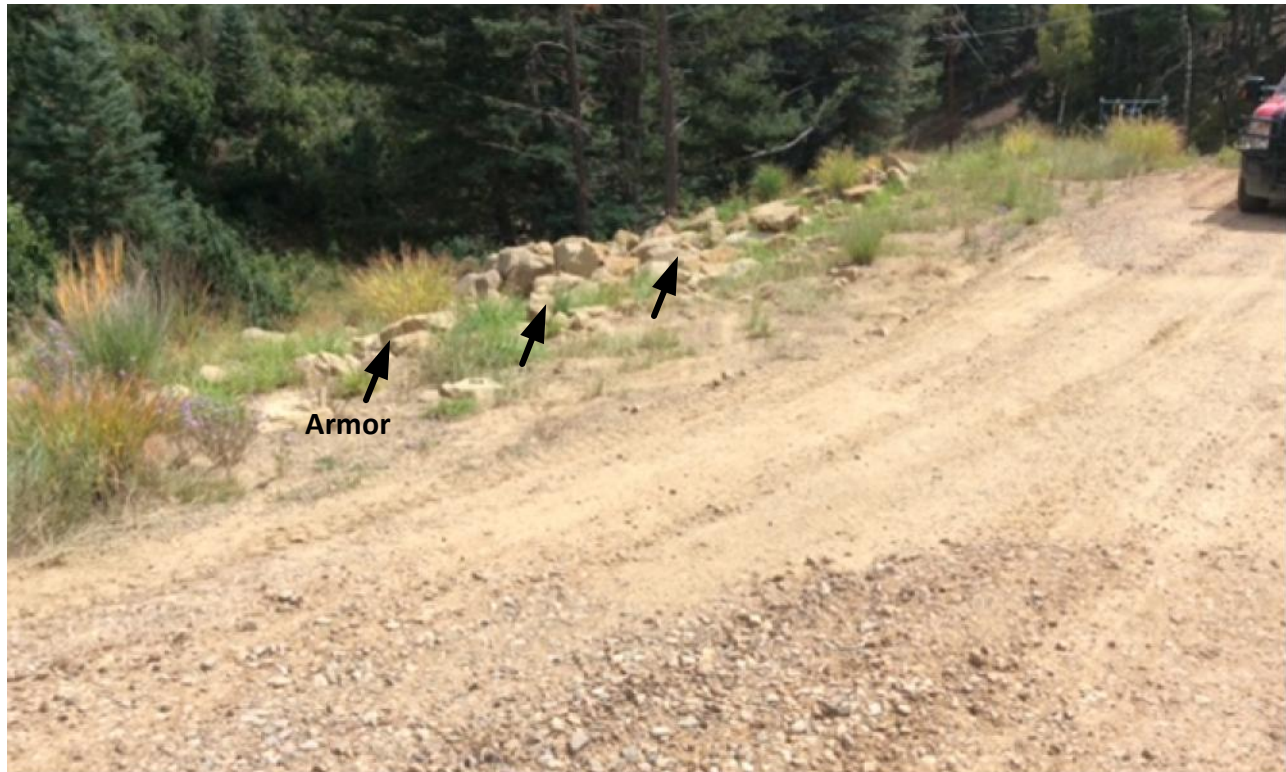
Photo 5: Access road to AC 01-12 well pad. Created sheet flow from the access road to drain water from the roadway surface to the east side of the access road where the existing armor on the culvert outlet side will be utilized for erosion control.

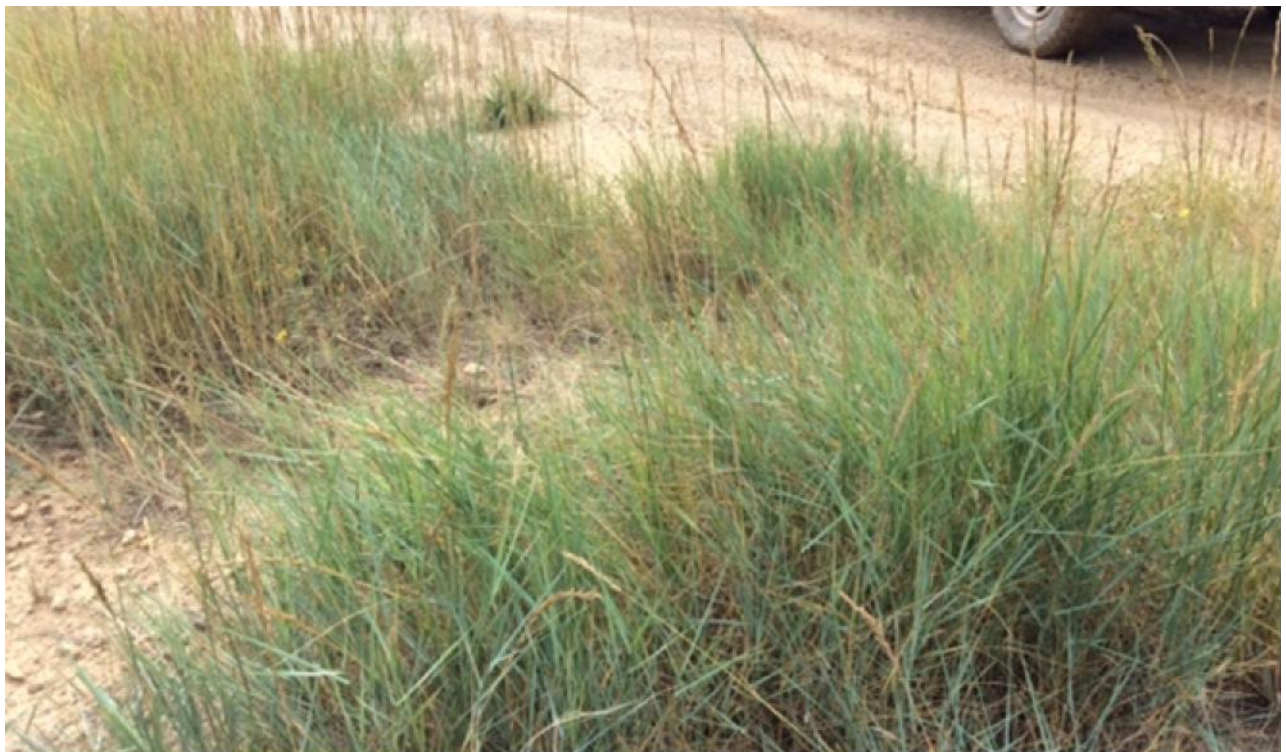
Photo 6: The noxious weeds (Bull Thistle) were removed and bagged on 08/28/17.
