Inspection Photos

Operator: NOBLE ENERGY INC - 100322

Location ID: 318670

Inspection Doc. Number: 682502623

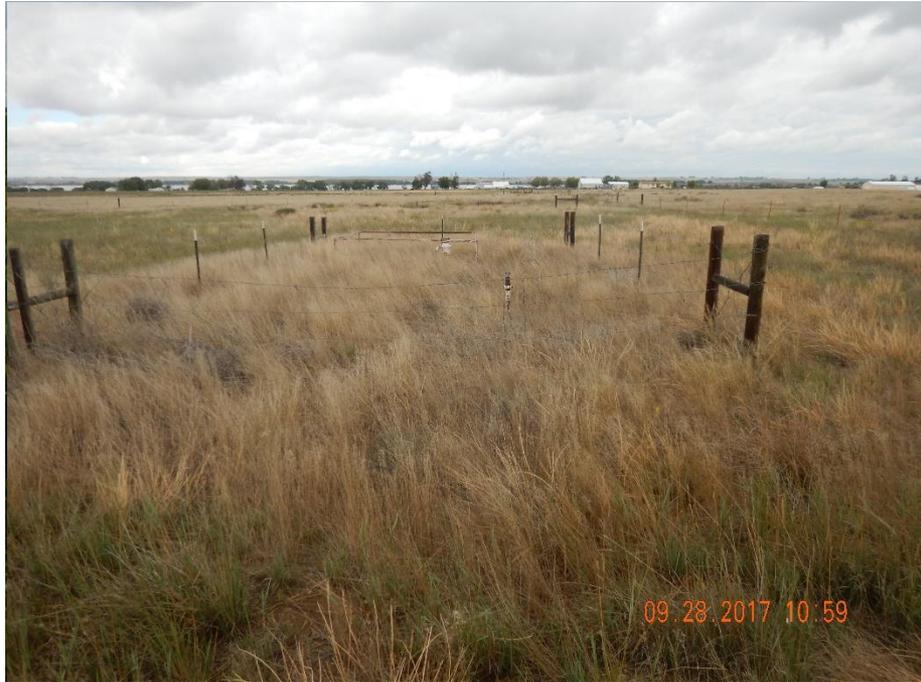
Photo 1: Photo taken from the east end of the well location, facing west. Photo shows two (2) pipe risers still remaining at the location. Inspection doc. #682502155 and #675103864 required operator to remove risers in accordance to COGCC 1004.a reclamation requirements.

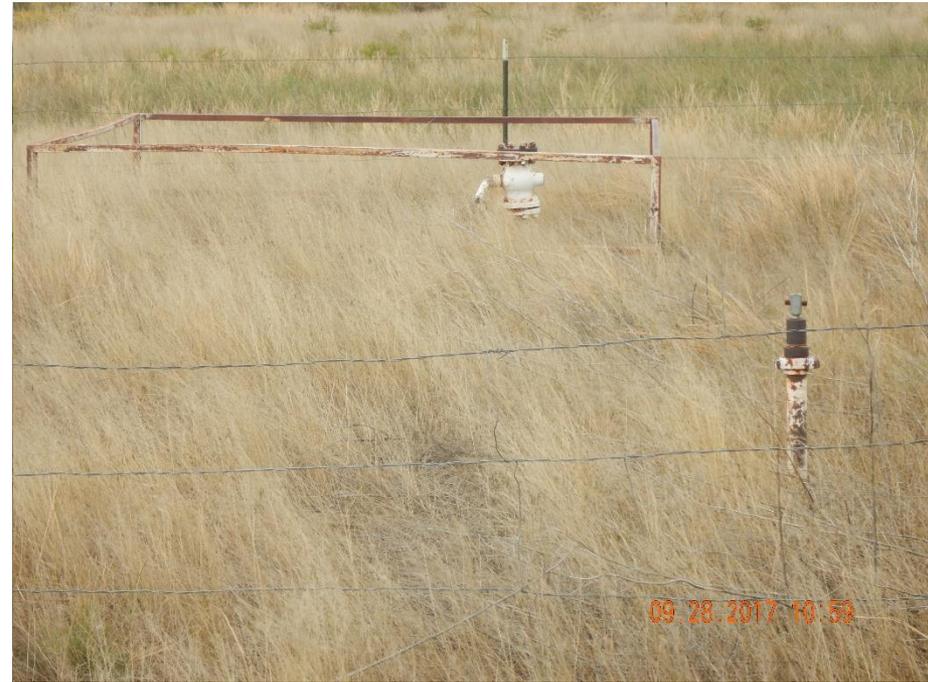
Photo 2: See comments under photo 1
