Inspection Photos

Operator: CASCADE PETROLEUM LLC - 10414

Location ID: 439341

Inspection Doc. Number: 682502781

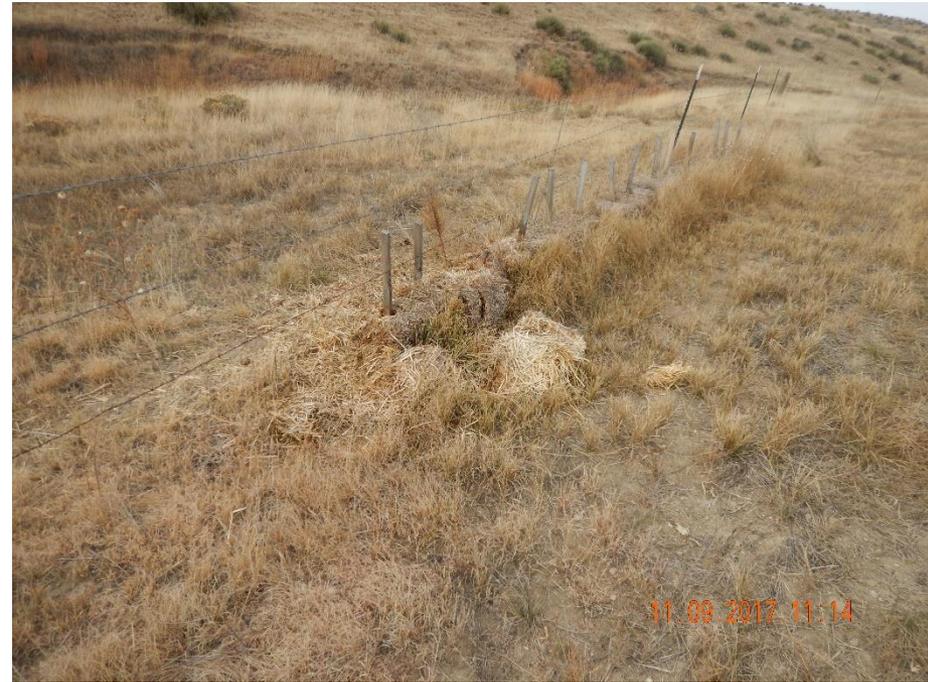
Photo 2: Photo taken from the southwest end of the location, facing west. Inspection #682502556 required operator to install or repair stormwater and sediment control BMPs on location. Photo shows hay-bale ponding BMP that has not been maintained or repaired, and is not in proper functioning condition.

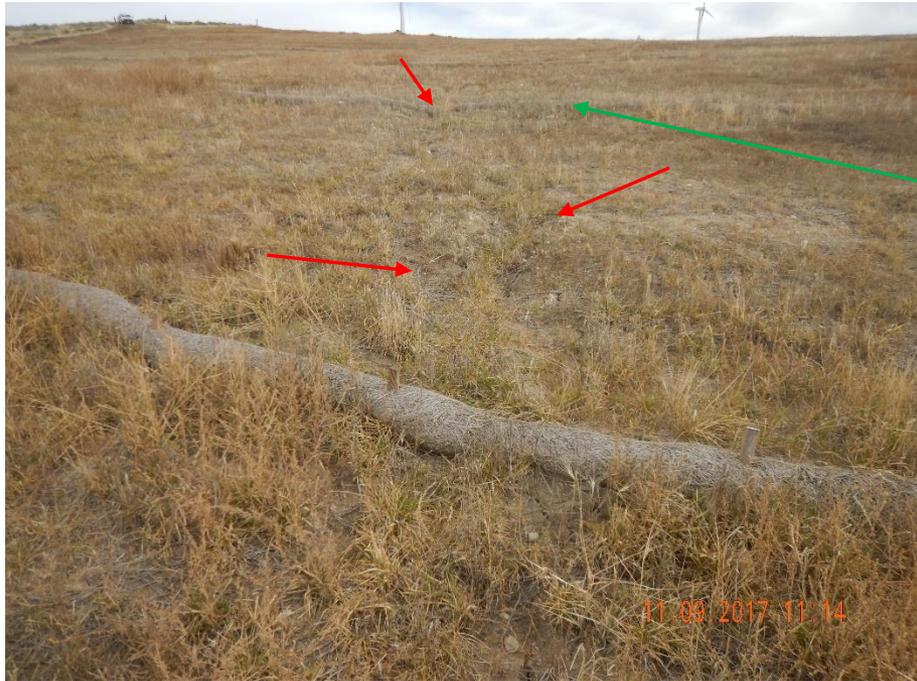
Photo 3: Photo taken from the southwest end of the location, facing north. Photo shows straw wattle ponding BMPs on location. Photo also shows areas where water movement has created gully erosion

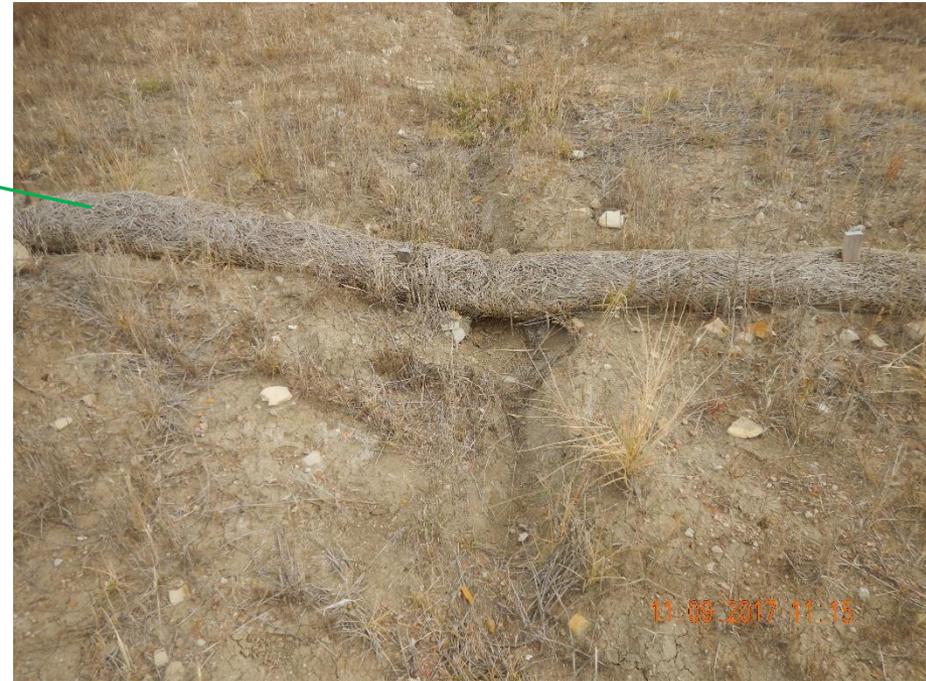
Photo 4: Photo taken from the straw wattle BMP at top of photo 3 (green arrow). Photo shows BMP is not longer in proper functioning condition as stormwater has cut under the wattle.

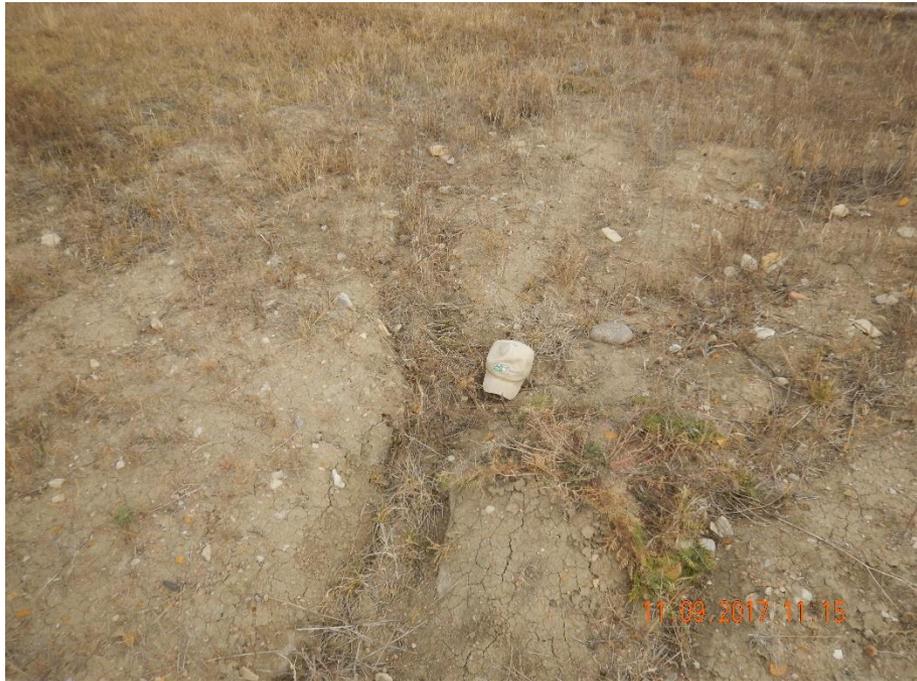
Photo 5: Photo taken from the southwest southwest end of the location. Inspection #682502556 required operator to repair erosion and stabilize the location. Photo shows erosion degradation has not been repaired, and stabilized. Hat for reference.

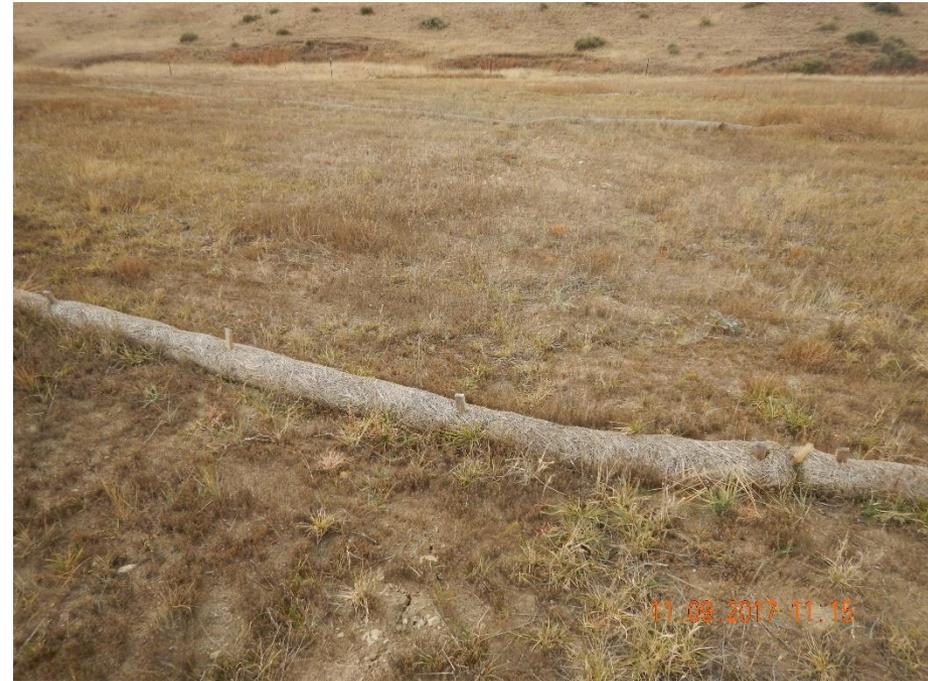
Photo 6: Photo taken from the south end of the location, facing southwest. Photo shows straw wattle ponding BMPs on location.
