Inspection Photos
Location Name: Haller 32-12
API: 05-123-08513

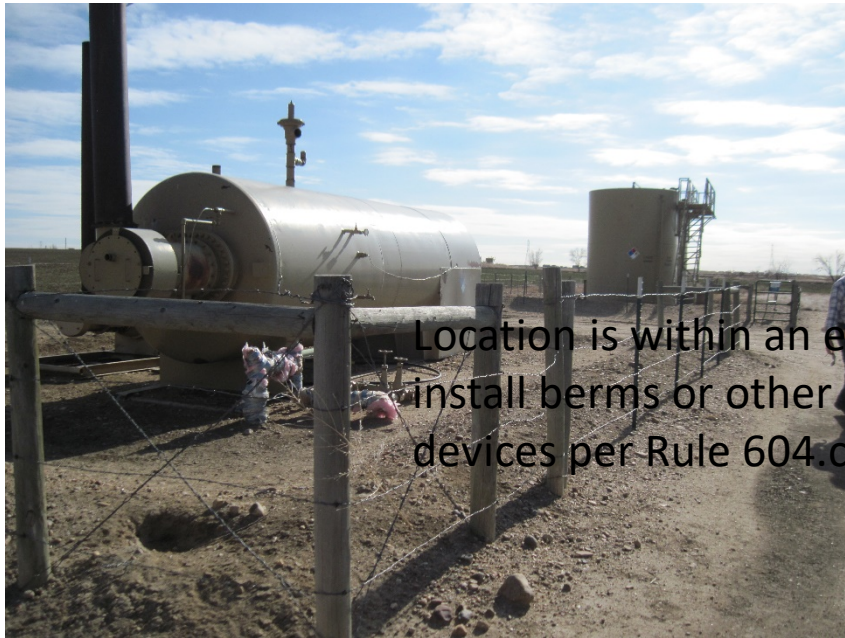
Location is within an exception zone, repair or install berms or other secondary containment devices per Rule 604.c.(3)B.
