Inspection Photos
Location Name: Haller 42-11
API: 05-123-08715

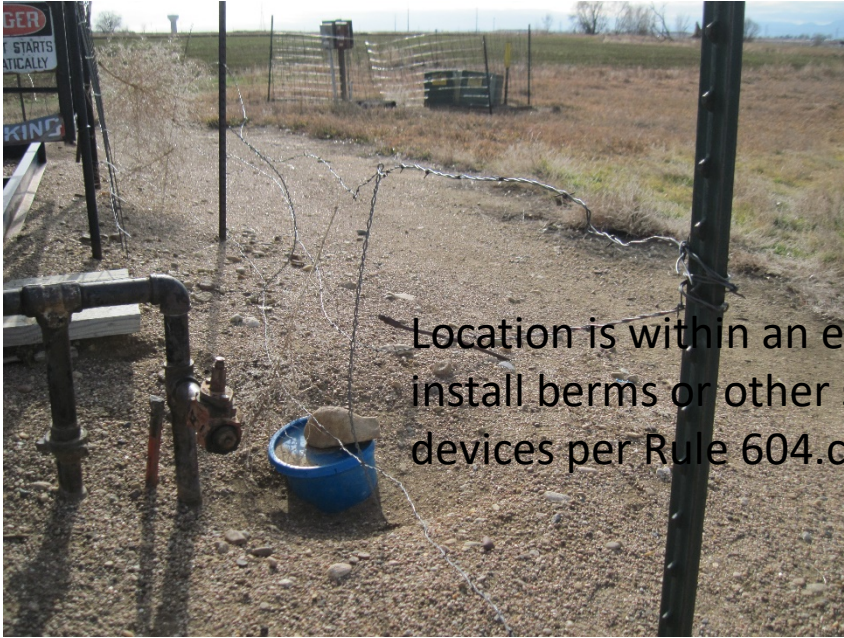
Location is within an exception zone, repair or install berms or other secondary containment devices per Rule 604.c.(3)B.
