Inspection Photos
Location Name: Goetz #1
API: 05-123-10157

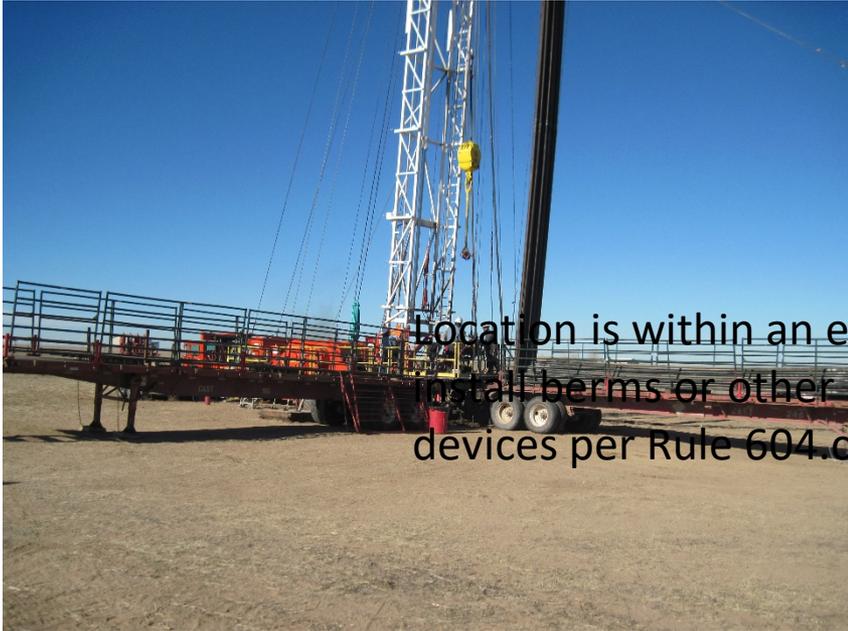
Rig on wellhead

Location is within an exception zone, repair or install berms or other secondary containment devices per Rule 604.c.(3)B.

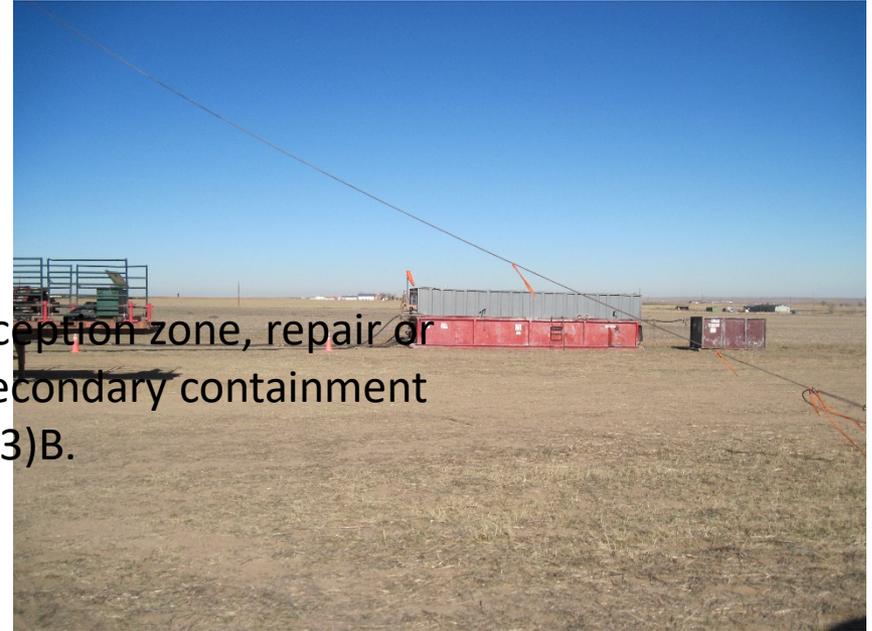
Circulating tank
