LT Environmental, Inc.

## BORING LOG/MONITORING WELL COMPLETION DIAGRAM

Boring/Well Number:	MW07			Project:	Cullen Odenbaugh C UT #1		
Date:	3/14/2014			Project Number:	14213230		
Logged By:	Jeremy Espinoza			Drilled By:	Drill Pro		
Drilling Method:	Direct Push			Sampling Method:	Continuous		
Seal:	Bentonite			Grout:	None		
Gravel Pack:	Silica Sand			Hole Diameter:	3"		
Casing Type:	PVC			Depth to Liquid:			
Screen Type:	PVC			Total Depth:	12'		
Slot:	0.01			Depth to Water:	7'		
Diameter:	1"						
Length:	2'						
Diameter:	1"						
Length:	10'

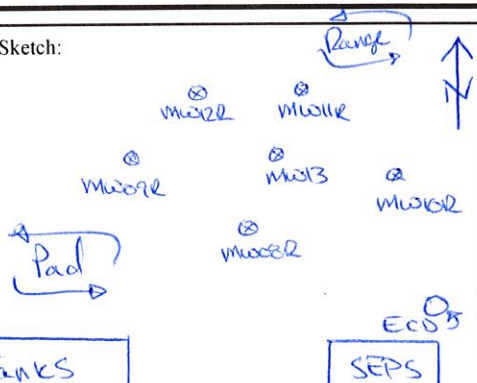
Well Location Sketch:

Boring/Well Number:	M008R	Project:	Odenbaugh, Cullen C Unit #1
Date:	5/31/2016	Project Number:	14215182
Logged By:	Kris Shepherd	Drilled By:	LTE

Penetration Resistance	Moisture Content	Vapor (ppm)	Staining	Sample #	Depth (ft. bgs.)	Sample Run	Recovery	Soil/Rock Type	Lithology/Remarks	Well Completion Diagram
					0					
	moist	0.4	none		2			CL	0' → 0.5' gravelly, sandy clay, brown, low cohesion, low plasticity, no odor, no stain, moist	
	↓	2.1			4			SM		
	wet	0.4			6			OH		
	↓	1.5			8			CL	0.5' → 1.75' silty fg → Mg sand, gray/tan, no odor, no stain, moist	
	moist	0.6			10			PE	1.75' → 3.0' highly organic clay, black/gray, no stain, no odor, low cohesion, low plasticity, moist	
	wet	4.3			12			SW	3.0' → 9.0' silty organic clay, black, no stain, no odor, moist, mod. cohesion, mod. plasticity	
	↓				14				→ wet @ ~4'	
					16					
					18				9.0' → 9.75' Peat, brown/black, no odor, no stain, moist	
					20				9.75' → 10.25' gravelly fg → coarse sand, tan, no odor, no stain, wet	
					22				→ could not progress past 10.25' due to flowing sands	
					24				→ flush mount
