FIGURE 3B
GROUNDWATER ELEVATION CONTOUR MAP
 SECOND QUARTER 2017
 ANDERSON 12-27/BOHLENDER 1-27
 SWNW SEC 27-T4N-R65W
 WELD COUNTY, COLORADO
KERR-MCGEE OIL & GAS ONSHORE LP

FIGURE 3D
GROUNDWATER ELEVATION CONTOUR MAP
FOURTH QUARTER 2017
ANDERSON 12-27/BOHLENDER 1-27
SWNW SEC 27-T4N-R65W
WELD COUNTY, COLORADO
KERR-MCGEE OIL & GAS ONSHORE LP

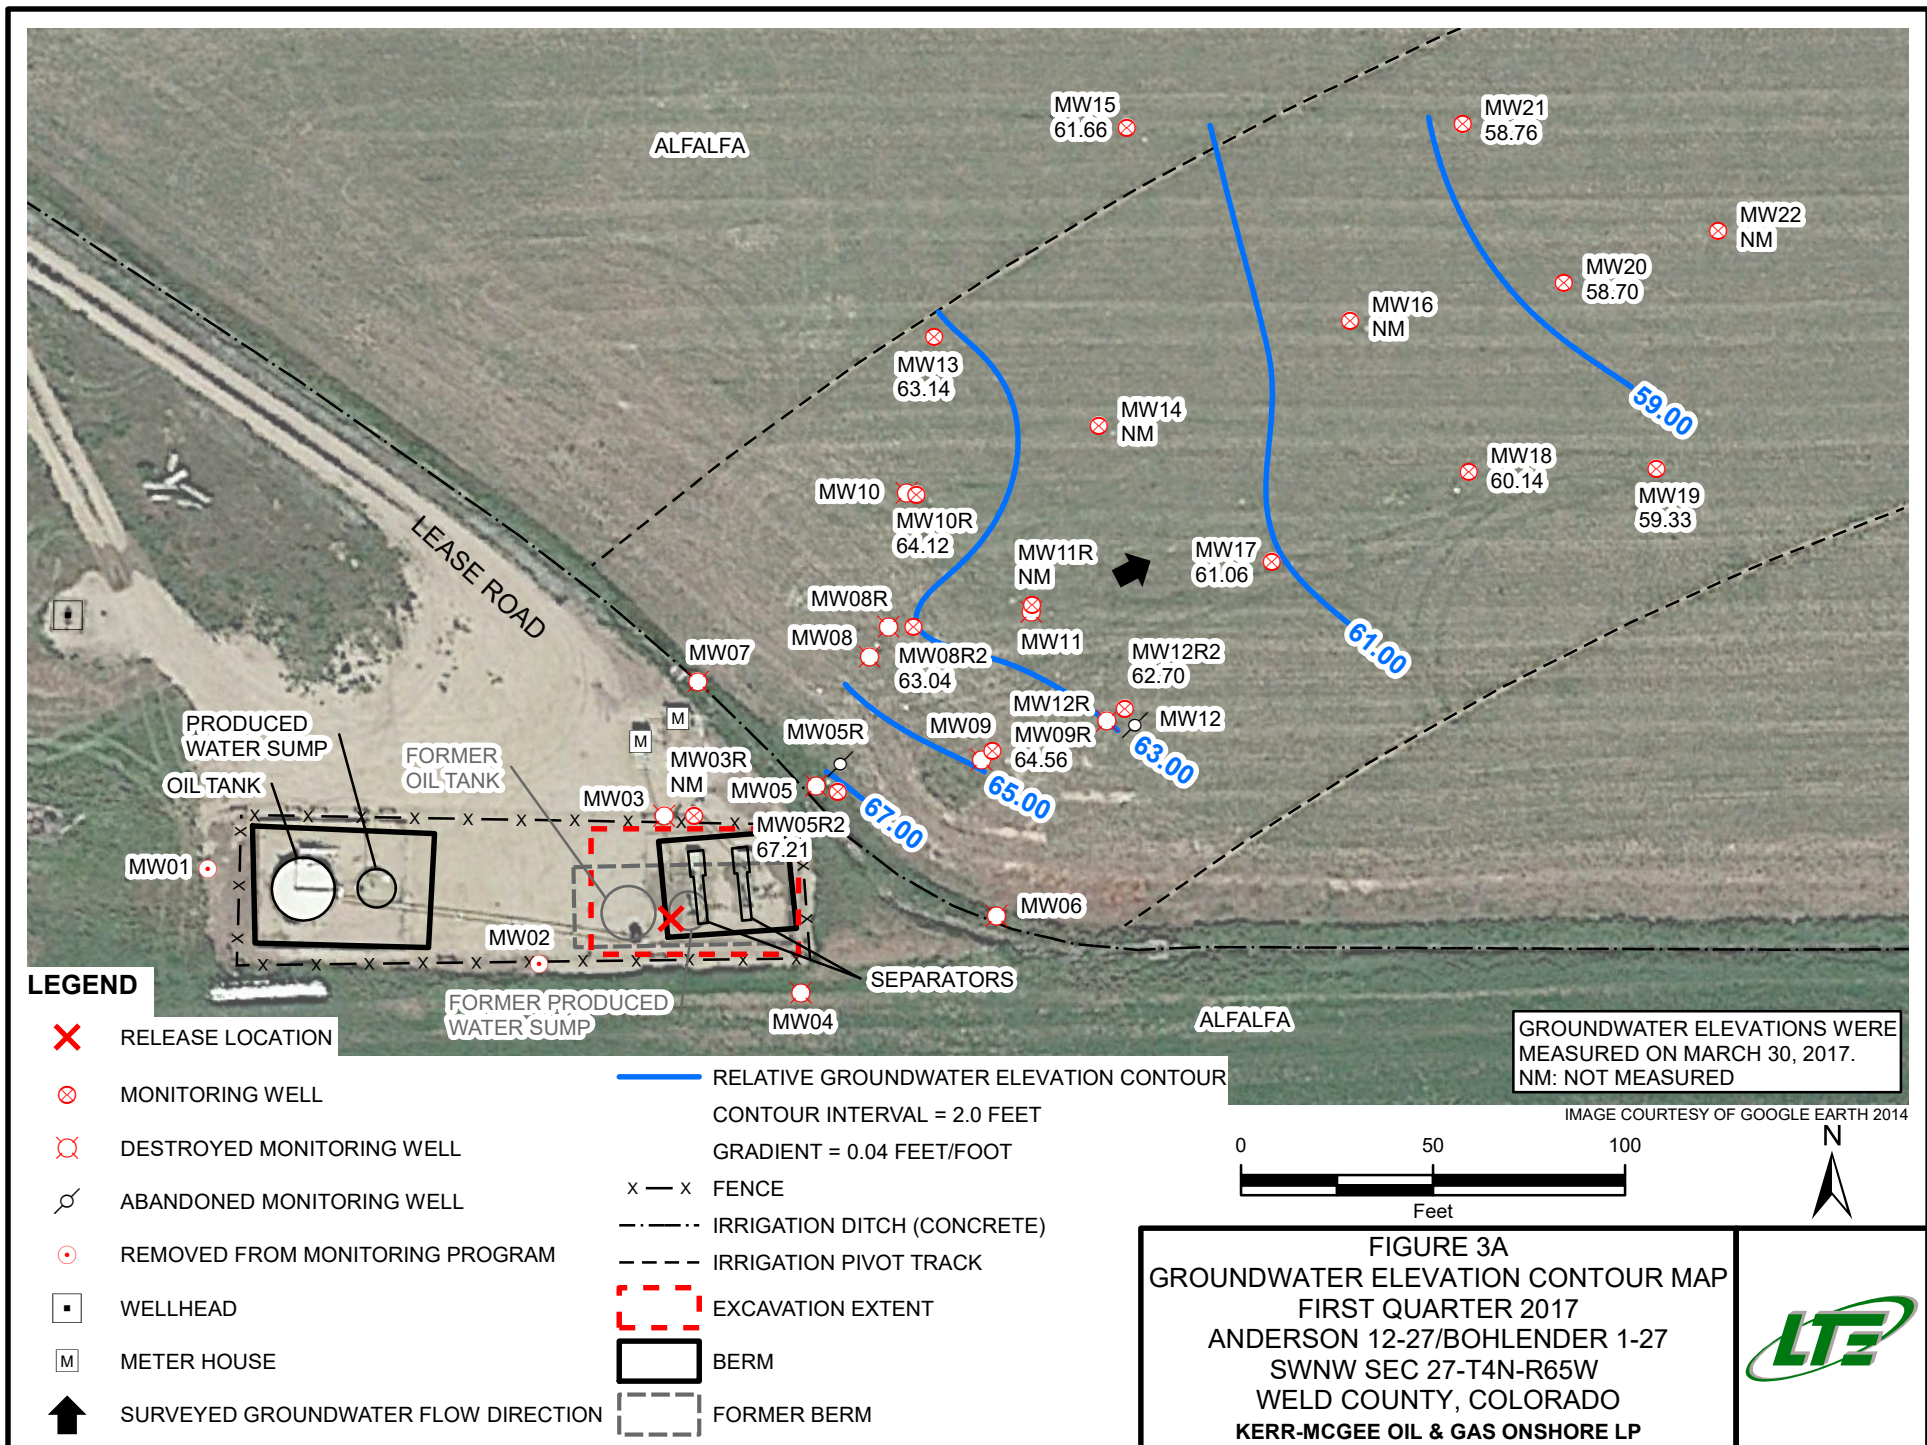
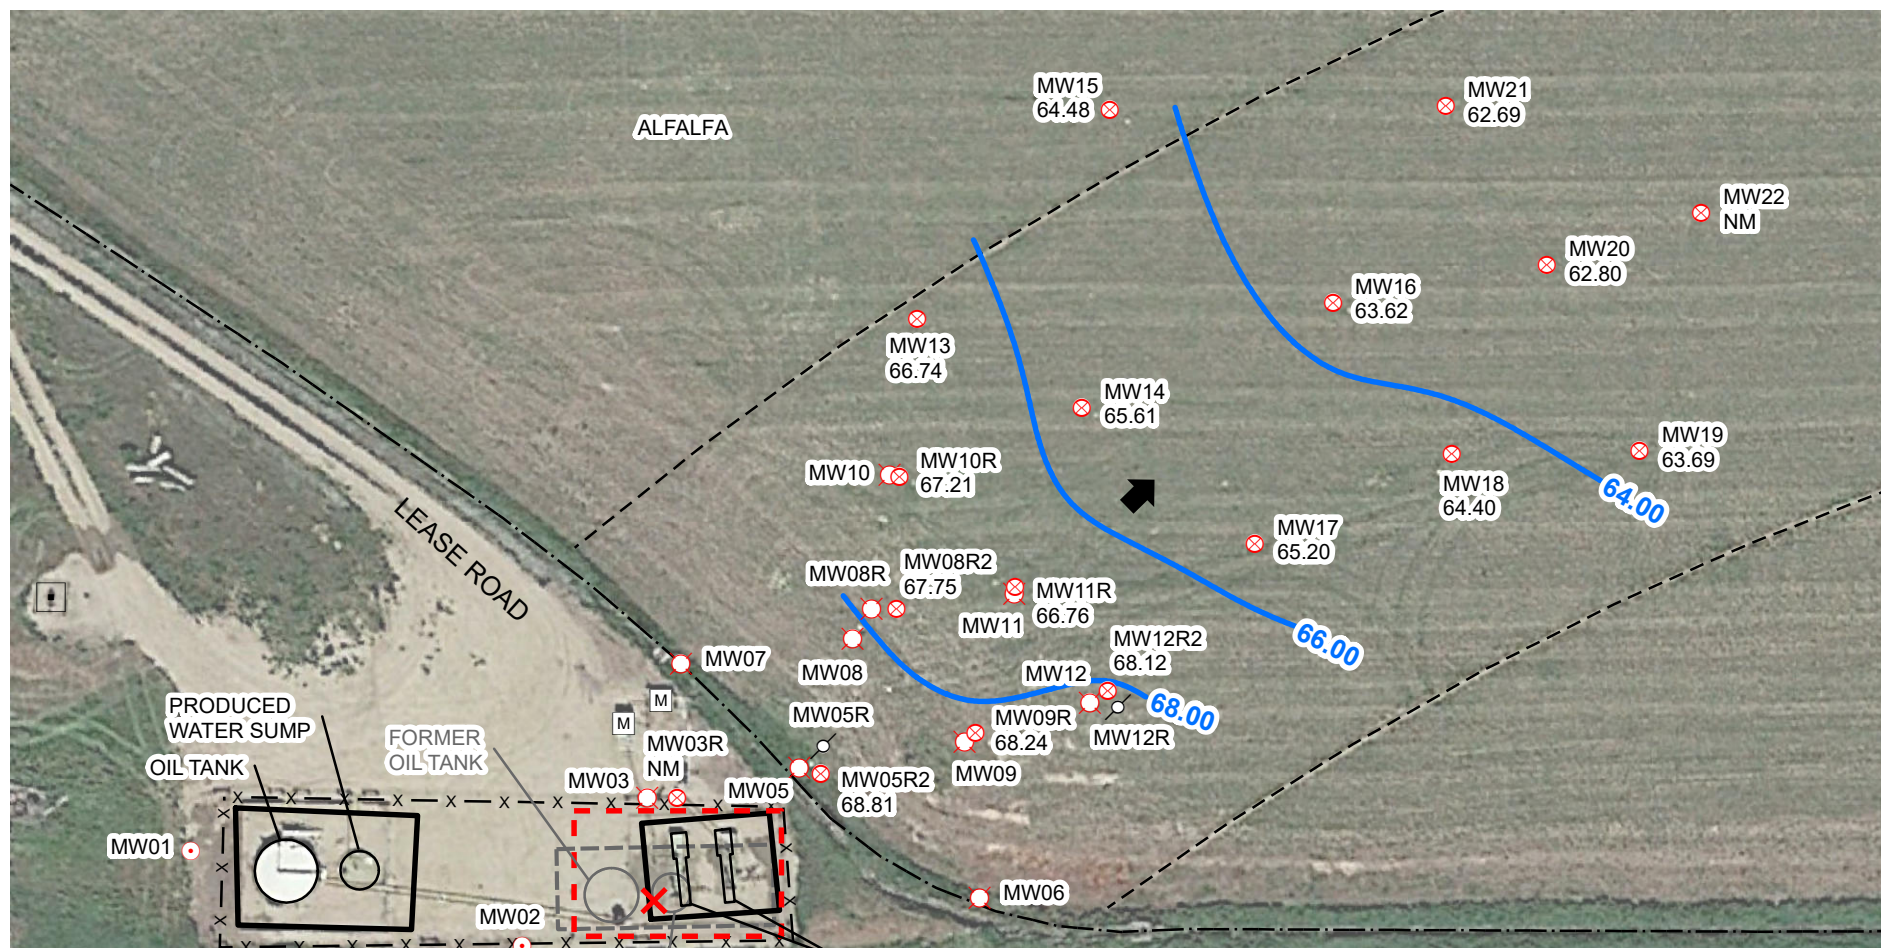
GROUNDWATER ELEVATIONS WERE MEASURED ON JUNE 21, 2017.
NM: NOT MEASURED
