Inspection Photos

Operator: NOBLE ENERGY INC - 100322

Location ID: 327240

Inspection Doc. Number: 682503066

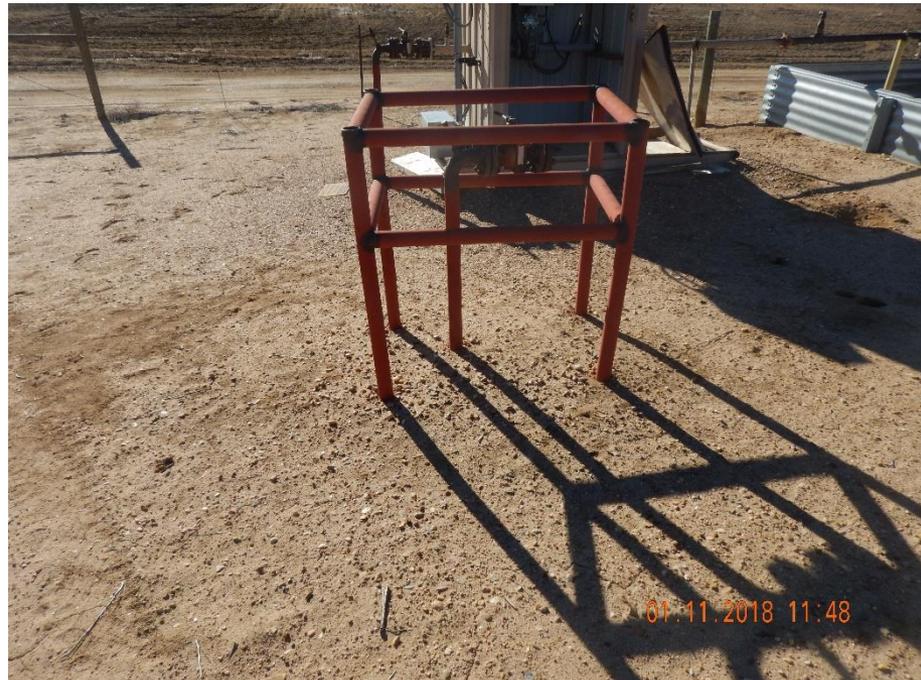
Photo 1: Photo taken from the western end of the battery location, facing south. Photo shows riser has not been removed in accordance to 1004.a and corrective actions

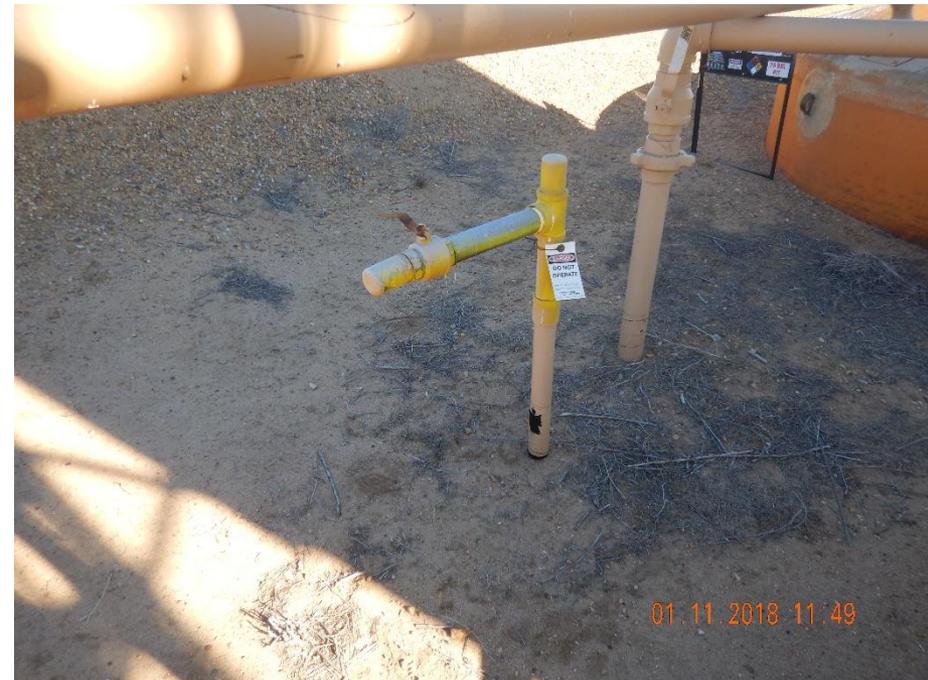
Photo 2: Photo taken from the east end of the battery location. Photo shows pipe riser that has been tagged and painted per the 2017 Flowline NTO, but has not been removed per the NTO required dates. This riser will need to be removed per the NTO and 1004.a.
