# Construction and Stormwater Inspection

Operator: CRESTONE PEAK RESOURCES OPERATING LLC - #10633

Location ID: 428577

Location Name: Ruegge Facility /4H-N165

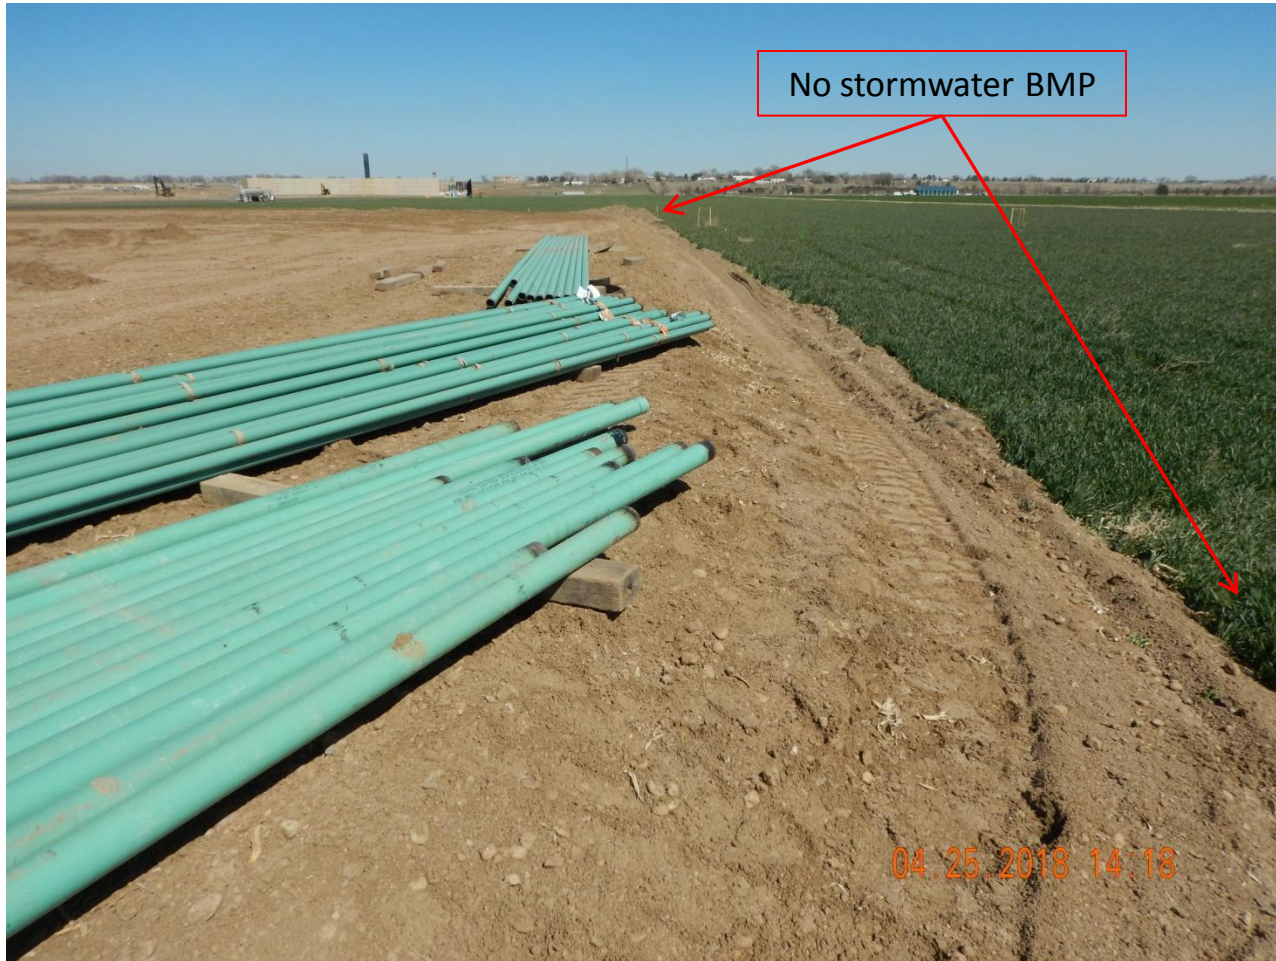
**Photo 1.** Photo taken from the southwest perimeter of the location, facing East. Operator failed to install stormwater BMPs during construction operations.

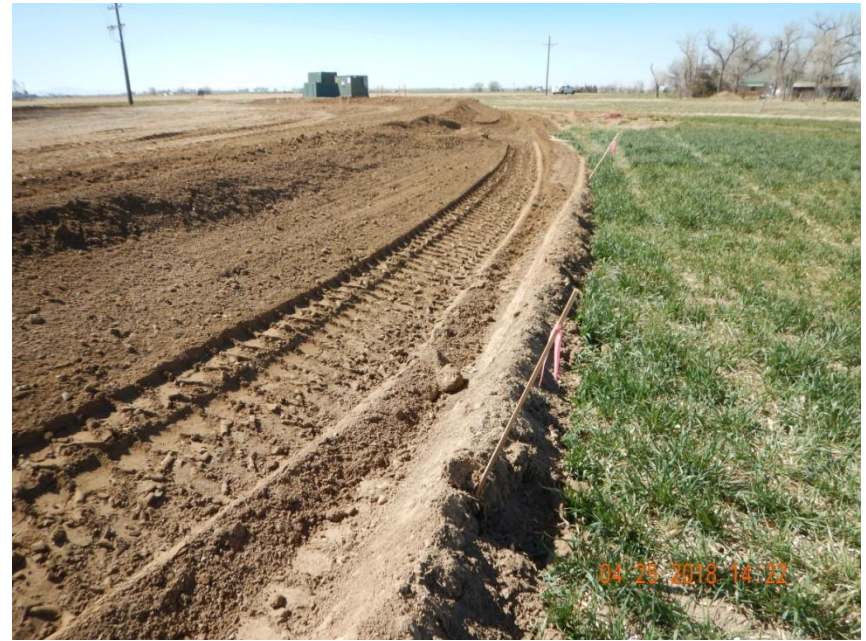
**Photo 4.** Photo taken from the northeast perimeter of the location, facing North. See comments under Photo 1 and 2.
