Final Reclamation Inspection

Operator: KERR MCGEE OIL & GAS ONSHORE LP #47120

API: 05-123-10031

Inspection Photos
Location Name: ANDERSON FAMILY TRUST C #2
API: 05-123-10031

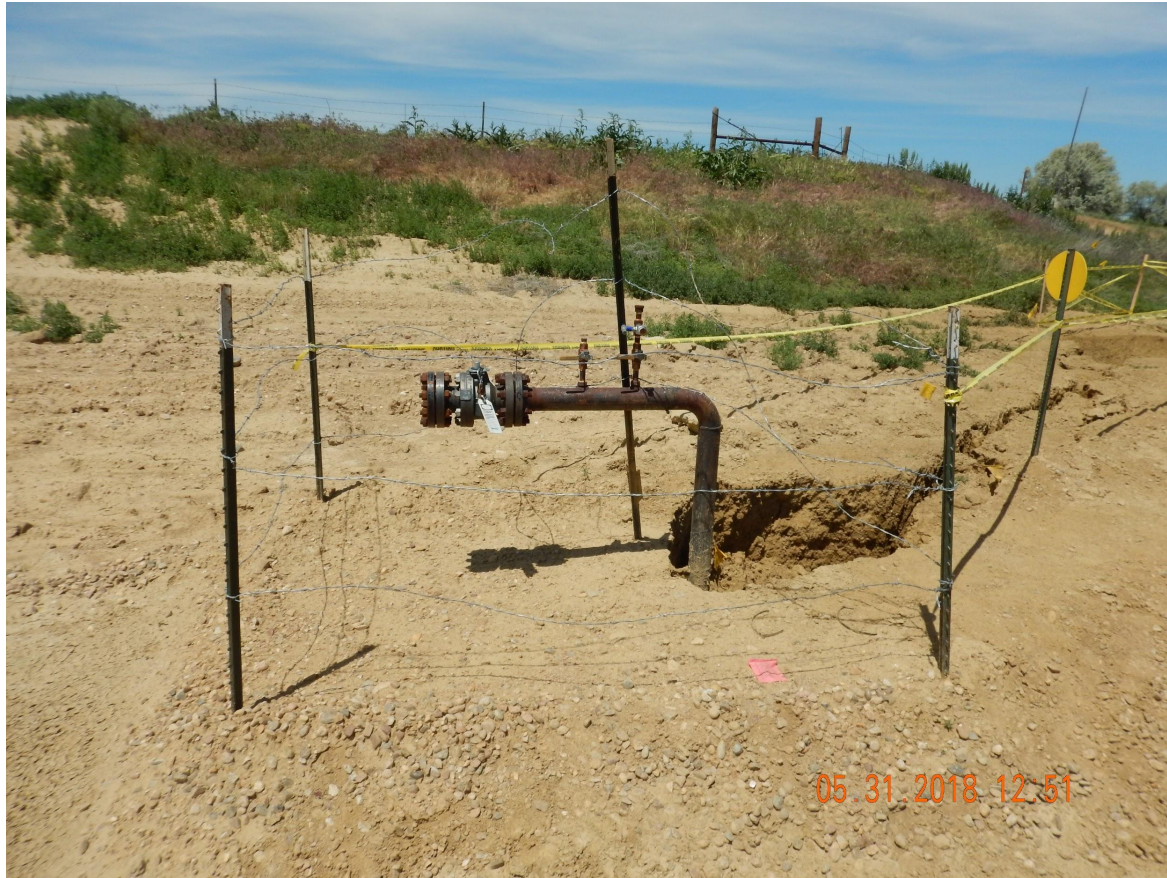
Photo 1. Photo taken from the battery location, facing North. Riser remains at the battery location and should have been removed by 11/31/2017.

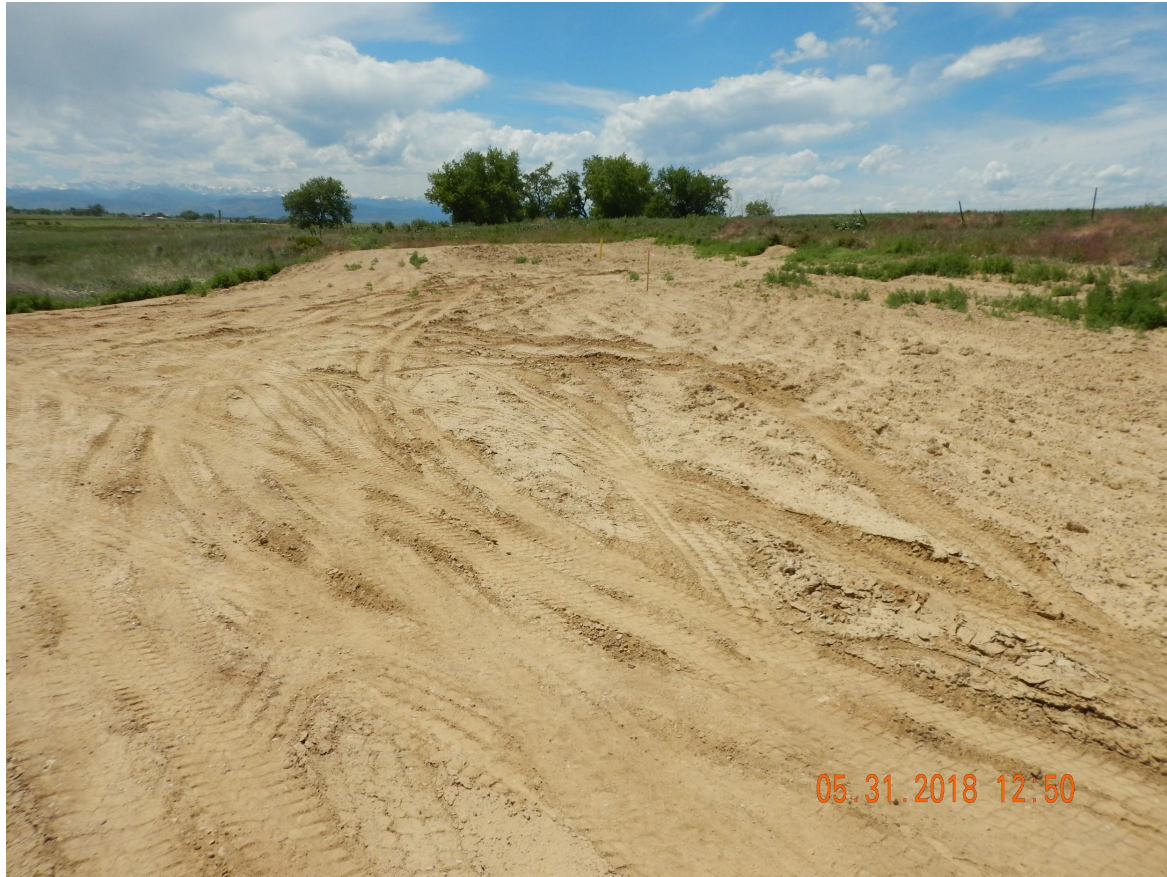
Photo 2. Photo taken from the battery location, facing West. Well has been plugged and abandoned. Operator shall complete final reclamation activities at the battery location per Rule 1004 by 8/31/2018.

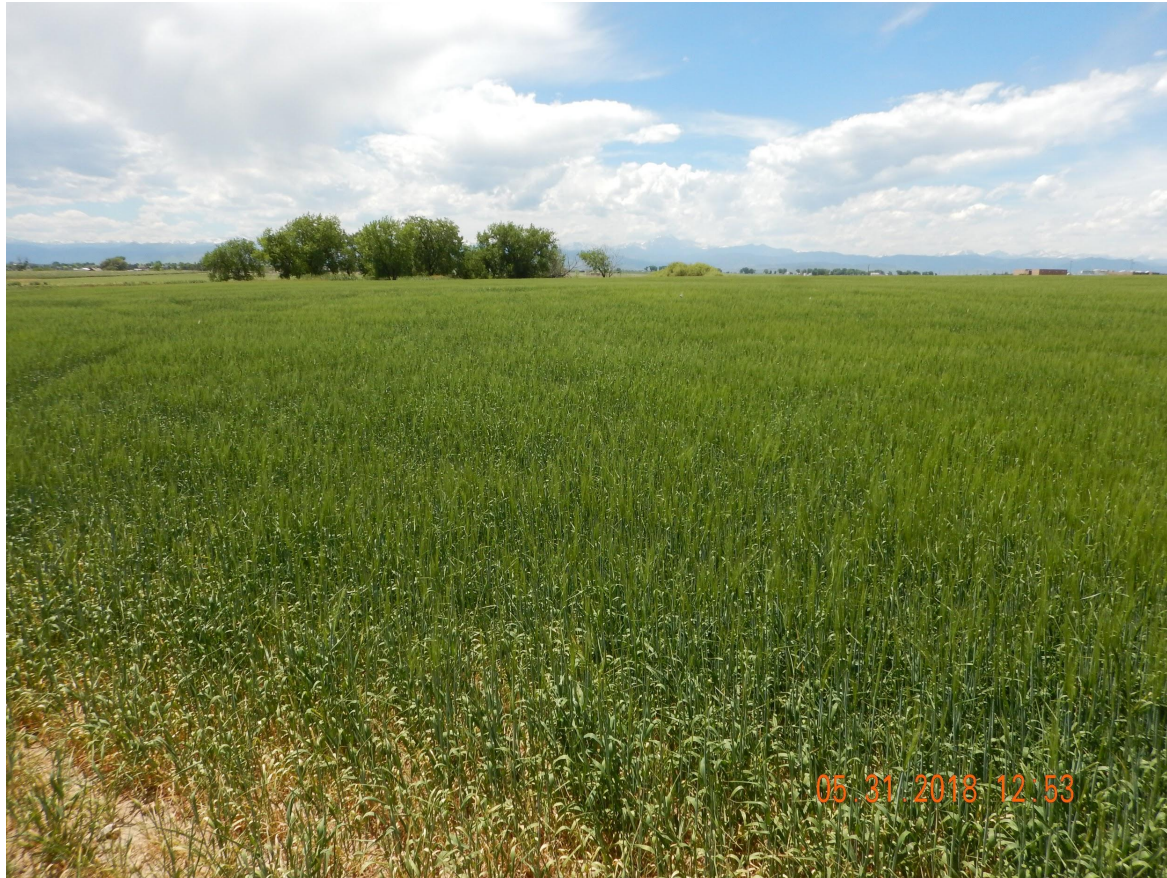
Photo 3. Photo taken from the well location access point, facing West. Well location and access road appear to meet final reclamation standards.
