# Final Reclamation Inspection

Operator: NOBLE ENERGY INC- #100322

API: 05-123-12851

Inspection Photos  
Location Name: ANDERSON-COOMBS #5  
API: 05-123-12851

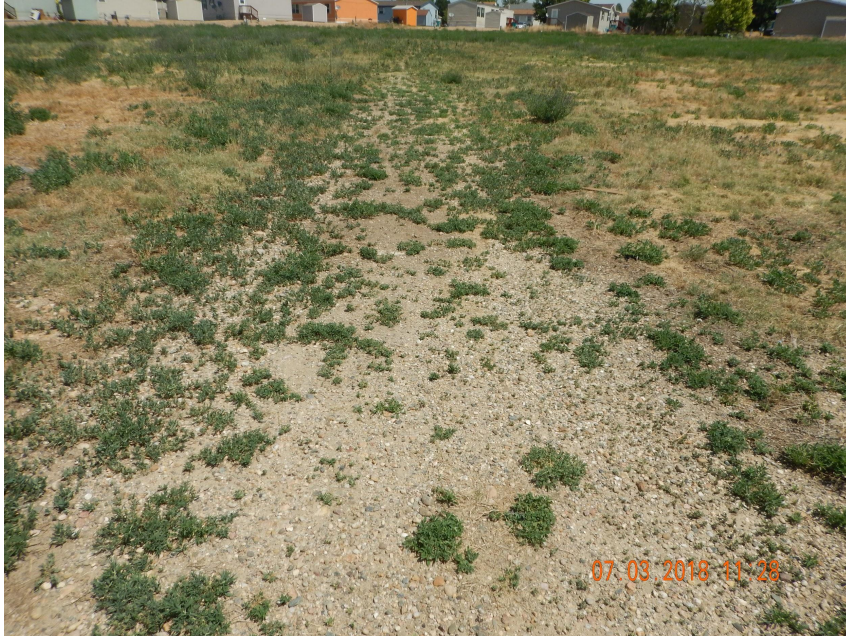
**Photo 1.** Photo taken from the entrance of the well location, facing North. Well location has not meet Rule 1004 standards, as bare patches and weedy, annuals (Kochia) were observed. Also, appears some gravel remains along portions of the access road. All equipment has been removed from the well location. The offsite tank battery has not meet Rule 1004 standards, as bare patches and weedy, annuals (Kochia) were observed.- see photos 3-4.

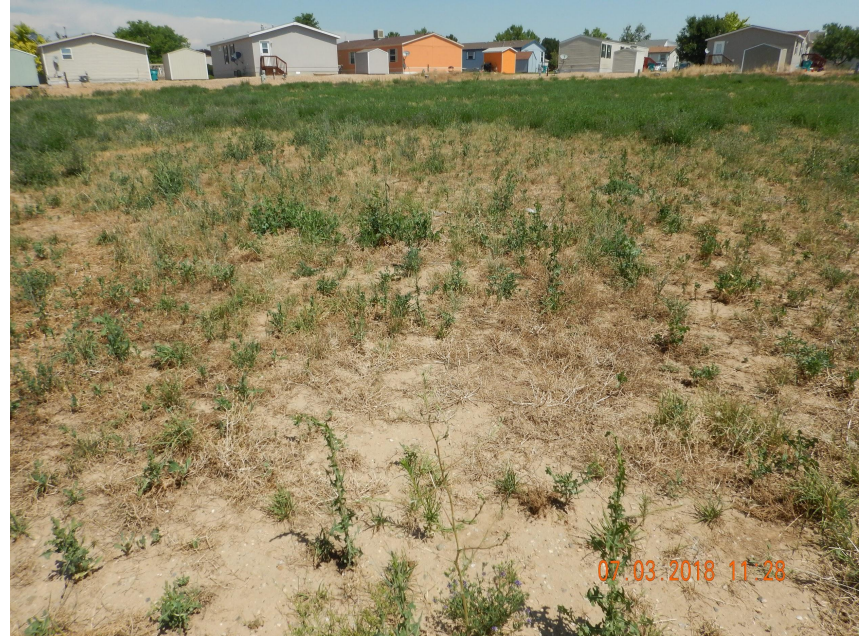
**Photo 2.** Photo taken from the well location, facing North. See comments under Photo 1.

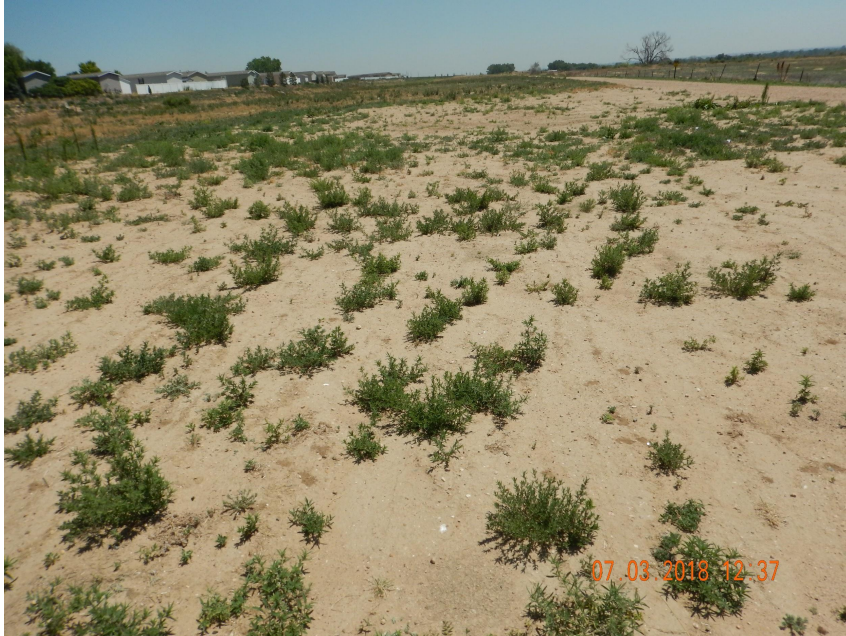
**Photo 3.** Photo taken from the offsite tank battery location (40.366600,-104.732970), facing East. See comments under Photo 1.

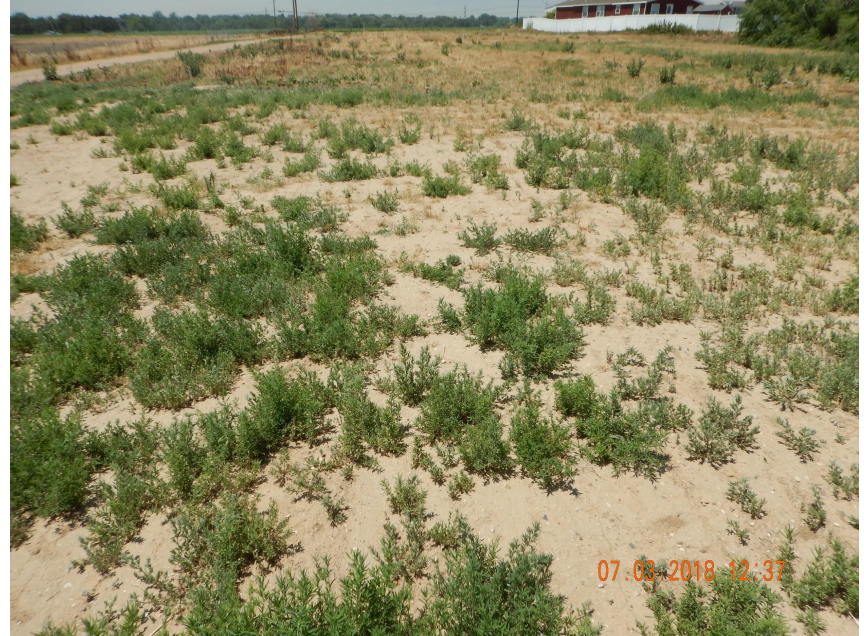
**Photo 4.** Photo taken from the offsite tank battery location, facing West. See comments under Photo 1.
