# Final Reclamation Inspection

API: 05-123-12850

Weld County, CO

Inspection Photos  
Location Name: ANDERSON-COOMBS #4  
API: 05-123-12850

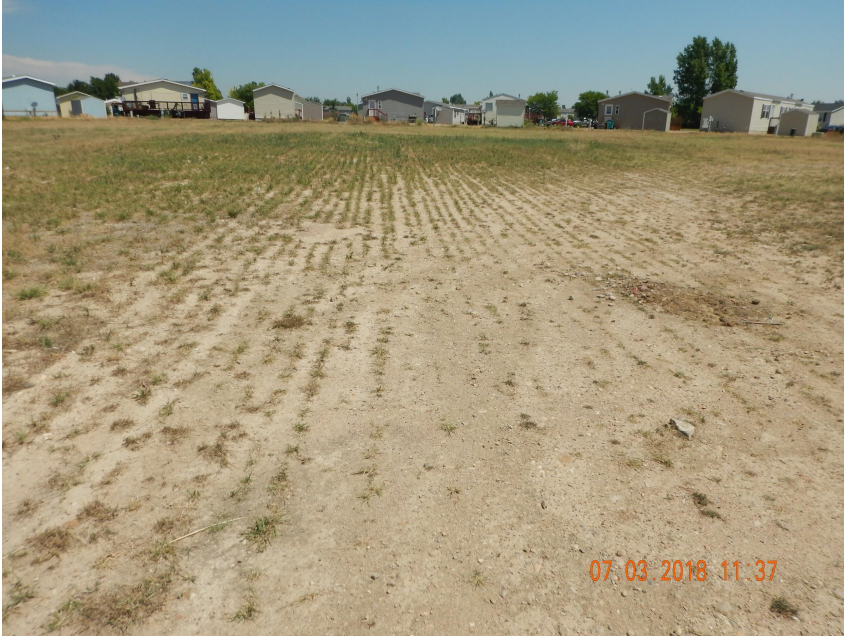
**Photo 1.** Photo taken from the entrance of the well location, facing North. Well location has not meet Rule 1004 standards, as bare patches and weedy, annual vegetation (Kochia) were observed. All equipment has been removed from the well location and the offsite tank battery. The offsite tank battery has not meet Rule 1004 standards, as bare patches and weedy, annuals (Kochia) were observed.- see photos 3-4.

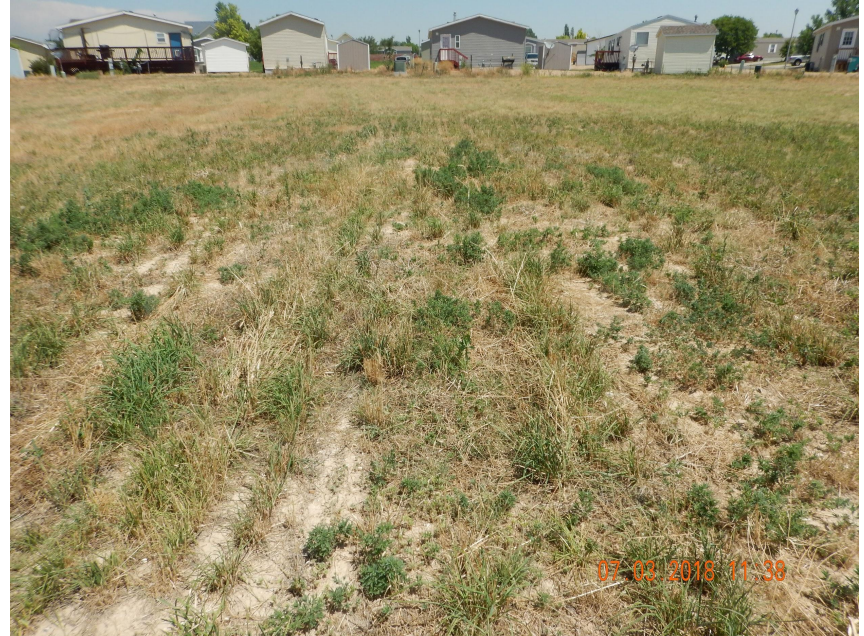
**Photo 2.** Photo taken from the well location, facing North. See comments under Photo 1.
