# Final Reclamation Inspection

Operator: SRC ENERGY INC- #10311

API: 05-123-24463

Inspection Photos  
Location Name: LOWE #31-14  
API: 05-123-24463

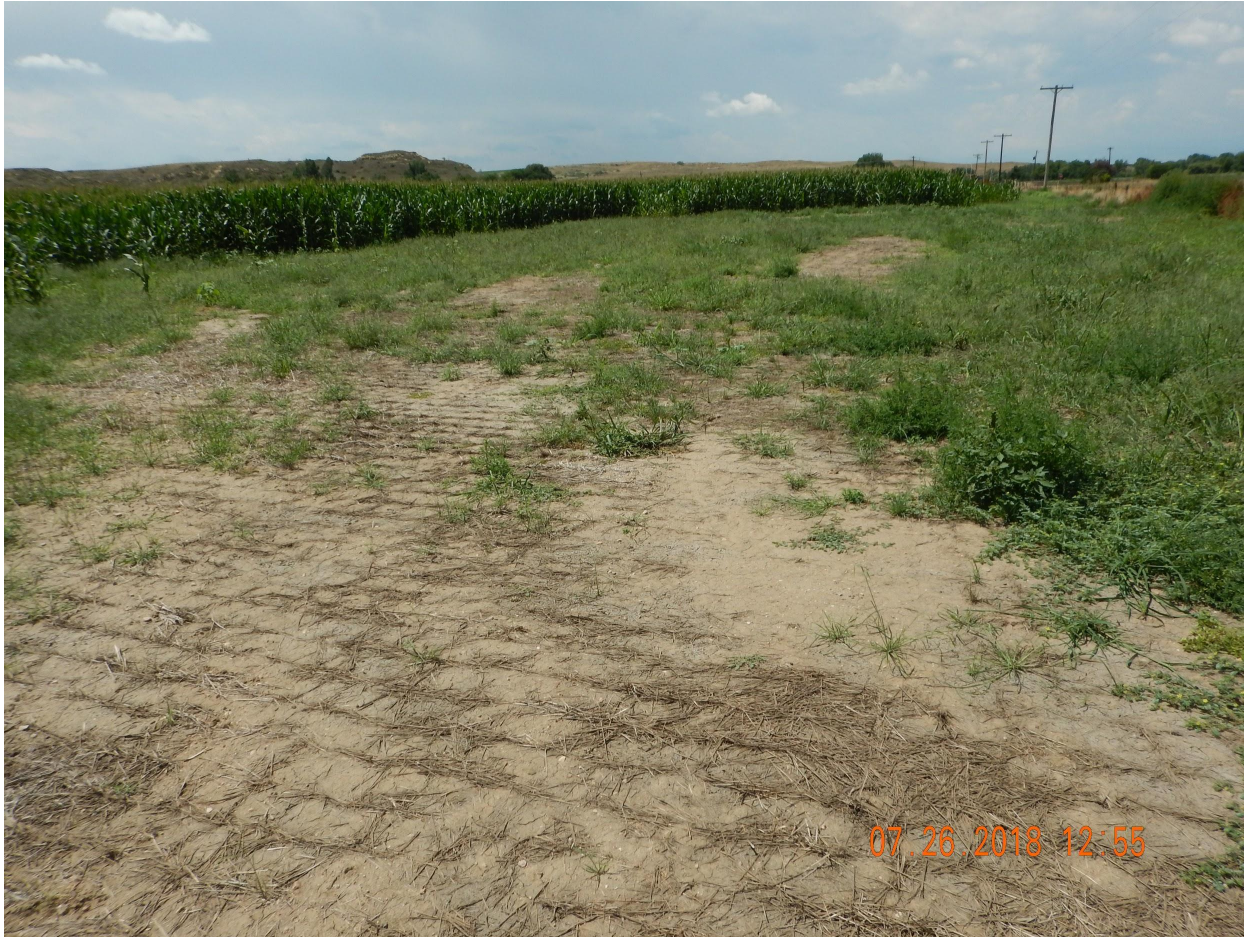
**Photo 1.** Photo taken from the tank battery location, facing West. Appears the Operator has performed final reclamation activities. No equipment was observed at the battery location. Vegetative assessment was only conducted at the battery location, not the well location or well access road. Does not appear the location was planted with reference crops. Location will remain in-process until the location meets Rule 1004 standards.

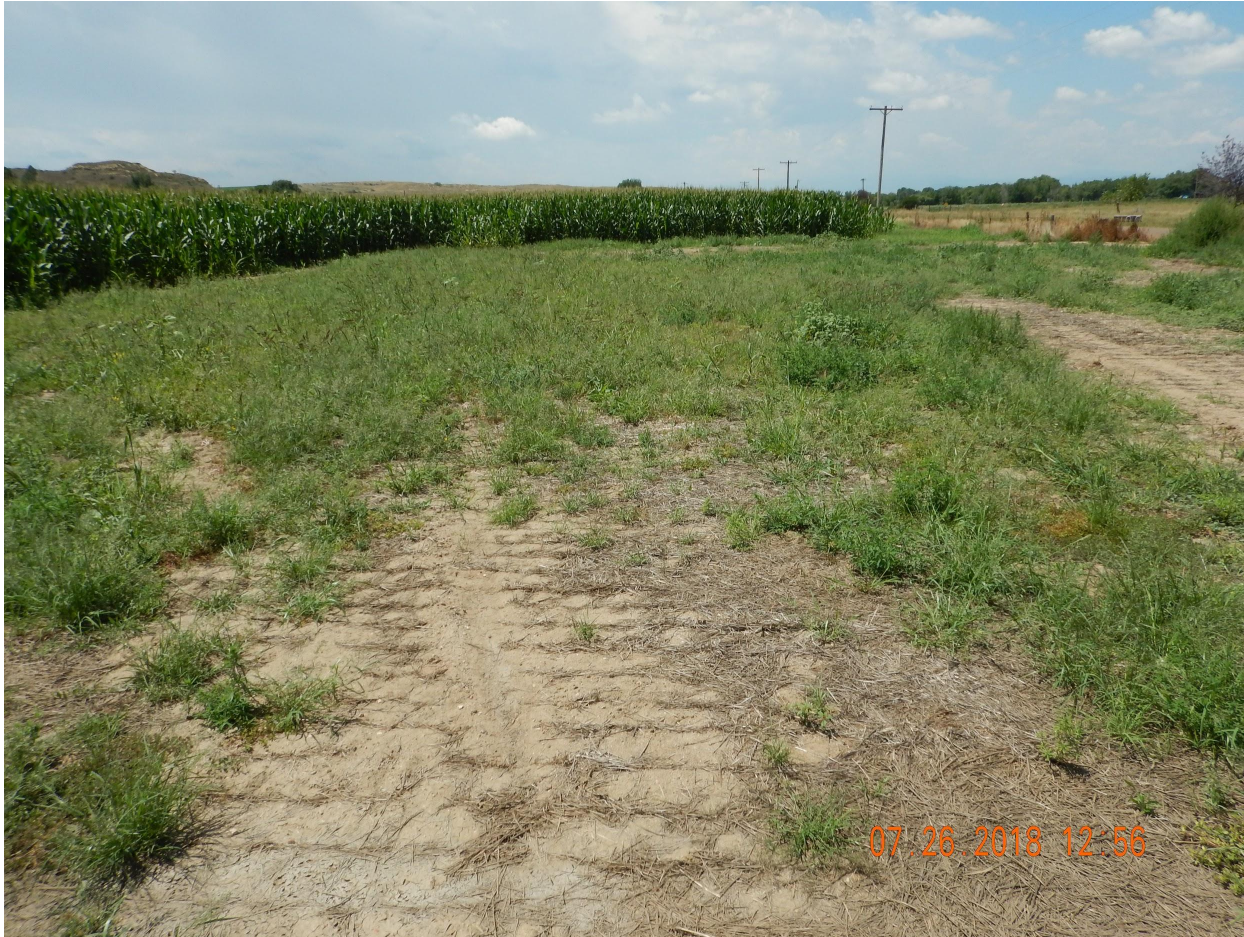
**Photo 2.** Photo taken from the central tank battery location, facing West. See comments under Photo 1.
