# Final Reclamation Inspection

Operator: KERR MCGEE OIL & GAS ONSHORE LP #47120

API: 05-123-07622

Inspection Photos  
Location Name: 1415 CORP GAS UNIT #1  
API: 05-123-07622

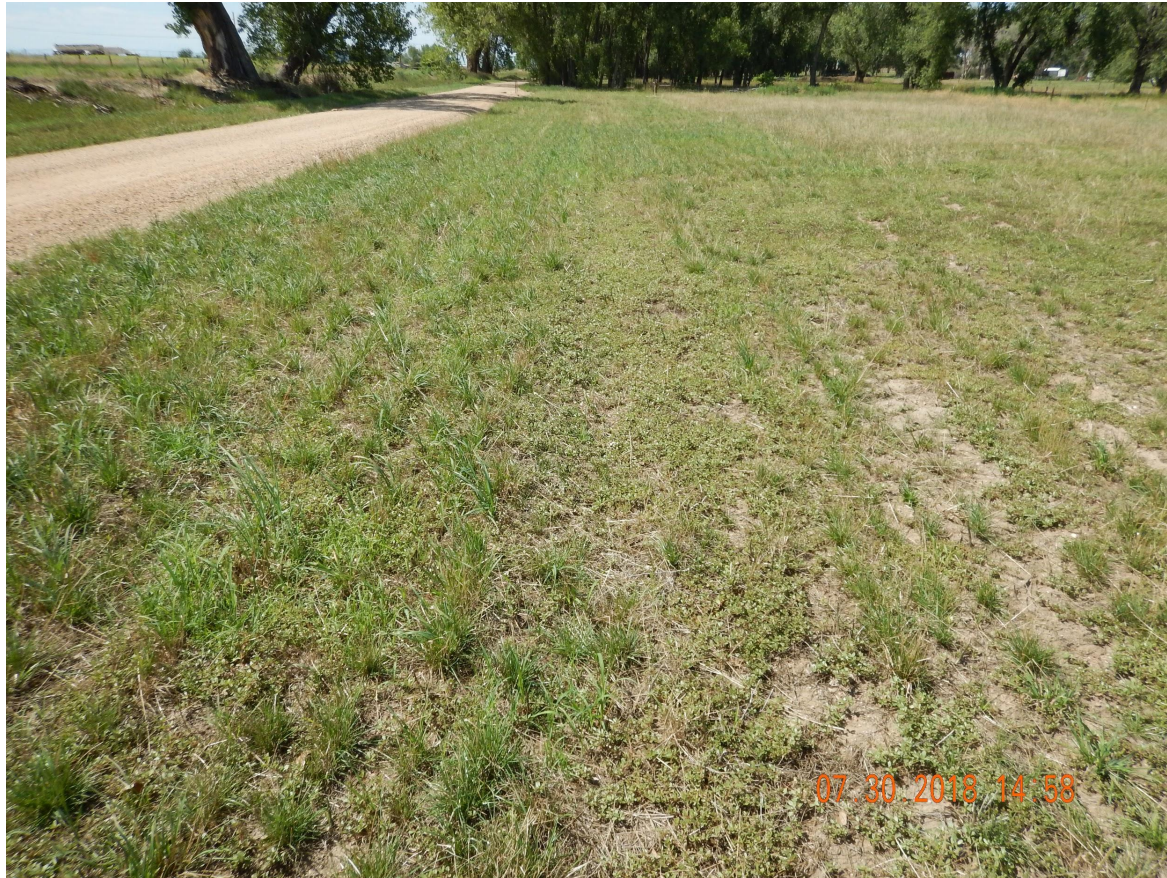
**Photo 1.** Photo taken from the southern location, facing North. Well has been plugged and abandoned. Desirable vegetation was observed throughout the disturbance area but has not achieved uniform vegetative cover. Common Purslane (*Portulaca oleracea*) was observed in high densities throughout the disturbance area.

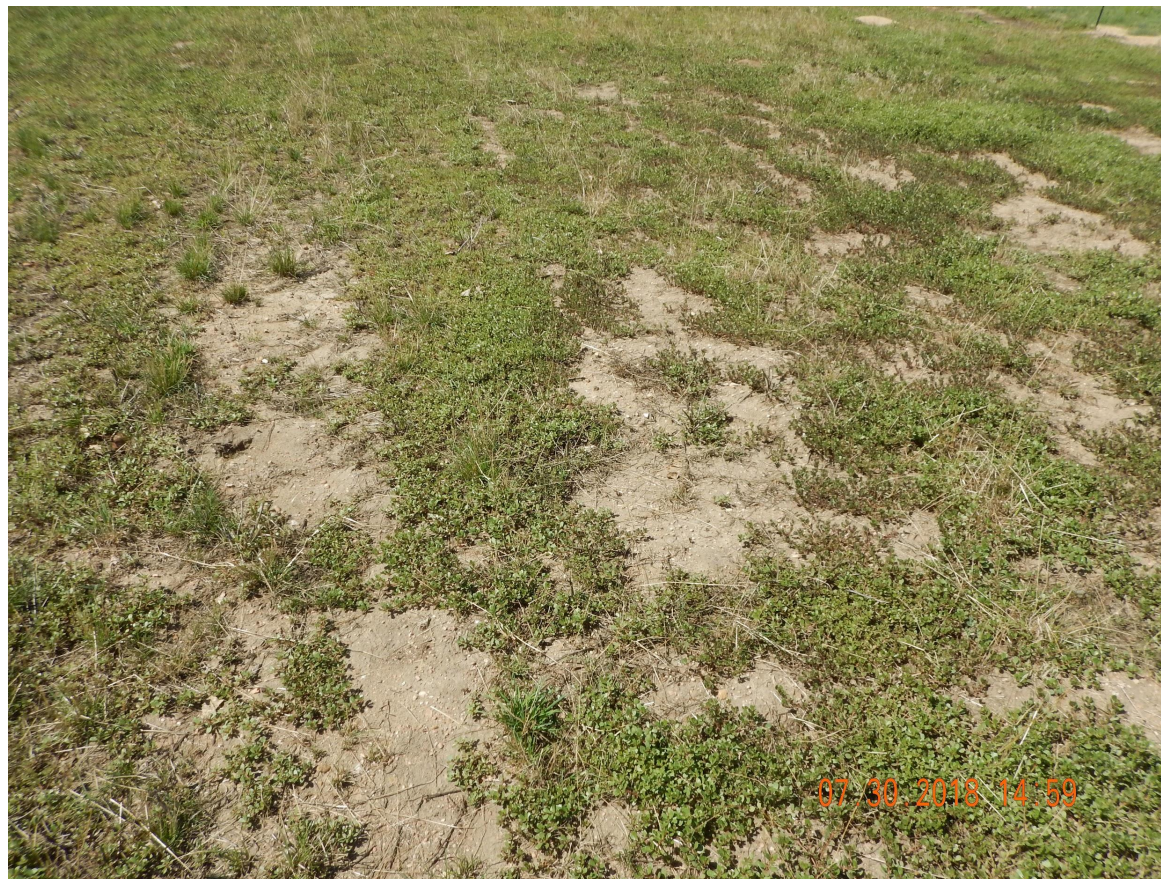
**Photo 2.** Photo taken from the eastern location. Photo illustrates bare ground and Common Purslane in high abundance.

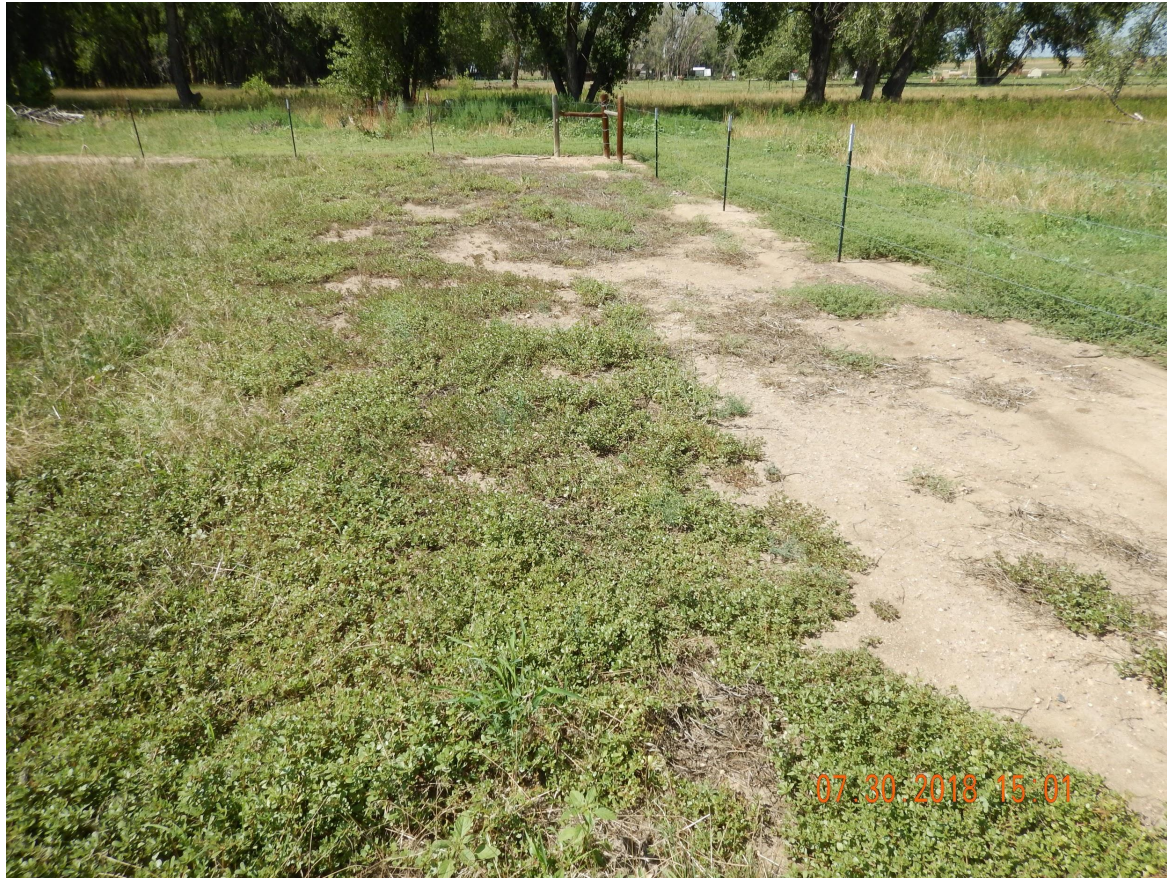
**Photo 3.** Photo taken from the northeastern location, facing North. See comments under Photo 1.

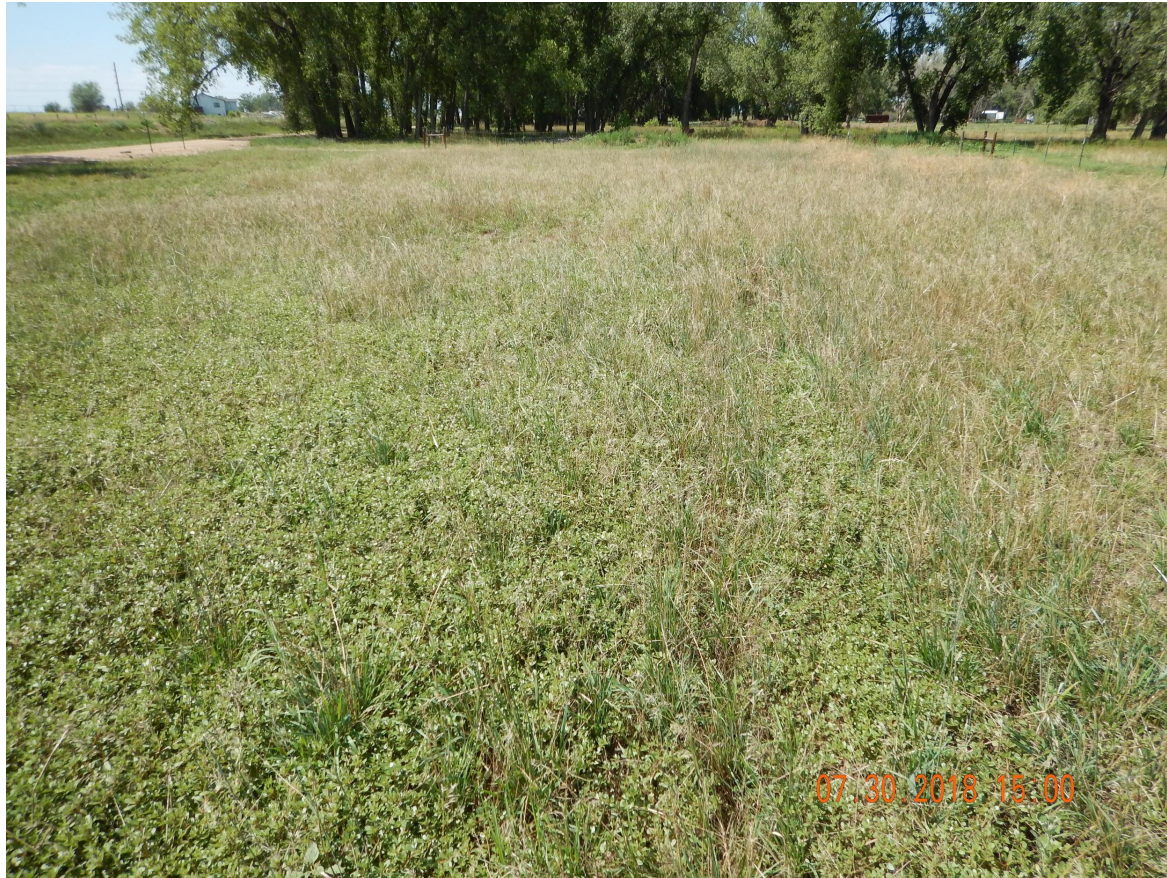
**Photo 4.** Photo taken from the approximate center of location, facing North. See comments under Photo 1.
