Final Reclamation Inspection

Operator: FOUNDATION ENERGY MANAGEMENT LLC- #10112

API #: 05-123-08029

Inspection Photos
Location Name: APPEL #2
API #: 05-123-08029

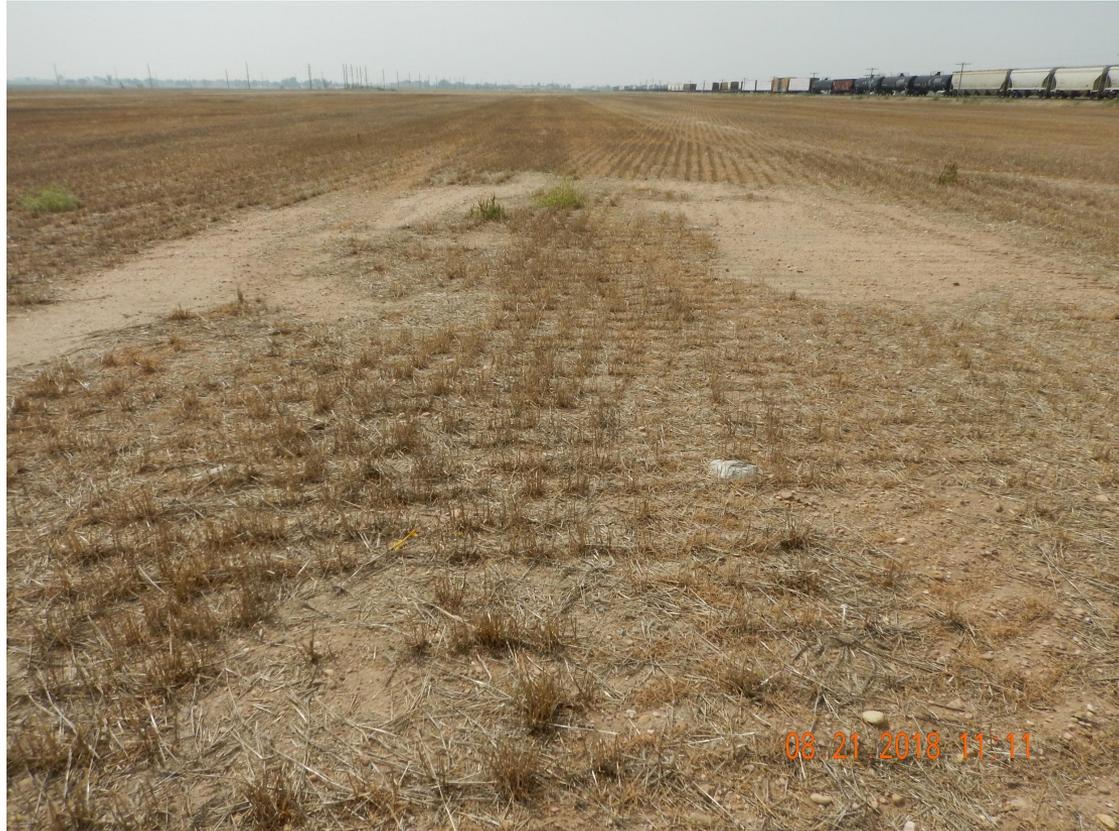
Photo 1. Photo taken from the well location, facing South. Operator has failed to perform all final reclamation activities. There appears to be some gravel and decompaction has not been performed. Last years crop was not able to establish due to the above failed conditions.

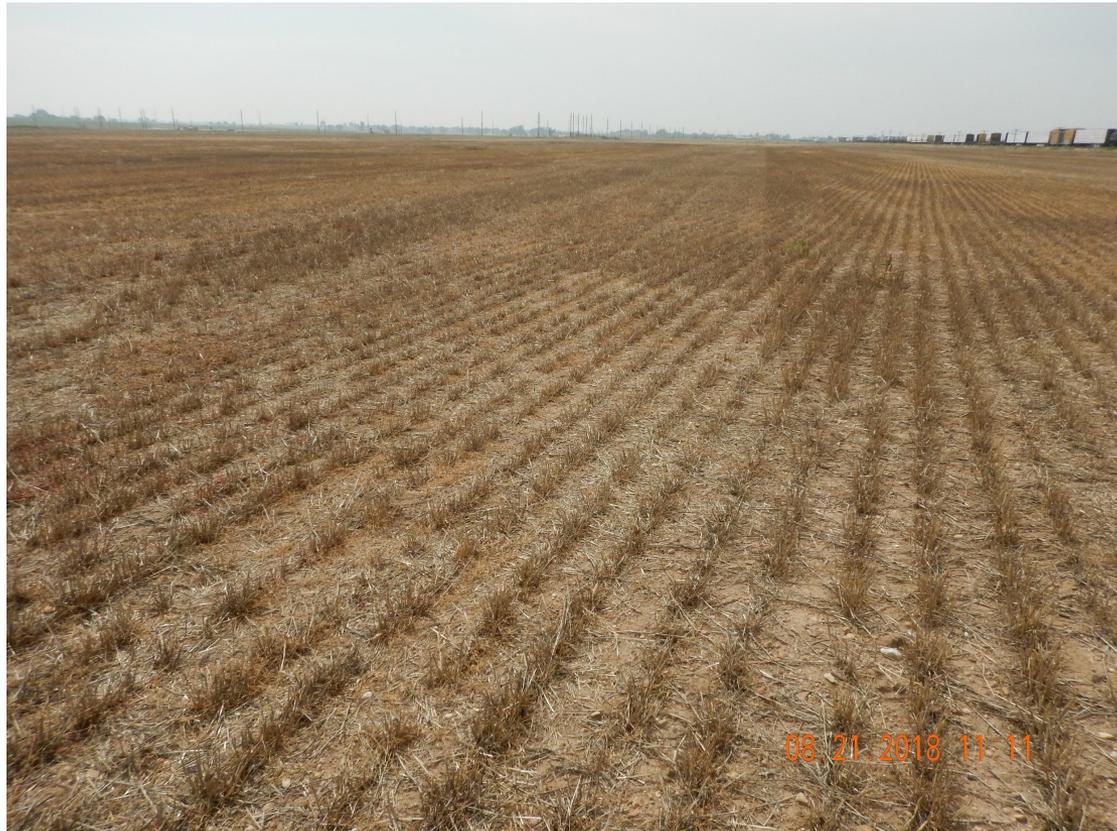
Photo 2. Reference photo taken east of the well location, facing South. Photo illustrates last years crop that has established with no evidence of gravel or bare patches.
