<b>CATEGORY:</b>	<b>Operations</b>	<b>Tank Cleaning Fire</b>
Operations Team:	<u>Piceance Production</u>	Incident date: <u>September 21, 2018</u>
Work type:	<u>Well, Pipeline &amp; Facility Operations</u>	Alert date: <u>October 10, 2018</u>
Location:	<u>C 26 NW</u>

## C26NW Tank Cleaning Fire

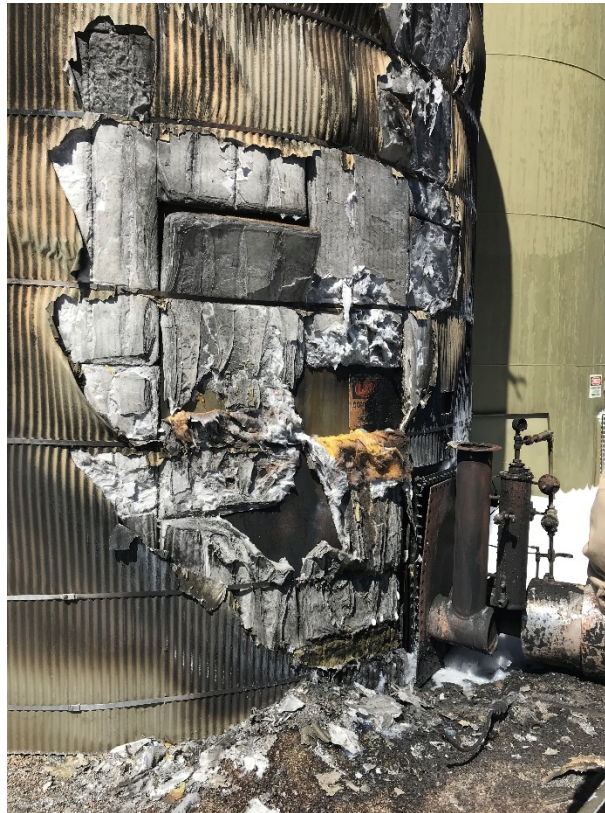
On Friday 09/21/2018 at approximately 11:35 am, a tank on the C26NW ignited a flash fire while being prepared for cleaning. No injuries occurred. The location was ESD'ed and everyone immediately evacuated and activated emergency services. The fluids had been drained from the tank. Gas monitors were in use but did not alarm. The event occurred as the crew began sliding the manway and associated tank heater assembly out of the tank. The source of ignition is not exactly known. All indications point to static discharge or a spark created by metal on metal contact as the manway/heater assembly was pulled through the sand and sludge mixture, across the bottom of the tank, and over the bolts that secure the assembly to the tank.

- As with most all other tank cleanings an amalgamation of sand and sludge could not be completely extracted from the bottom of the tank.
- A PVC stinger was used on the hydrovac that was waiting to collect any fluids that began to escape the vessel.
- Fully evacuating all flammable gases from the head space prior to removing the man way/heater and beginning the cleaning of the tank is not always possible.

1. The use of non-sparking tools, such as brass pry bars will be used when freeing the mayway/heater assembly for removal.
2. The manway/heater assembly will be bonded and grounded to dissipate any static build up created by the removal of the assembly

3. When the potential for static ignition is identified, hydrovac operators will insure that their trucks are grounded/bonded and their stinger and hose combinations do not have materials known to allow for the build up of static charge.

4. When cleaning tanks, air movers will be utilized in an effort to accomplish the three objective outlined below. When possible, we would request that the air movers be attached, and be in operation the night prior to the start of the tank cleaning process.

- a. To evacuate the head space of the tank from as much LEL as possible.
  - b. To improve the air in the breathing zone of those individuals working at the manway.

- c. To hopefully redirect any fire that may occur away from the workers at the manway and out the hatch at the top of the tank.
