# Final Reclamation Inspection

Operator: ANADARKO E&P ONSHORE LLC - #2800

API: 05-123-33866

Inspection Photos  
Location Name: CHRISTNER #8-66-5-3XH  
API: 05-123-33866

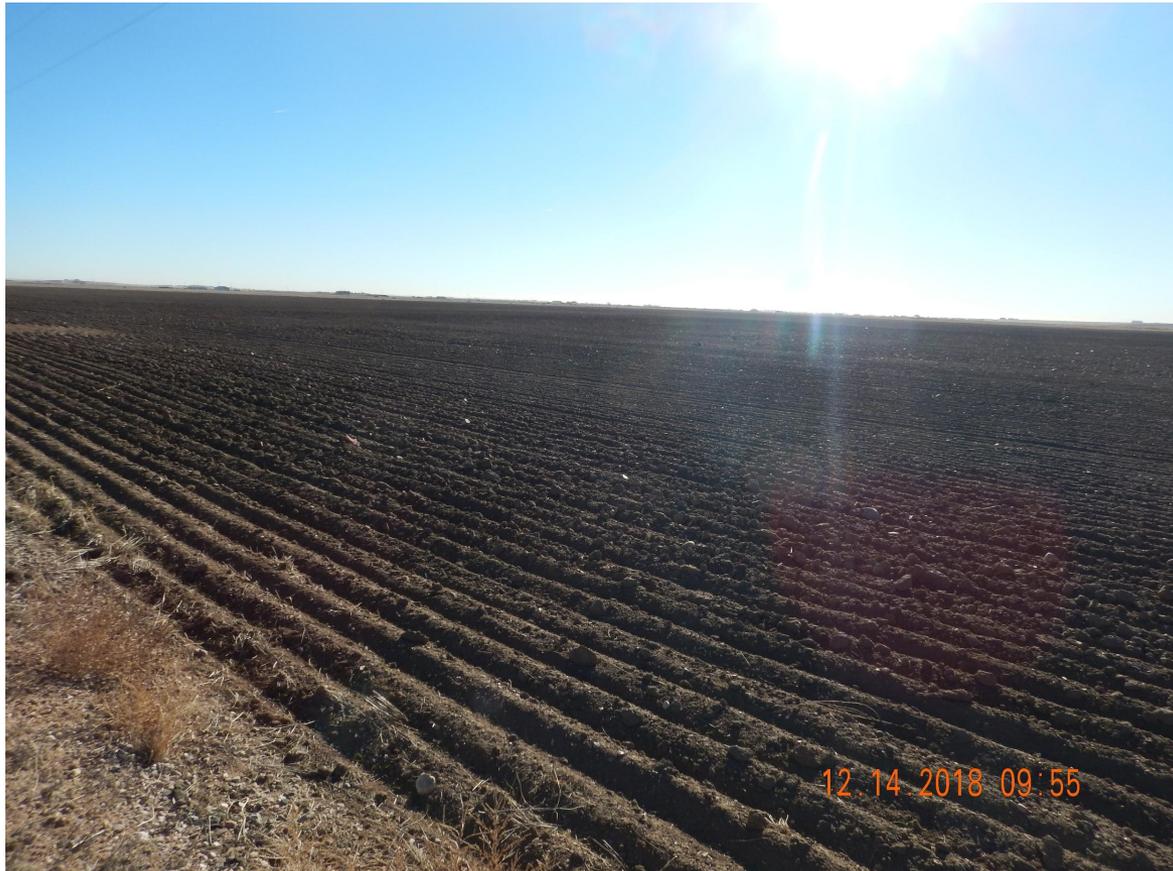
**Photo 1.** Photo taken from the well location AND battery location, facing Southeast. No equipment or debris observed. Appears the location has been returned to the surface owner for crop production. Operator shall continue to monitor and manage the Location until it meets Rule 1004 standards.

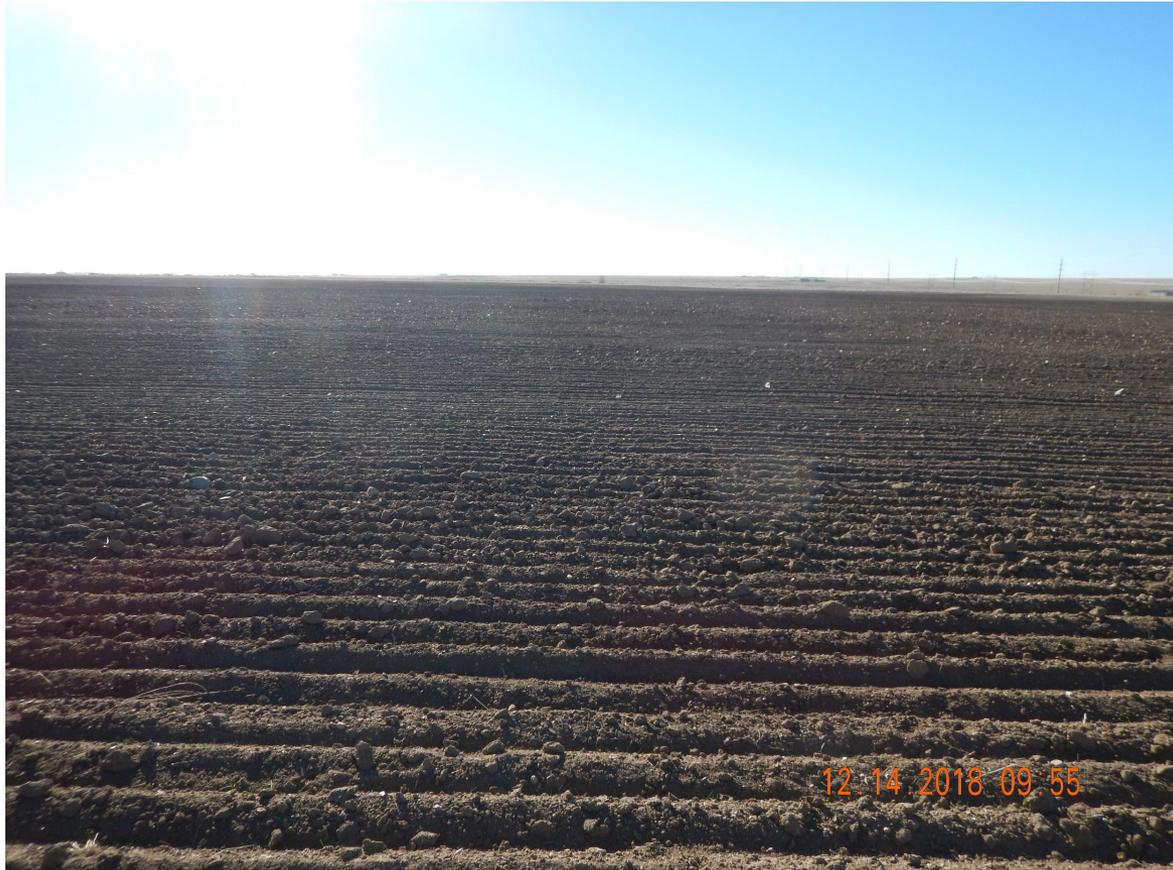
**Photo 2.** Photo taken from the well location AND battery location, facing South.  
See comments under Photo 1.
