# Final Reclamation Inspection

Operator: PDC ENERGY INC - #69175

API: 05-123-12782

Inspection Photos  
Location Name: MARY MILLS #41-18  
API: 05-123-12782

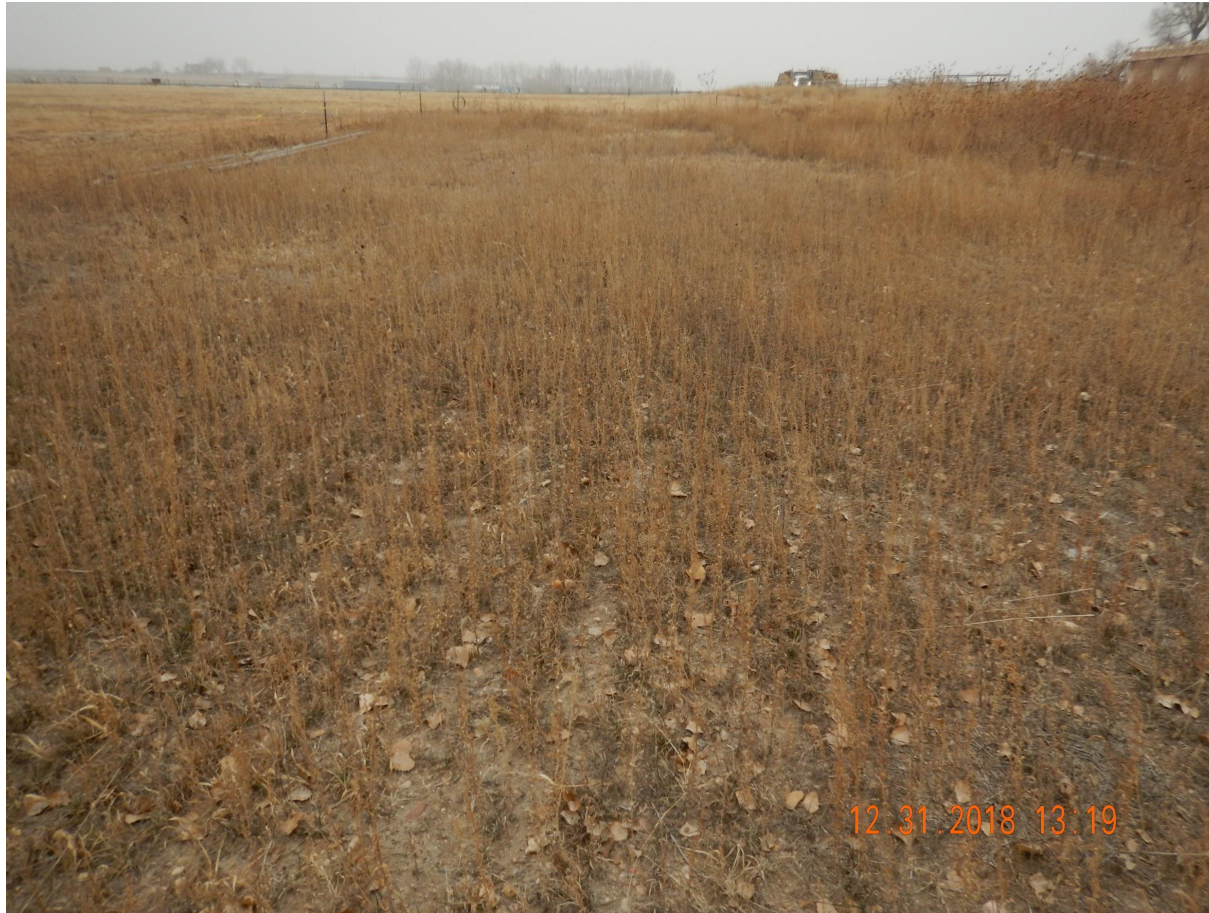
**Photo 1.** Photo taken from the eastern tank battery location, facing West. No equipment observed at the well location. Germination of desirable species was observed. Operator shall continue to monitor and manage the location until it meet Rule 1004 standards, including weed management.

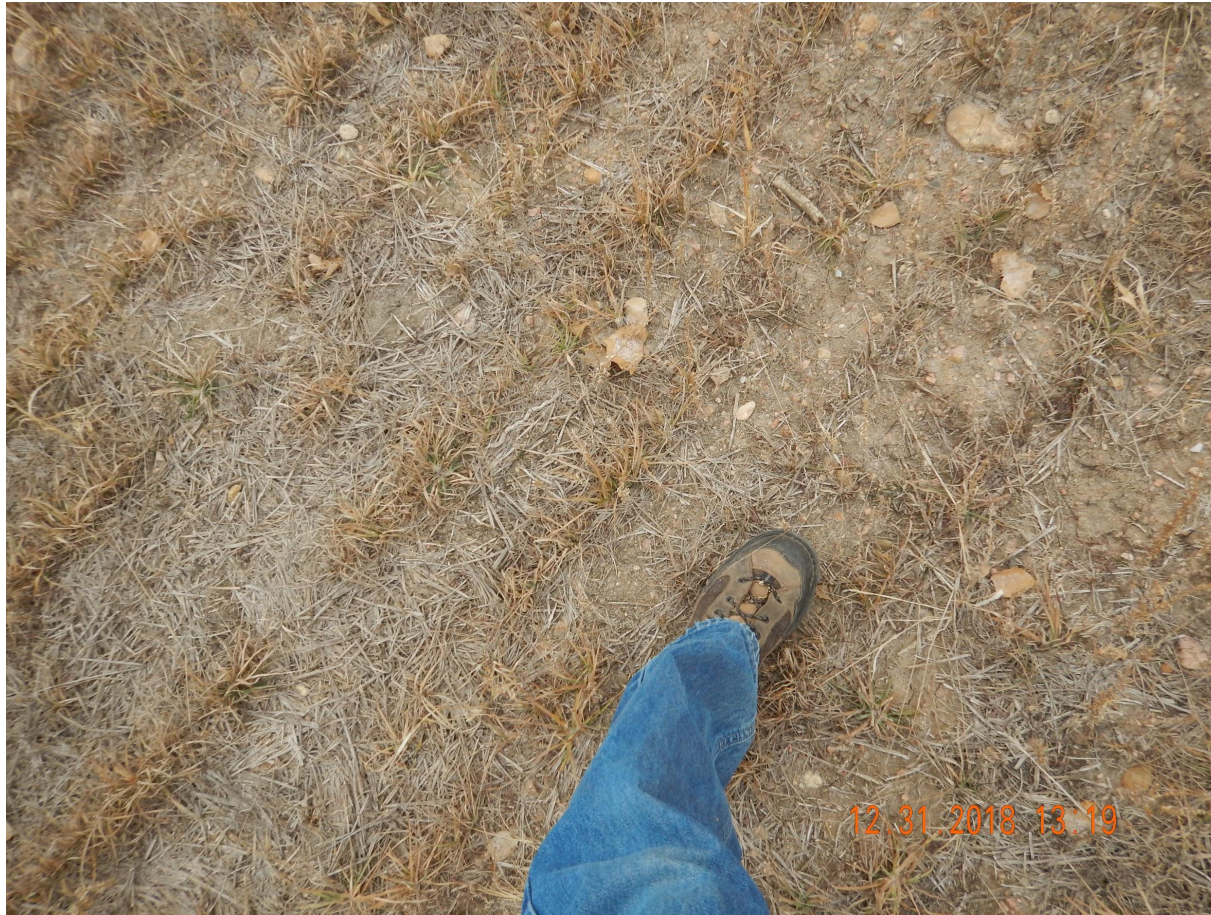
**Photo 2.** Close up photo taken from the tank battery location. Photo illustrates germination of desirable species.

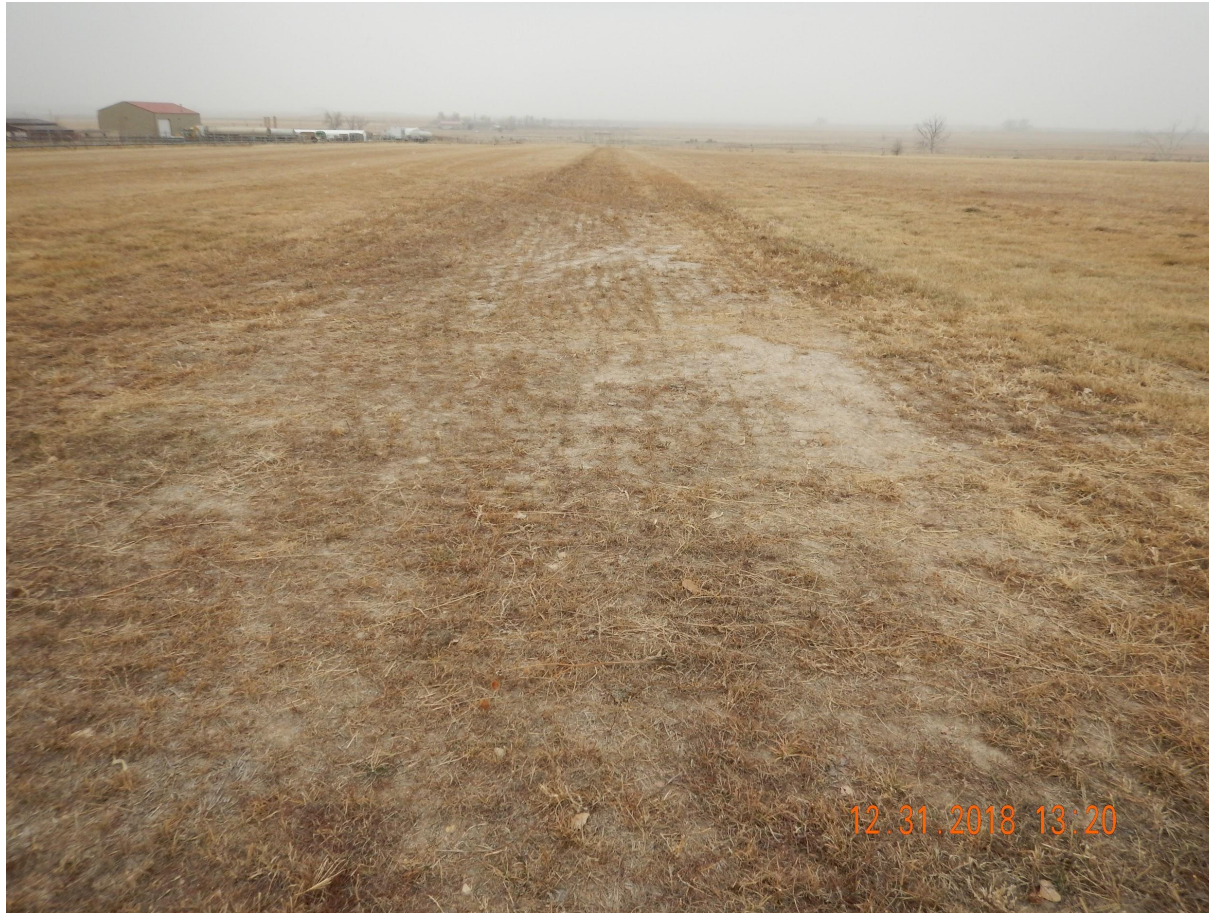
**Photo 3.** Photo taken from the northern well location access road, facing South. See comments under Photo 1. Note- There is an approved variance to leave the access point off CR 46 and retain the cattle guard.
