Inspection Photos

Operator: KLABZUBA OIL & GAS INC - 10148

Location ID: 393701

Inspection Doc. Number: 682504395

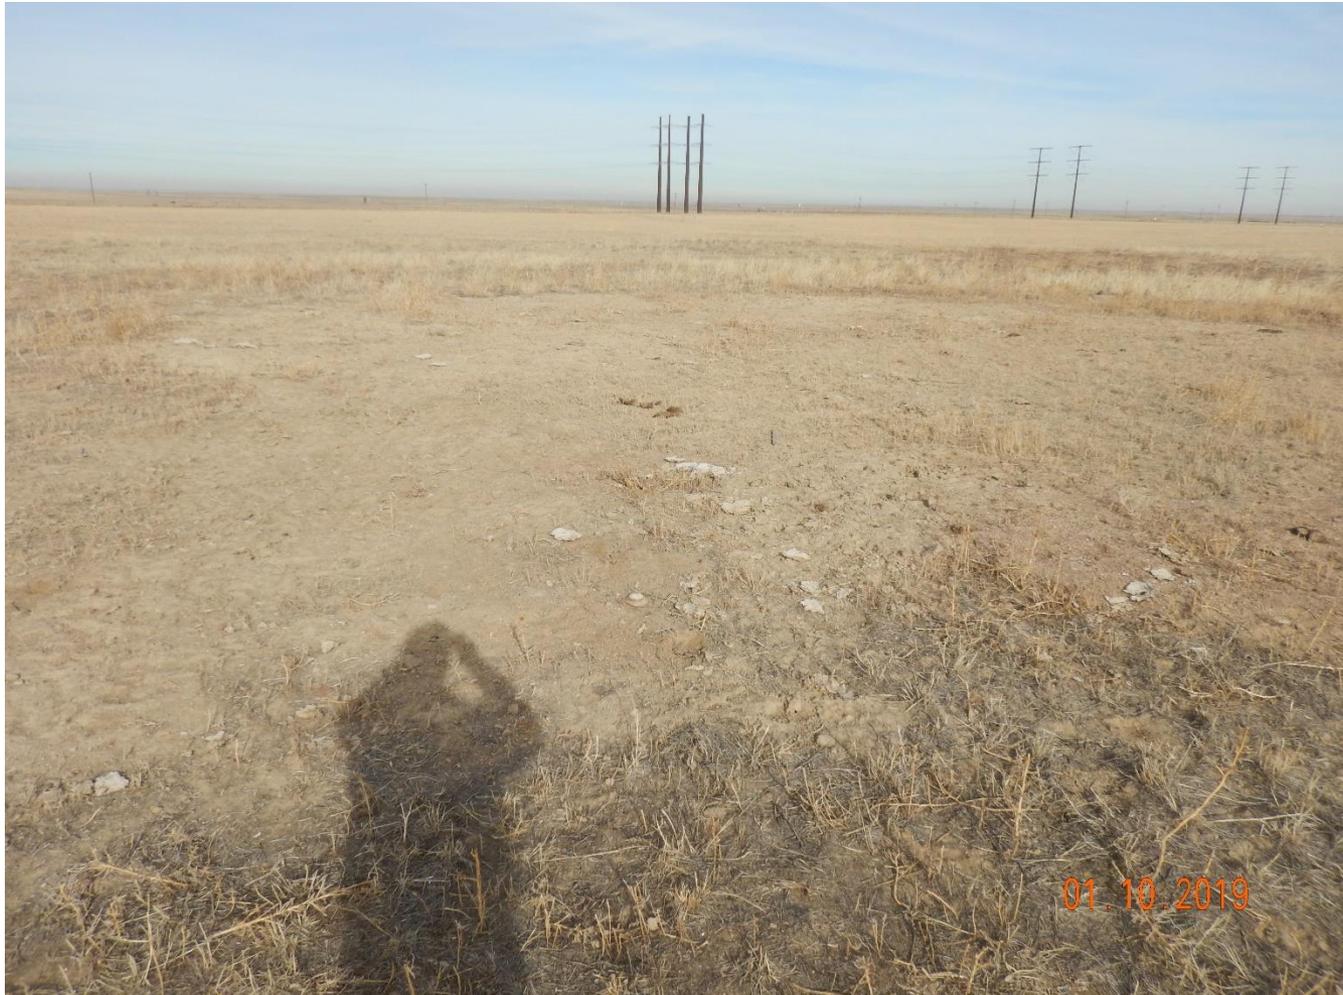
Photo 1: Photo taken from the south end of the location, facing north. Previous inspection documented a concrete pump base remaining and that location remains predominantly bare and exposed soil. Base appears to have been removed, however location remains predominantly bare and exposed soil. Unable to find evidence that additional reclamation activities have been conducted.

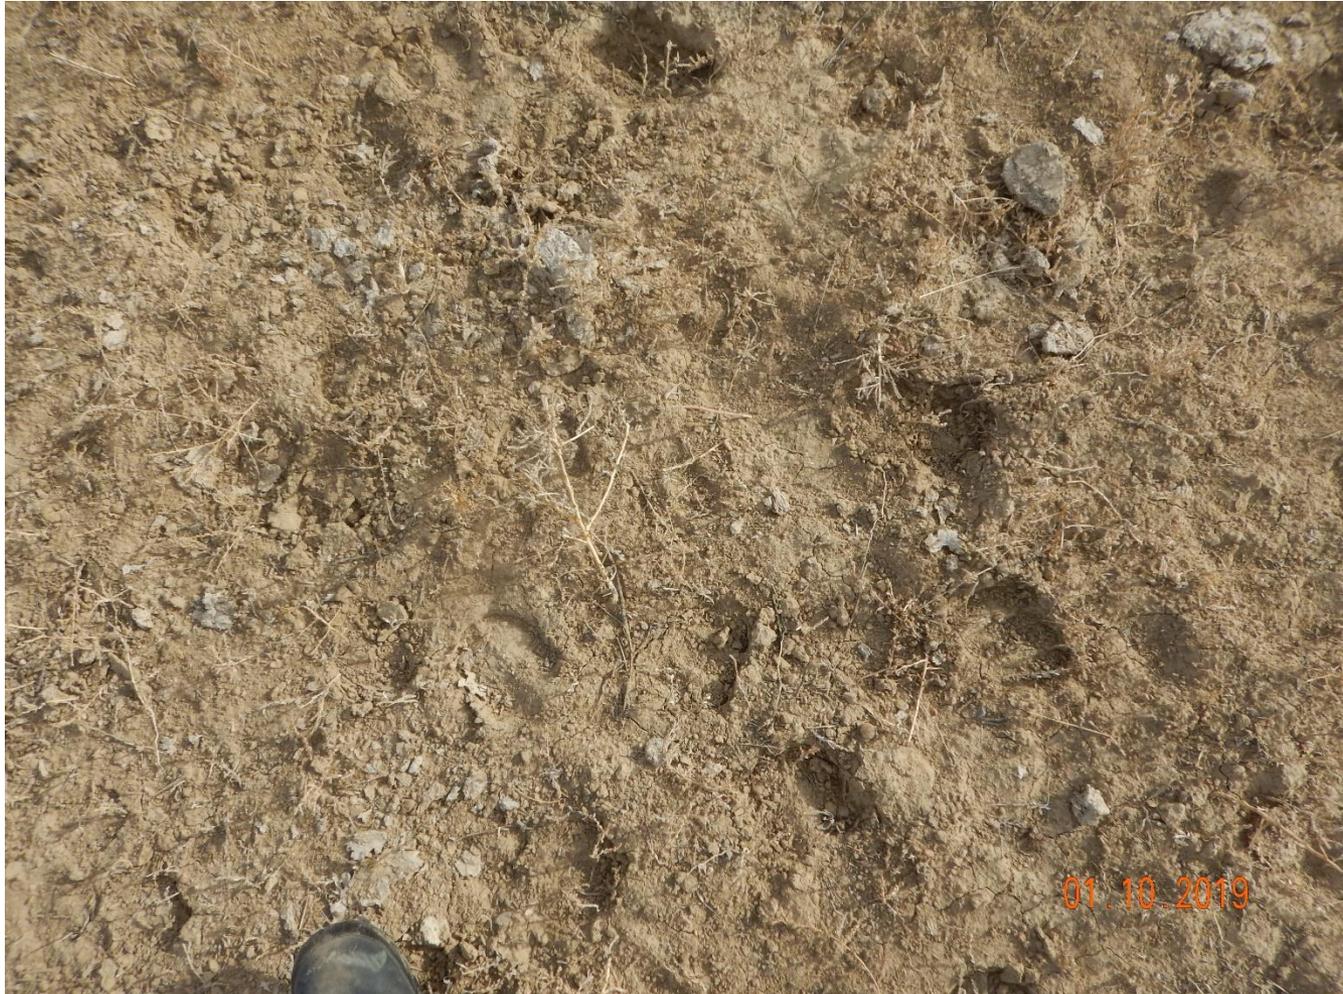
Photo 2: Photo taken from location. Photo shows location remains predominantly bare and exposed soil.

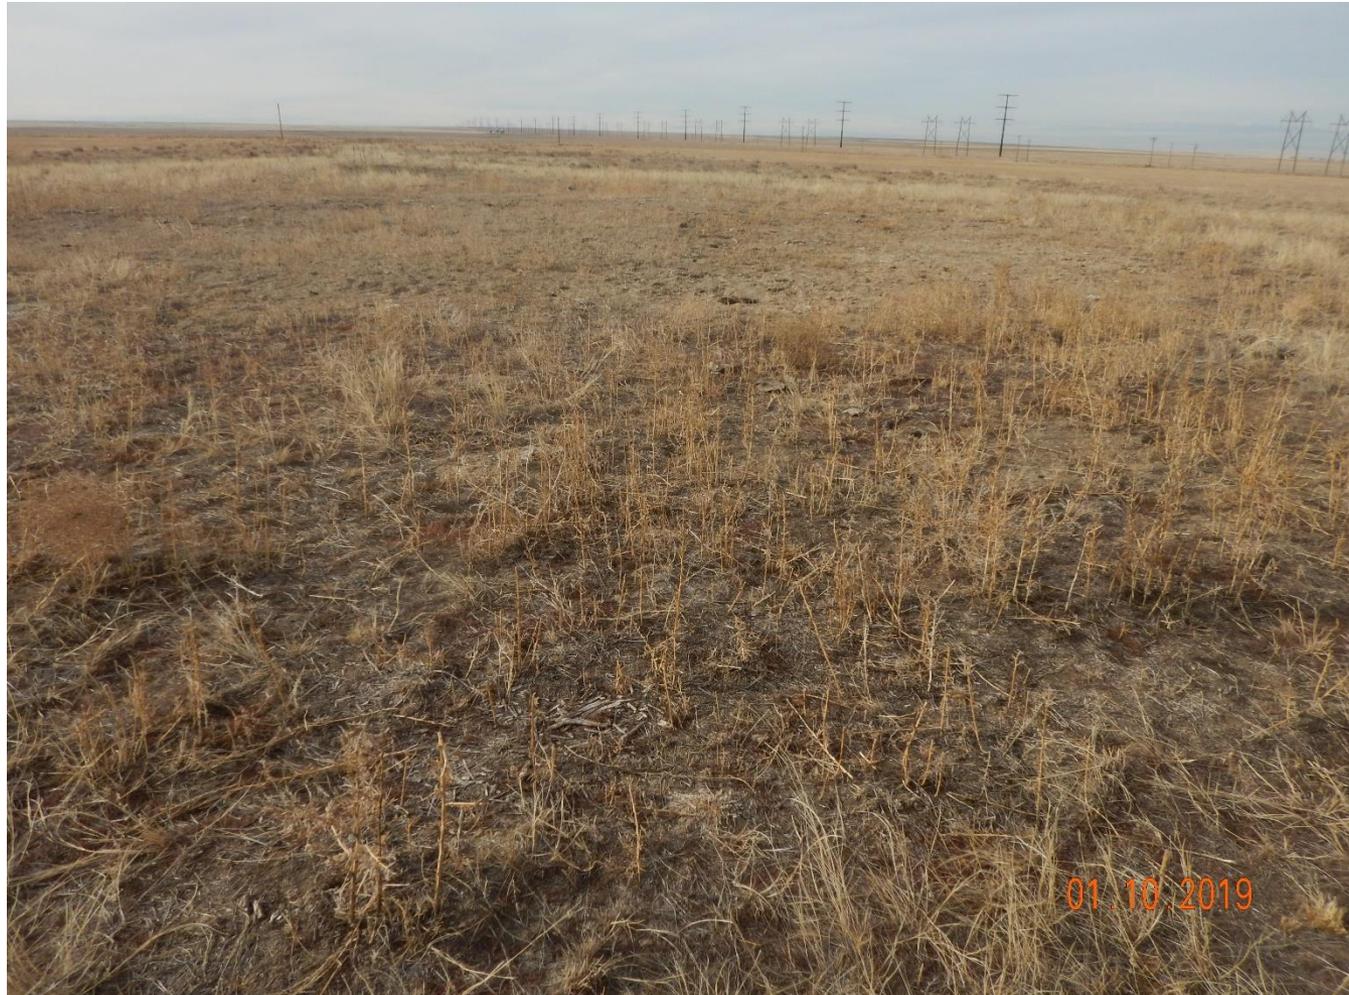
Photo 3: Photo taken from the east end of the location, facing west. Photo shows location remains predominantly bare and exposed soil, or dominated by undesirable weedy plant species.

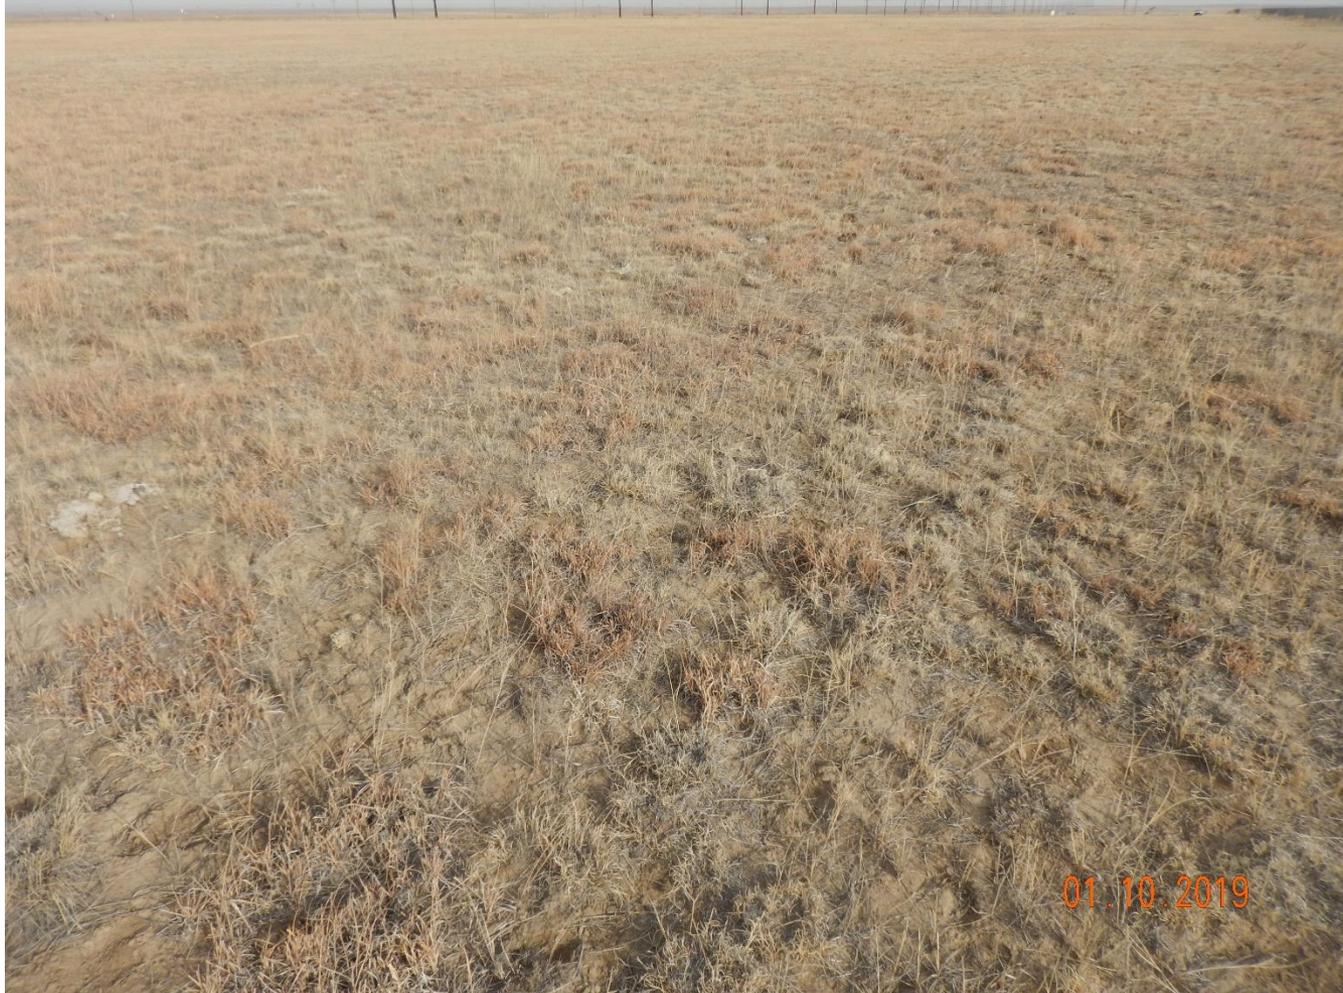
Photo 4: Photo taken from the adjacent reference area. Vegetation observed over reference includes Sideoats grama, blue grama, switchgrass, western wheat, sand dropseed, etc...
