Re: Williams/Bargath 16" Pipeline release update

January 21, 2019 field visit update:

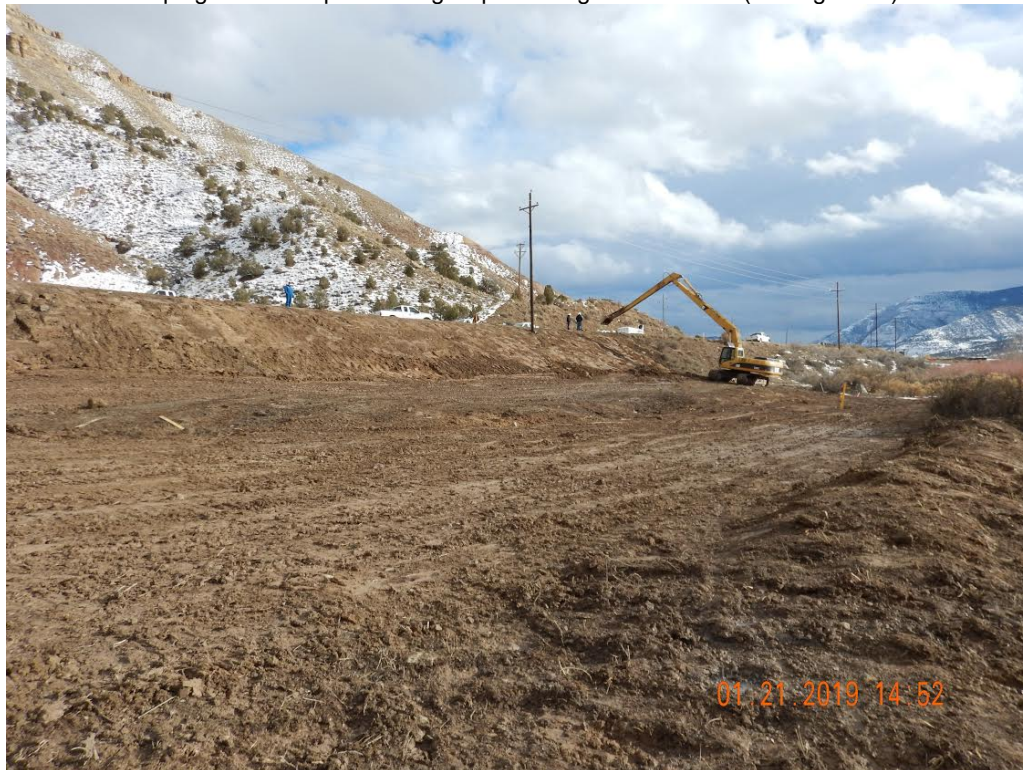
- Operator continued scraping areas with surface impacts resulting from fluids sprayed from pipeline. An excavator was utilized to scrape surface impacts from slope leading to Co Rd 215. Photo below.

Excavator scraping surface impacts along slope leading to Co Rd 215 (looking south)

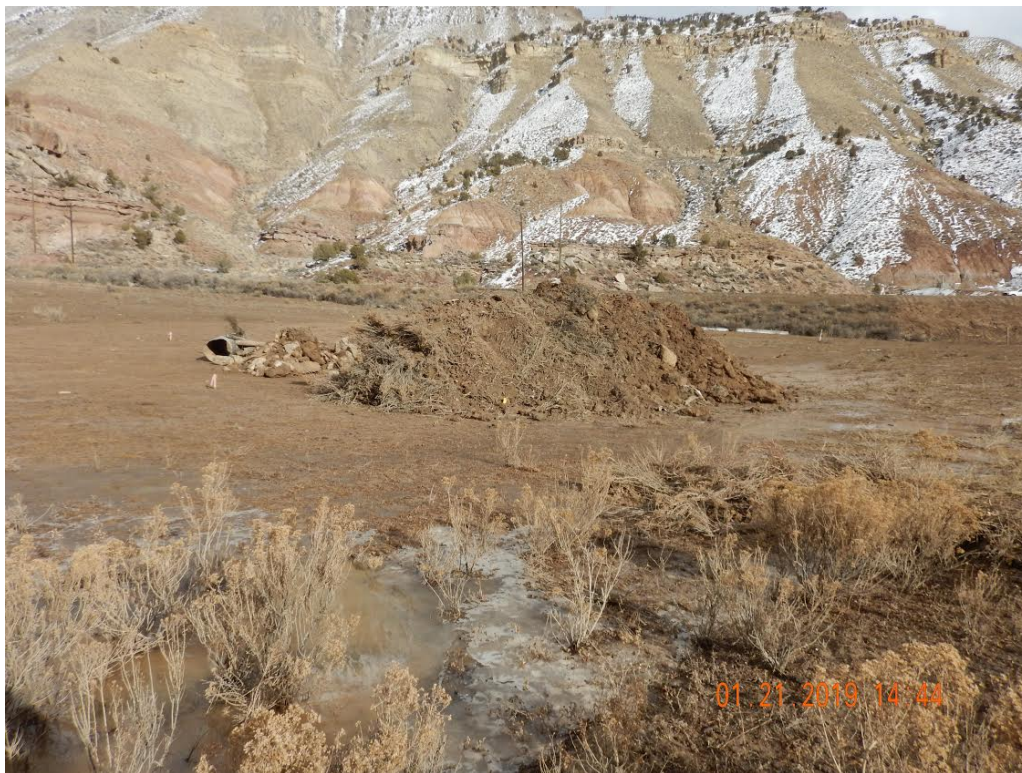
- Impacted soil east of irrigation ditch was being stockpiled in an area ~300' north of pipeline excavation (East Stockpile). This stockpile did not have a downgradient earthen berm constructed at the time of my field visit (2:15 PM), but the operator did express plans to construct the berm today. Photo below.

View of East Stockpile (looking east)

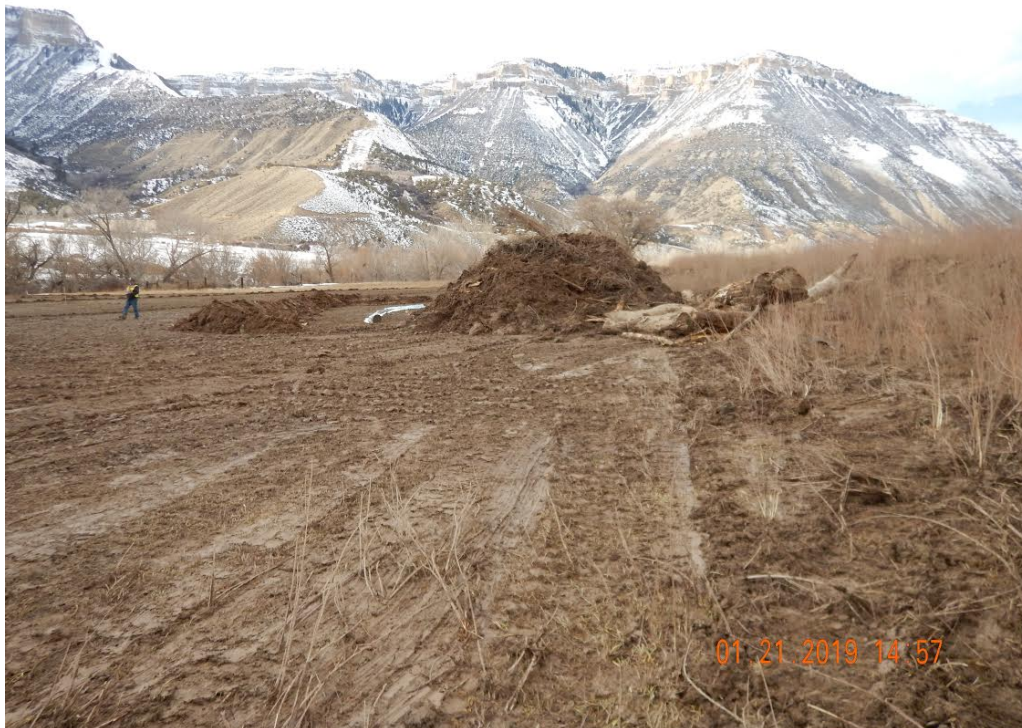
- Impacted soil west of irrigation ditch was being stockpiled in area ~150' WNW of pipeline excavation (West Stockpile). Operator had constructed earthen berm and absorbent boom downgradient from this stockpile to contain stormwater runoff. Photo below.

View of West Stockpile (looking north) with absorbent boom and earthen berm
