Interim Reclamation and Stormwater Inspection

Operator: BISON OIL & GAS II LLC - #10661

Location ID: 432352

Inspection Photos
Location Name: State 16-7-60 /1H
Location ID: 432352

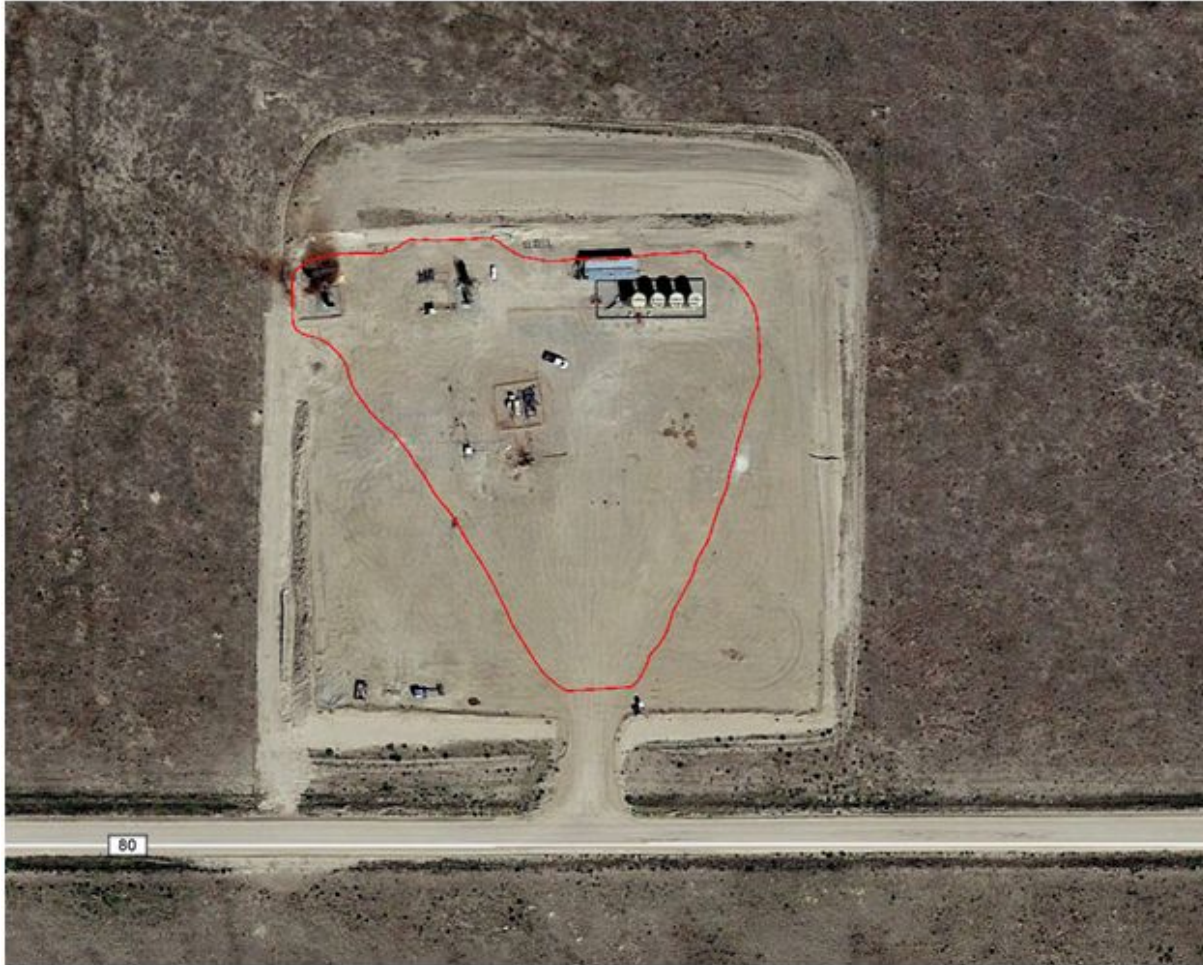
Google Earth aerial imagery taken September 7, 2013, before Interim Reclamation activities were performed illustrating the total disturbance area. COGCC Staff mapped the current production area (red-polygon) on 1/28/19. Appears the Location has been reduced in size to only reasonable areas needed for production operations per Rule 1003. Vegetation throughout the Interim areas will remain IN-PROCESS.

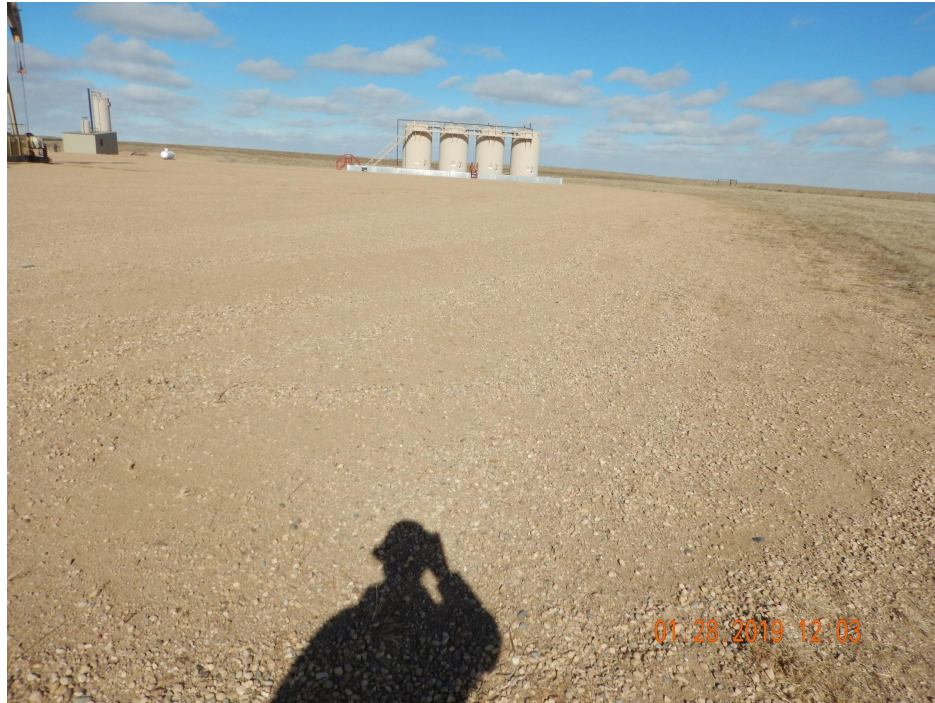
Photo 1. Photo taken from the southern entrance to Location, facing North. Photo illustrates interim reclamation activities have been performed to reduce disturbance areas only needed for production operations. Vegetation throughout the interim areas has not met Rule 1003 standards and will remain IN-PROCESS.

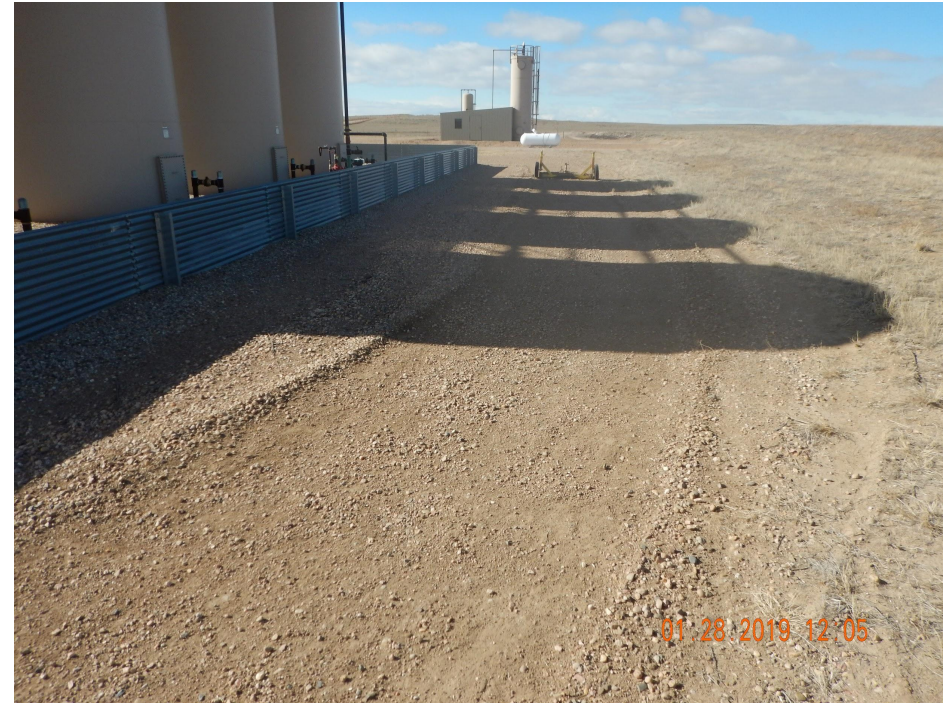
Photo 2. Photo taken from the northeastern Location, facing West. See comments under Photo 1.

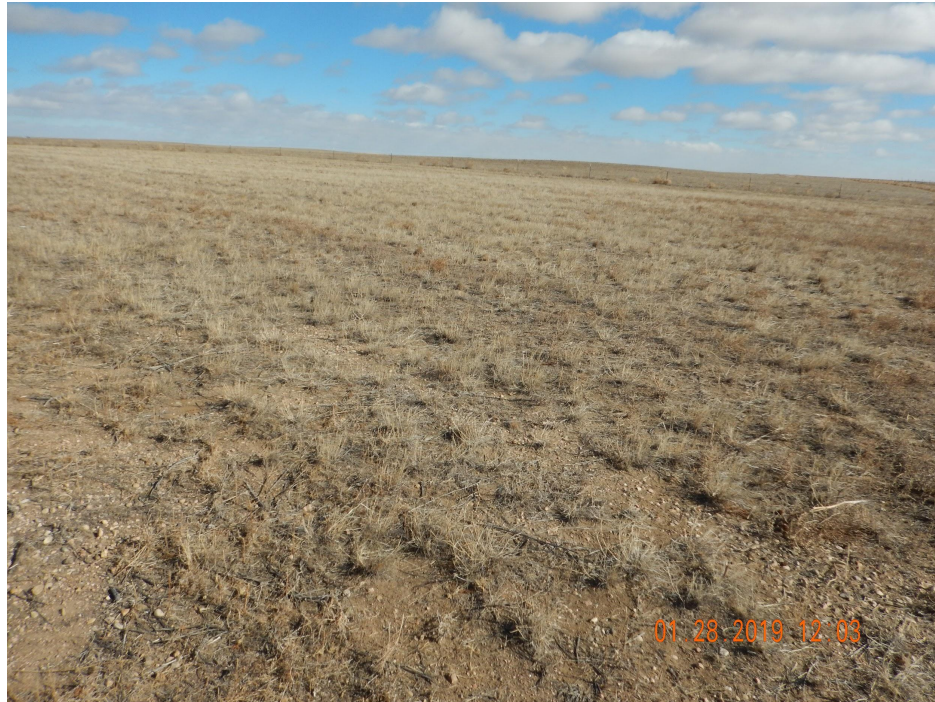
Photo 3. Photo taken from the eastern interim reclamation area, facing East. Photo illustrates desirable vegetation and the current vegetative state. Vegetation is not uniform and density is not reflective of reference area vegetation.

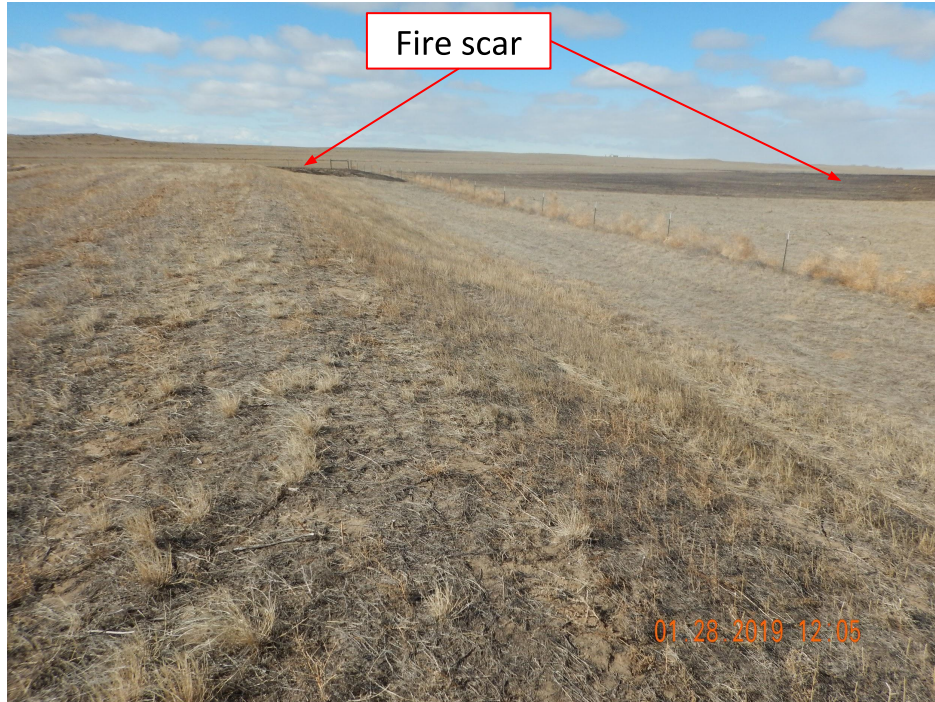
Photo 5. Photo taken from the eastern topsoil stockpile, facing West. Operator shall comply with Rule 1002.c. to ensure topsoil is protected until final reclamation activities.

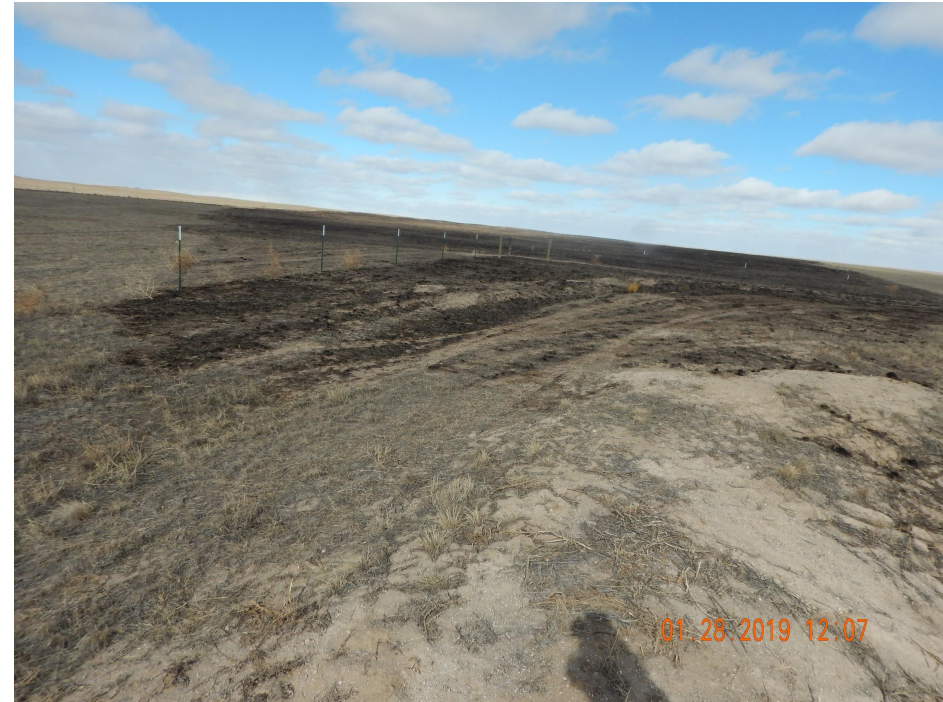
Photo 6. Photo taken from the northwestern Location, facing North. Appears a fire came onto Location. Operator will be responsible for complying with Rule 1003 vegetative standards.
