Construction and Stormwater Inspection

February 28, 2019

Operator: HIGHPOINT OPERATING CORPORATION- #10071

Location ID: 460339

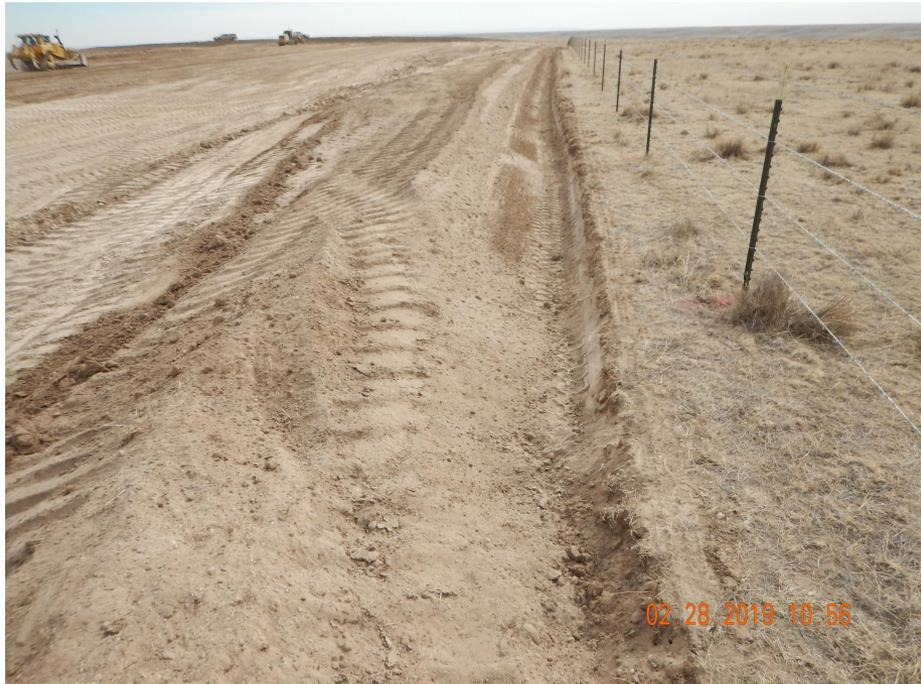
Photo 1. Photo taken from the southwestern perimeter of location, facing East. Photo illustrates a berm and ditch BMP. Operator shall stabilize the berm BMP, as unconsolidated soil material is susceptible to wind and water erosion.

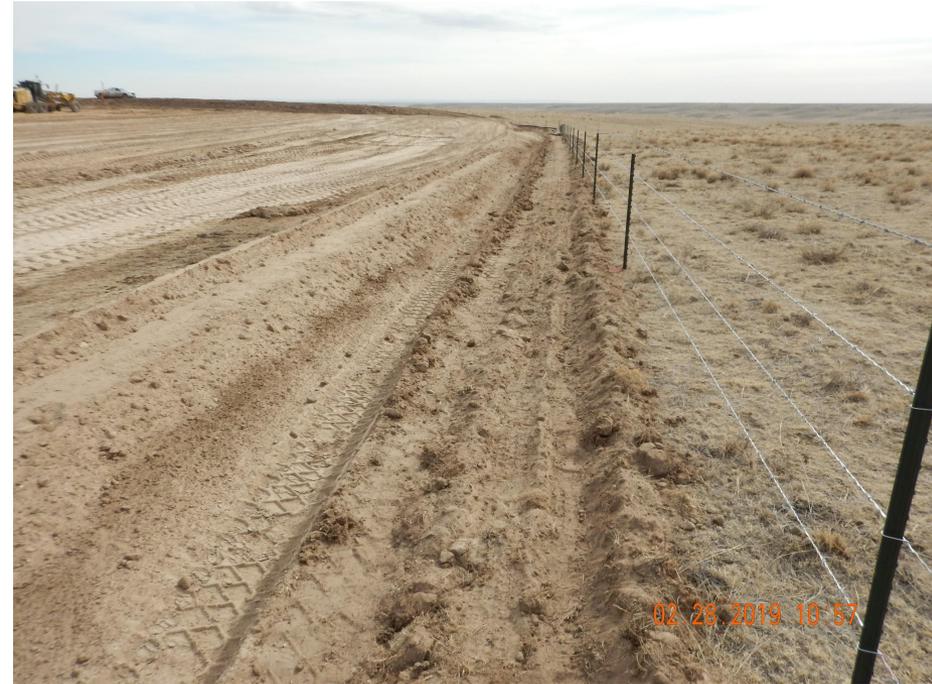
Photo 2. Photo taken from the southern perimeter of location, facing East. See comments under Photo 1.

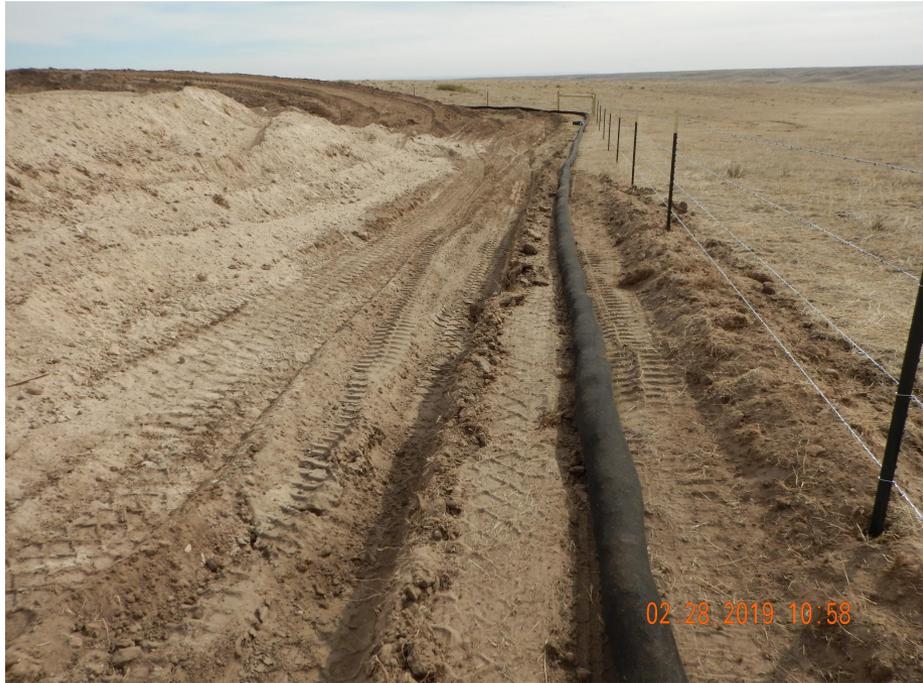
Photo 3. Photo taken from the southeastern perimeter of location, facing East. Photo illustrates wattle BMP which has not been staked. Wattle BMP should be installed to the outermost disturbance area.

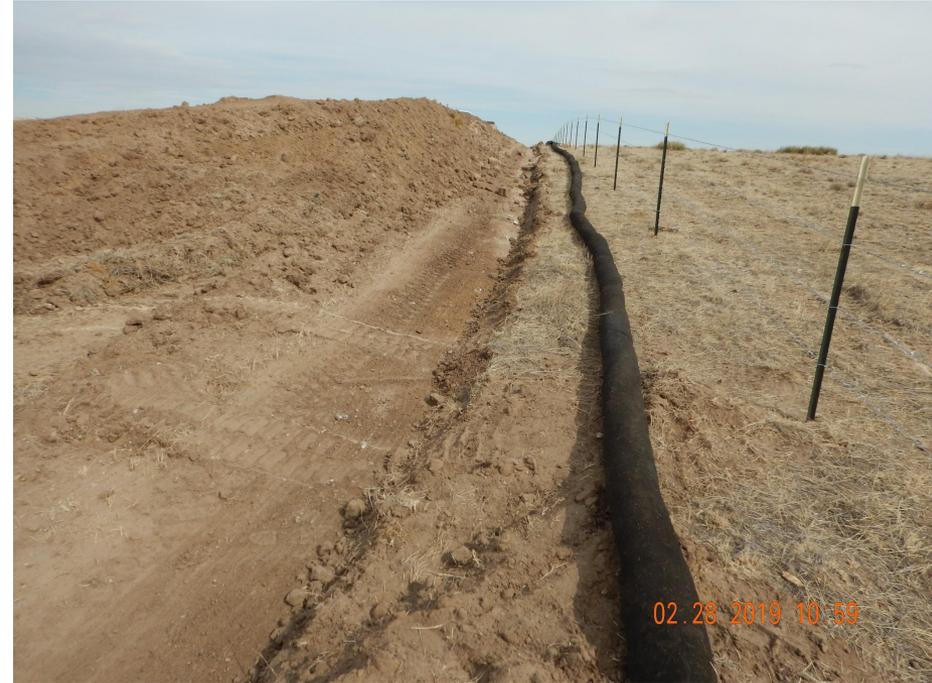
Photo 4. Photo taken from the southeastern perimeter of location, facing North. Photo illustrates the topsoil stockpile and perimeter BMPs. Wattle BMP has not been staked.

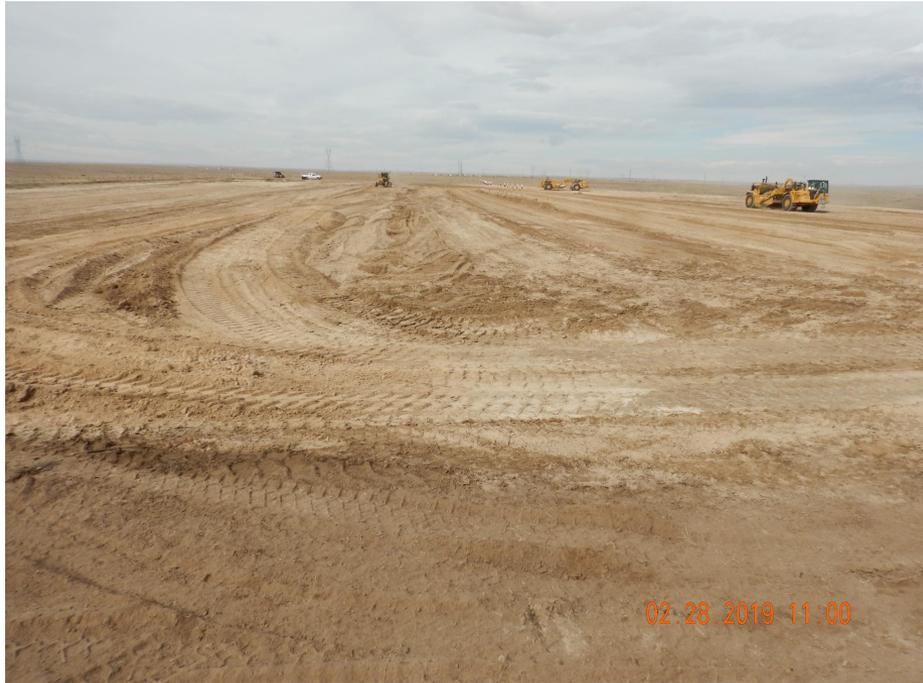
Photo 5. Photo taken from the eastern perimeter of location, facing West. Appears the Operator has completed topsoil salvage operations.

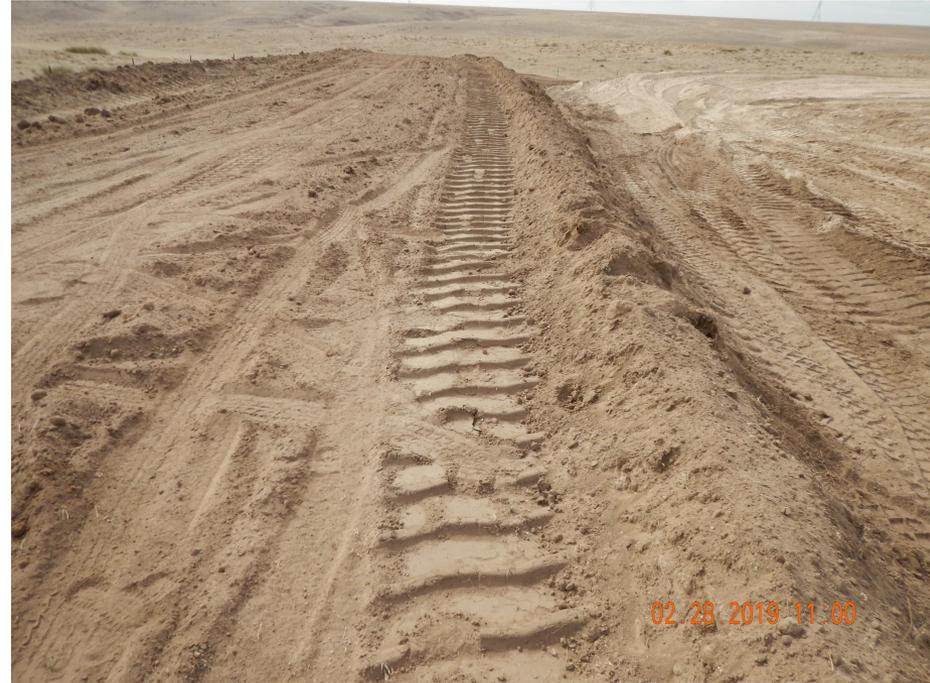
Photo 6. Photo taken from the topsoil stockpile, facing South. Operator shall properly stabilize topsoil stockpile upon completion of the construction operations.

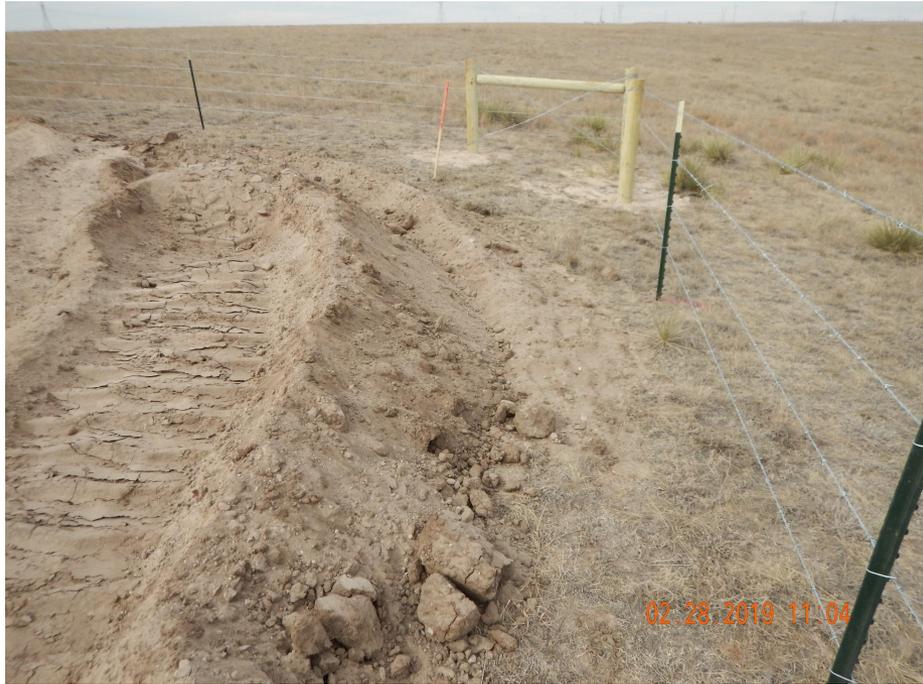
Photo 7. Photo taken from the northwestern perimeter of location, facing West. Photo illustrates unconsolidated soil material without a perimeter BMP. Operator on Location stated that wattle BMPs would be installed around the remainder of the location.

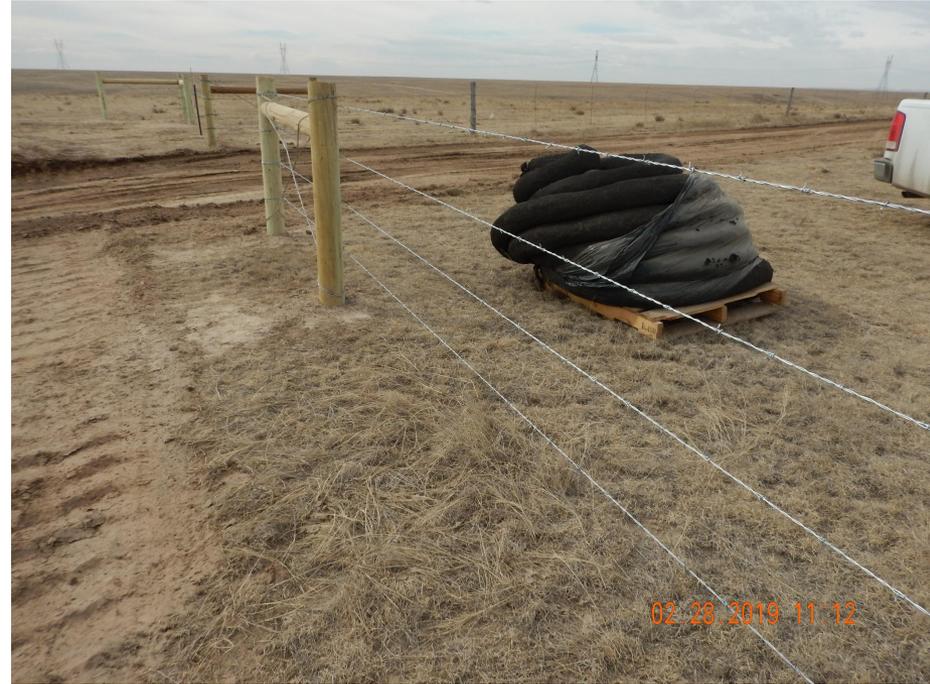
Photo 8. Photo taken from the entrance of location, facing South. Wattle BMPs were scheduled to be installed the same day of the inspection.
