Figure 1
Norton 13N-29HZ -
Facility Layout &
Sample Locations

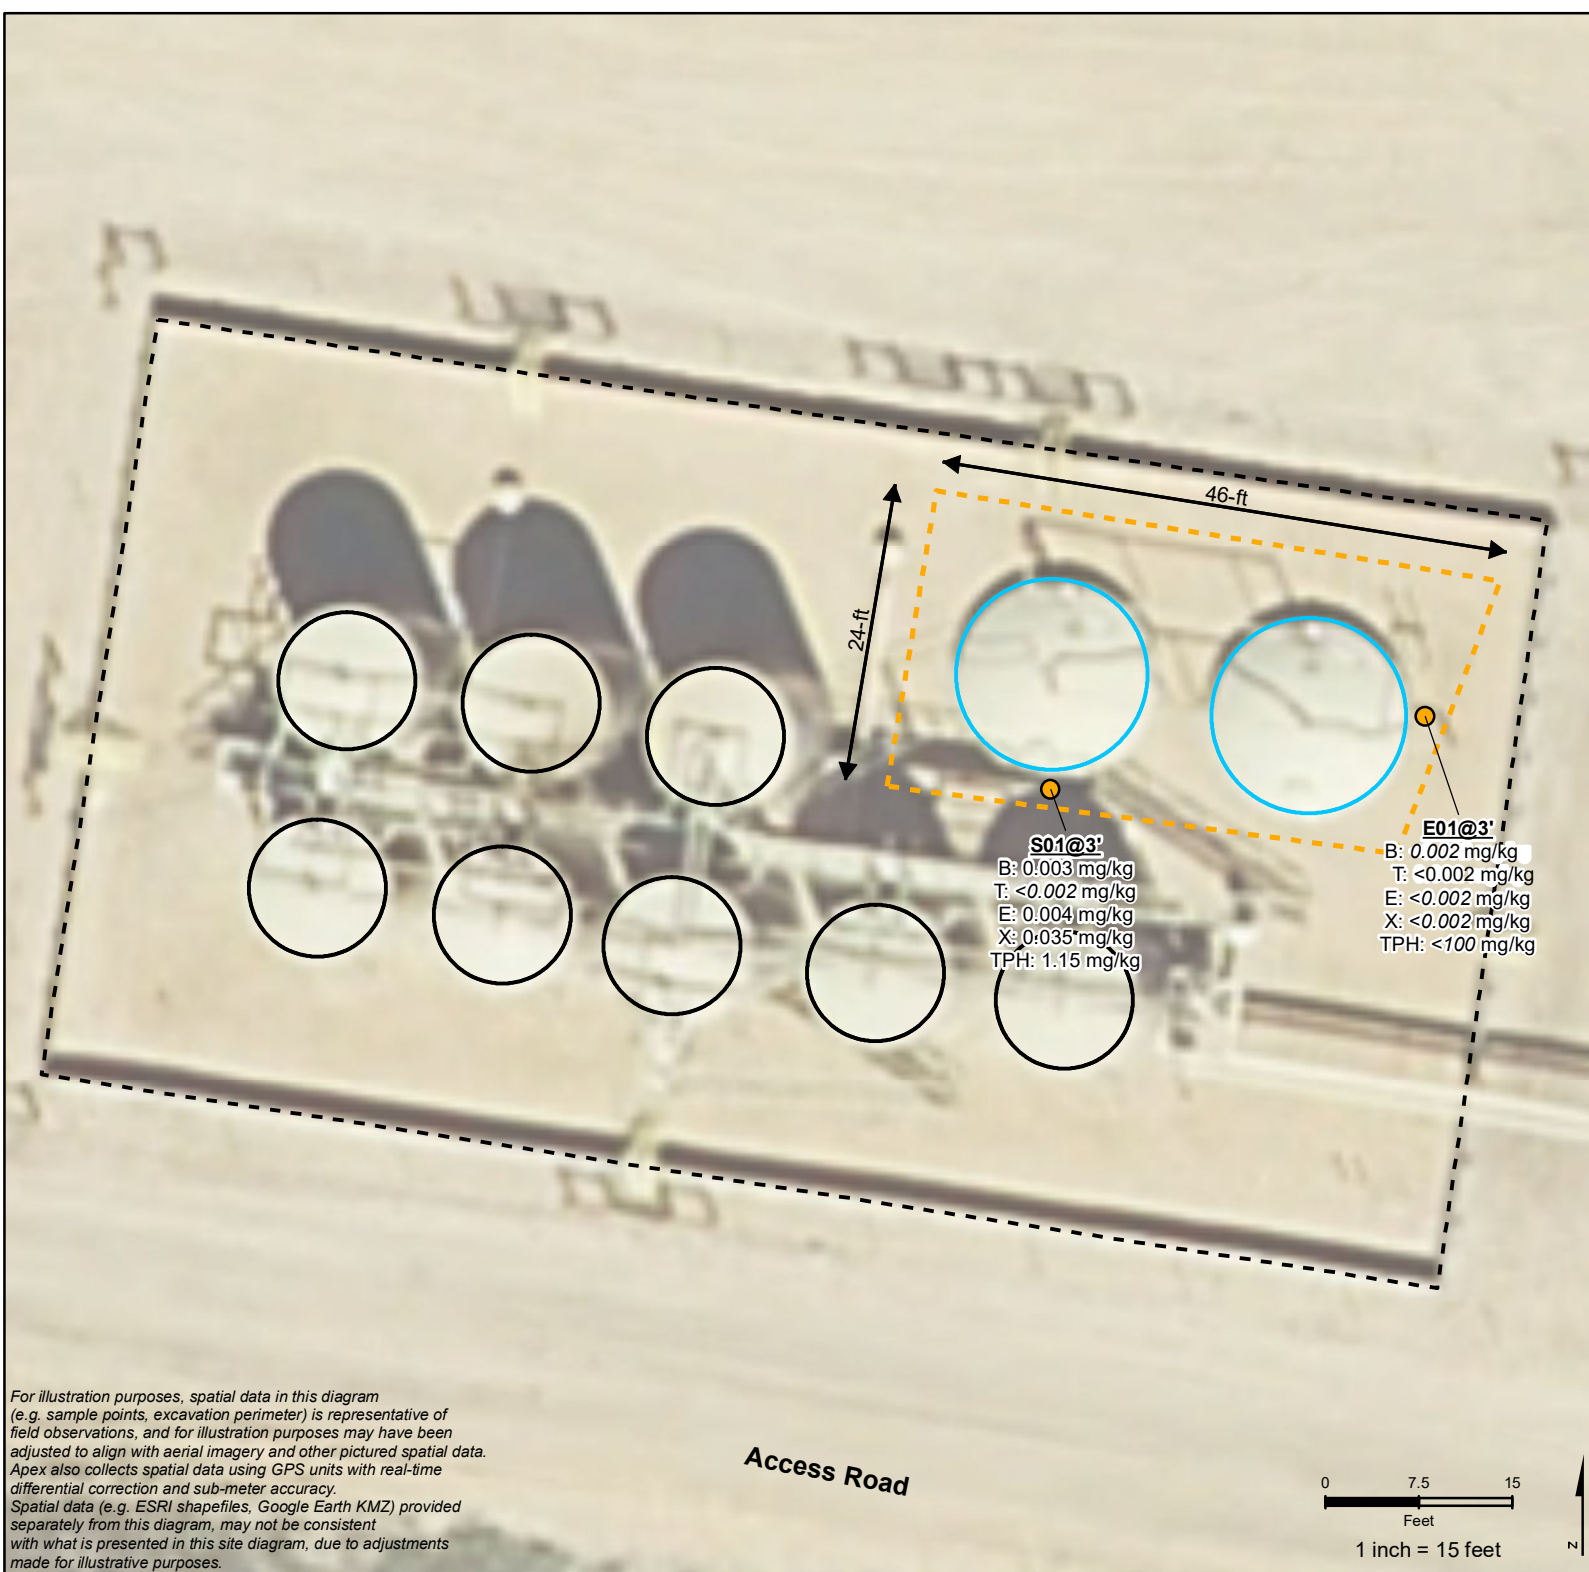
REVISED	BY	COMMENT
1/23/2019	BJB	Figure 1

- Soil Sample (1/15/2019)
- Crude Oil Tank
- Former Produced Water Sump
- Secondary Containment
- Excavation Extent (1/15/2019)

Bold values exceed COGCC Table
910-1 allowable concentrations
