Inspection Photos  
Location Name: TONKS 44-33  
API #: 05-071-08781  
INSP. #:695100607

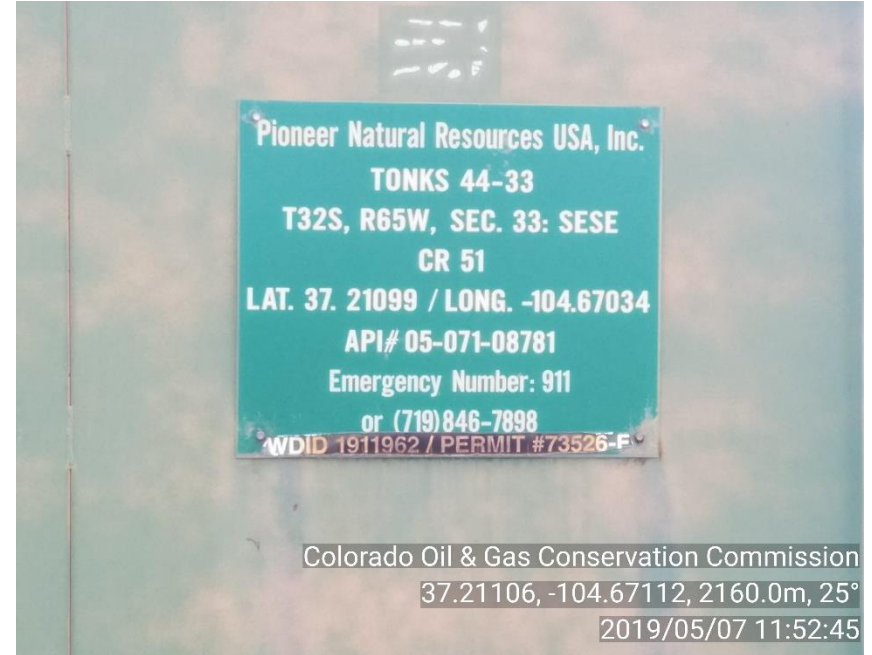
PHOTO 2: WELL SIGN/ OPERATOR ON POSTED WELL SIGN IS  
INACCURATE **Install sign to comply with Rule 210.b. CA DUE DATE  
7/7/19**

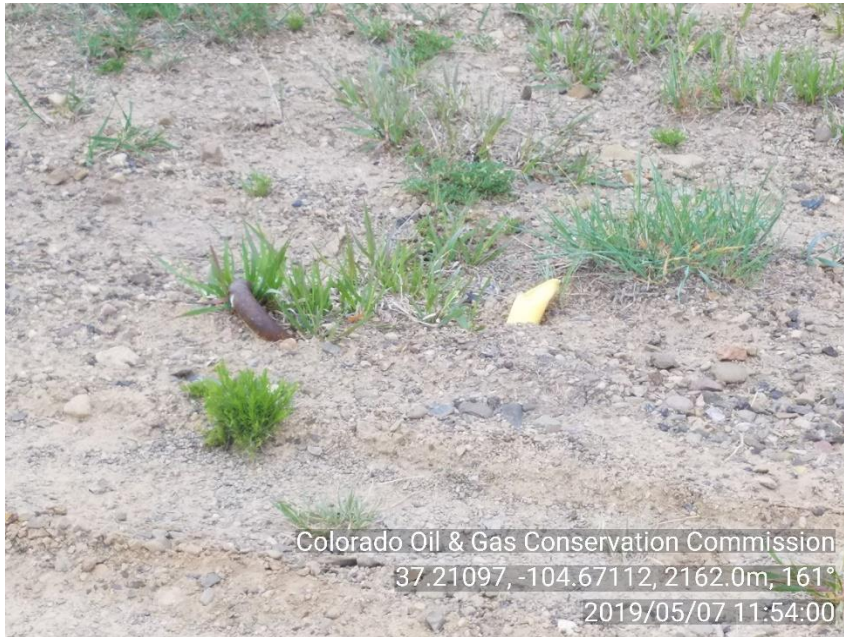
**PHOTO 3: NO ANCHOR MARKER ON NORTHWEST ANCHOR. Install  
proper guy line markers per Rule 1003.a CA DATE 6/7/19**
