Inspection Photos
Location Name: CODY 41-19 FOLLOWUP
API #: 05-071-06362
INSP. #:695100638

Inspection Photos

Location Name: CODY 41-19 FOLLOWUP

API #: 05-071-06362

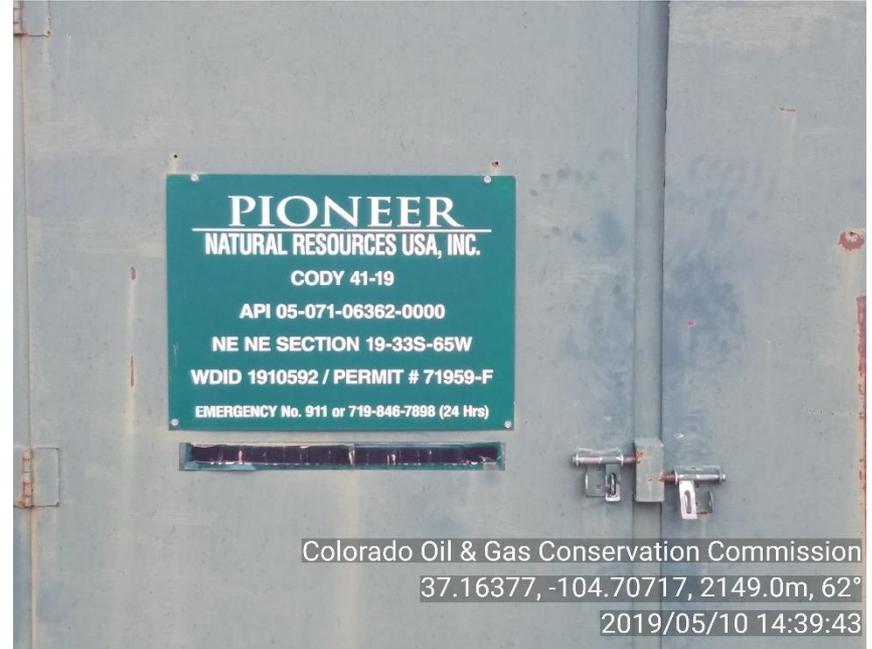
PHOTO 2: WELL SIGN/ OPERATOR ON POSTED WELL SIGN IS
INACCURATE **Install sign to comply with Rule 210.b. CA DUE DATE
7/10/19**

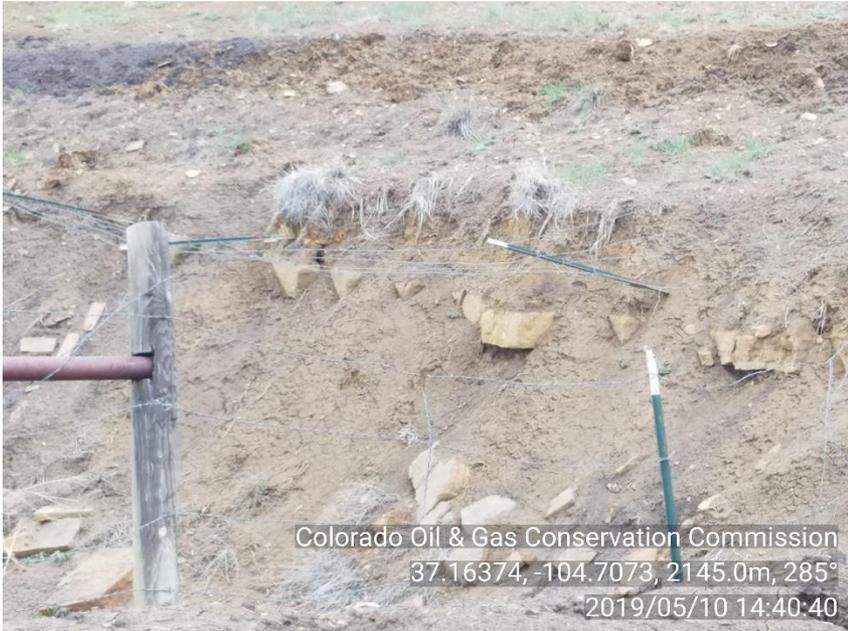
PHOTO 3: The fence needs maintenance. Fence pit to prevent access per rule 902.d. CA DATE 1/4/19
