Inspection Photos

Operator: PCR OPERATING LLC - 10657

Location ID: 454154

Inspection Doc. Number: 696200076

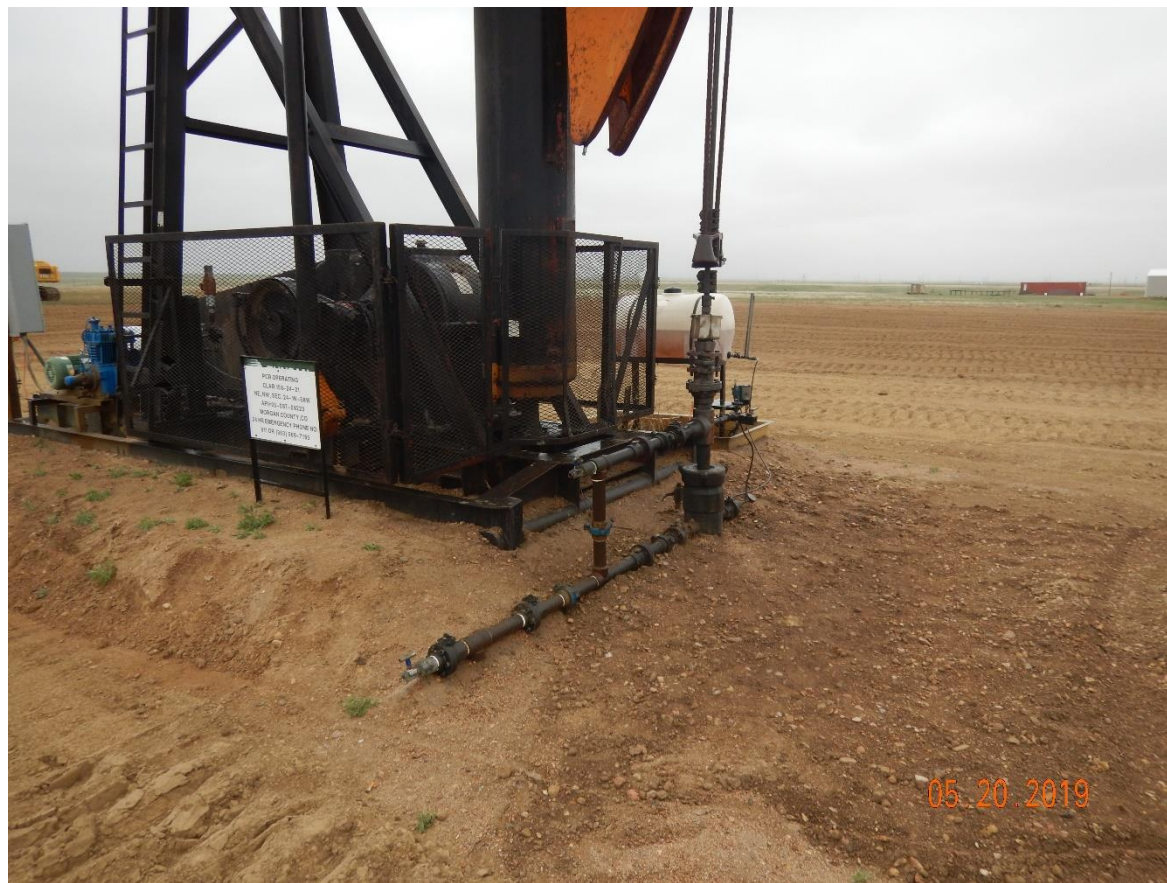
Photo 1: Photo taken from the well location, facing north. Photo shows operator has stopped the fluid discharge from the well, and appears to have cleaned the stained soils.

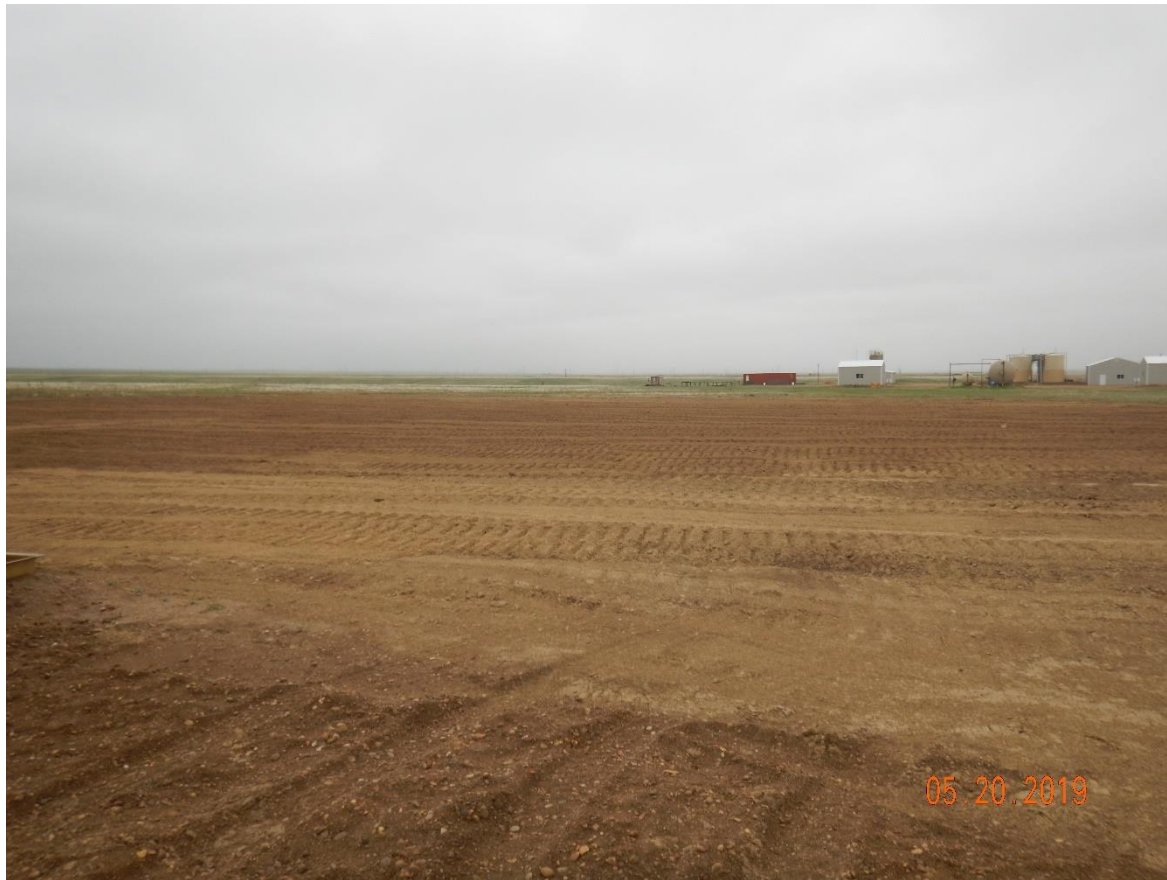
Photo 2: Photo taken from the north end of the location, north. Photo shows operator appears to have closed the drilling pit.

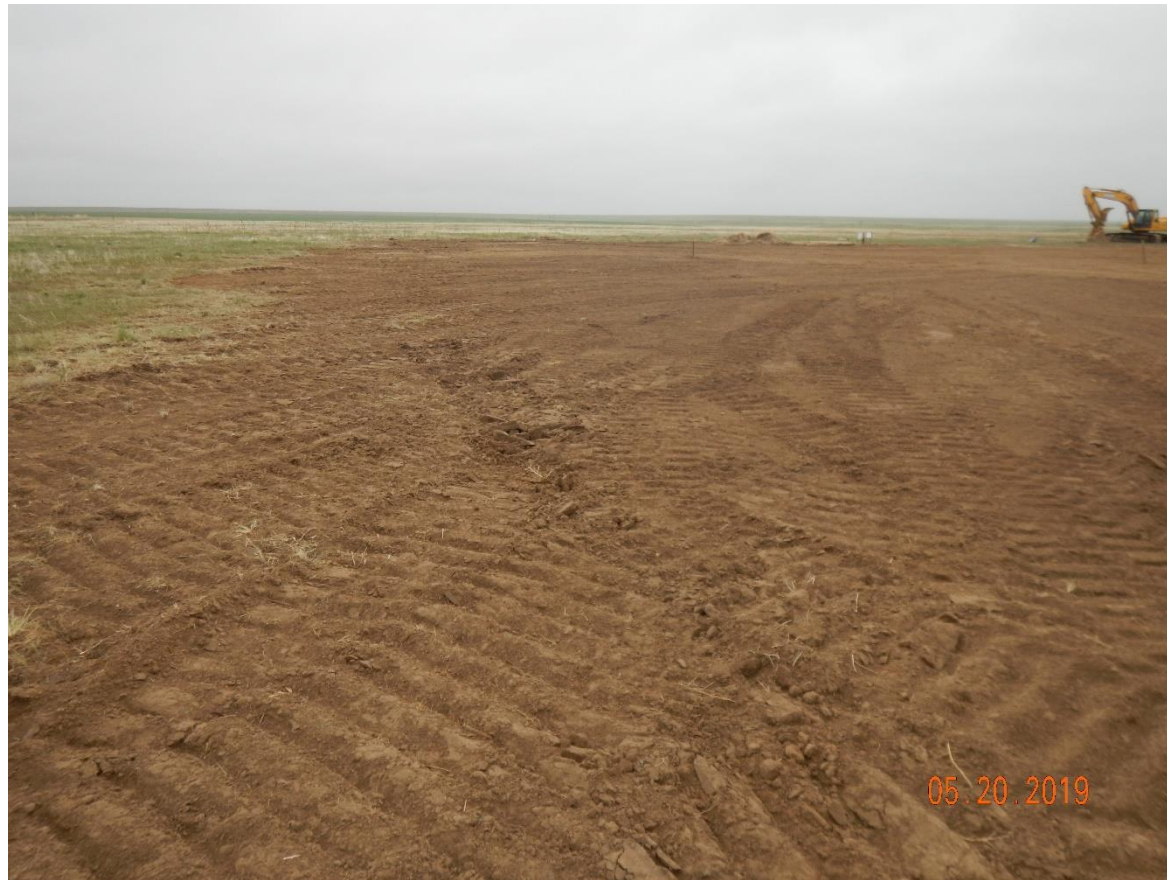
Photo 3: Photo taken from the south end of the location, facing west. Photos 3-6 provide an overview of the location from west, northwest, northeast to east. Photos show operator appears to have replaced the segregated soils/topsoil over the location.

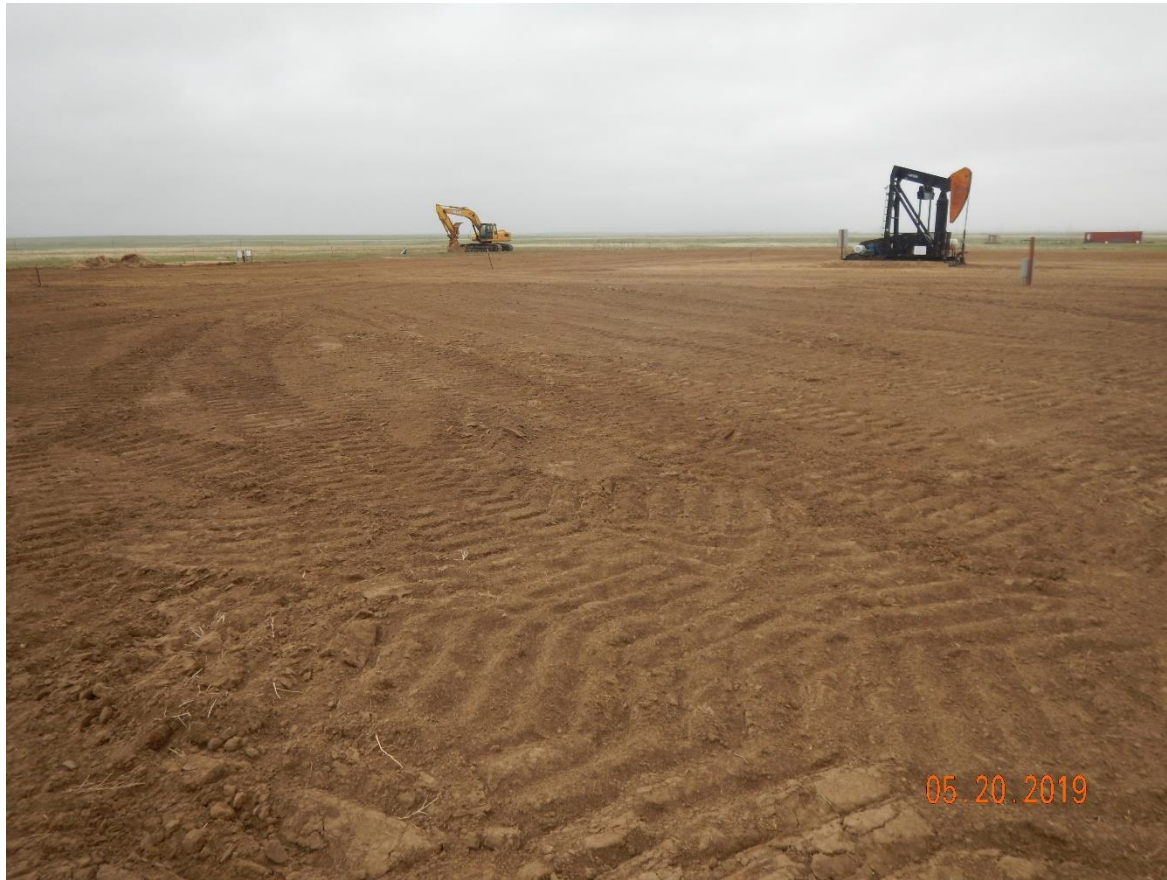
Photo 4: See comments under photo 3.

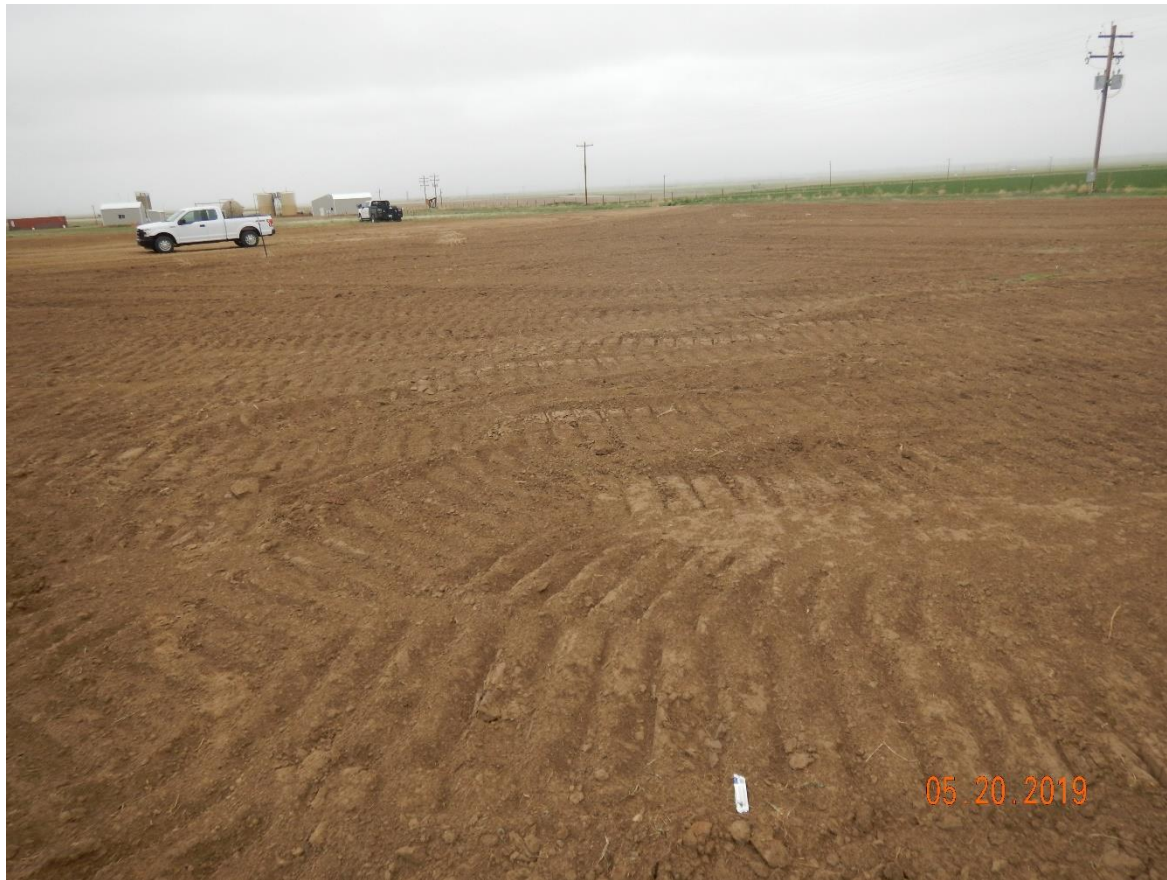
Photo 5: See comments under photo 3.

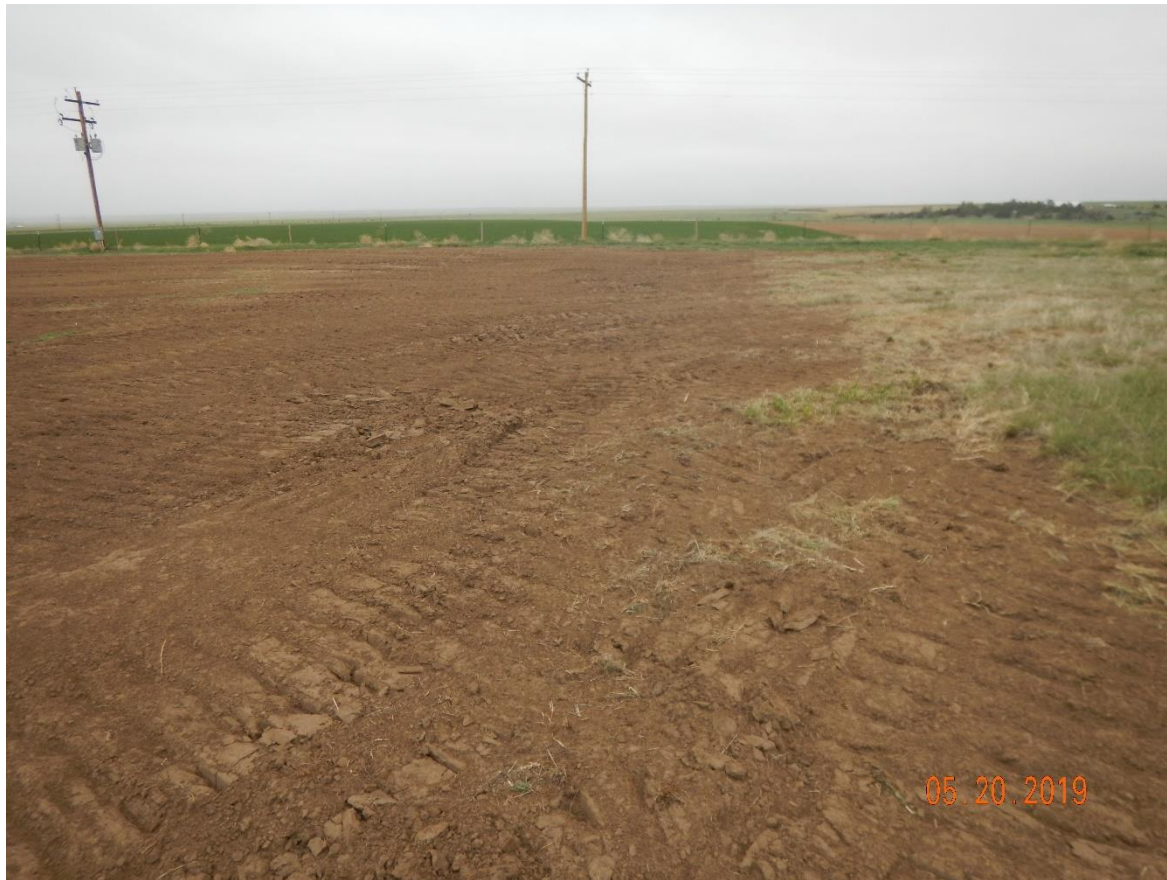
Photo 6: See comments under photo 3.

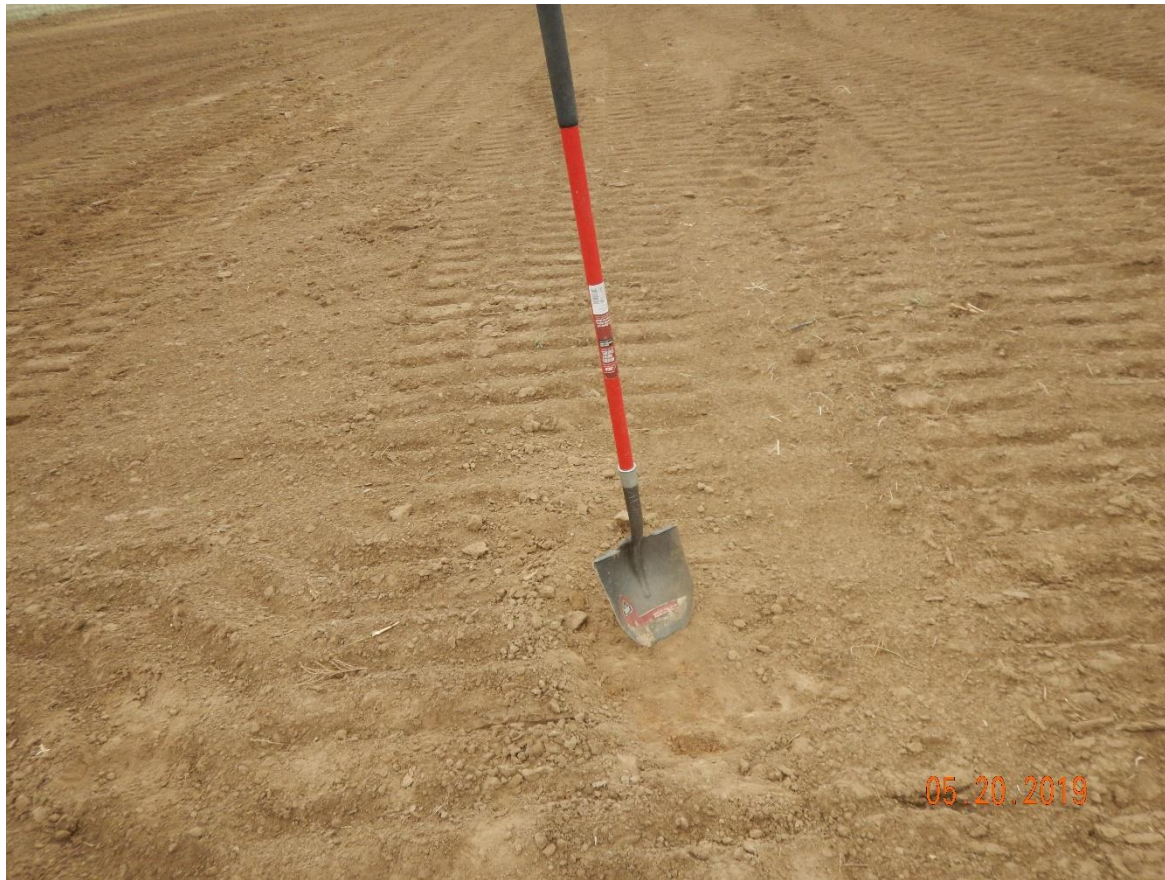
Photo 7: Photo taken from the interim areas of the location. Photo shows reclamation specialist tested the interim areas for compaction. Compaction zones were discovered directly under the recently replaced topsoil; Unable to find evidence that compaction alleviation has been conducted in accordance with 1003.c

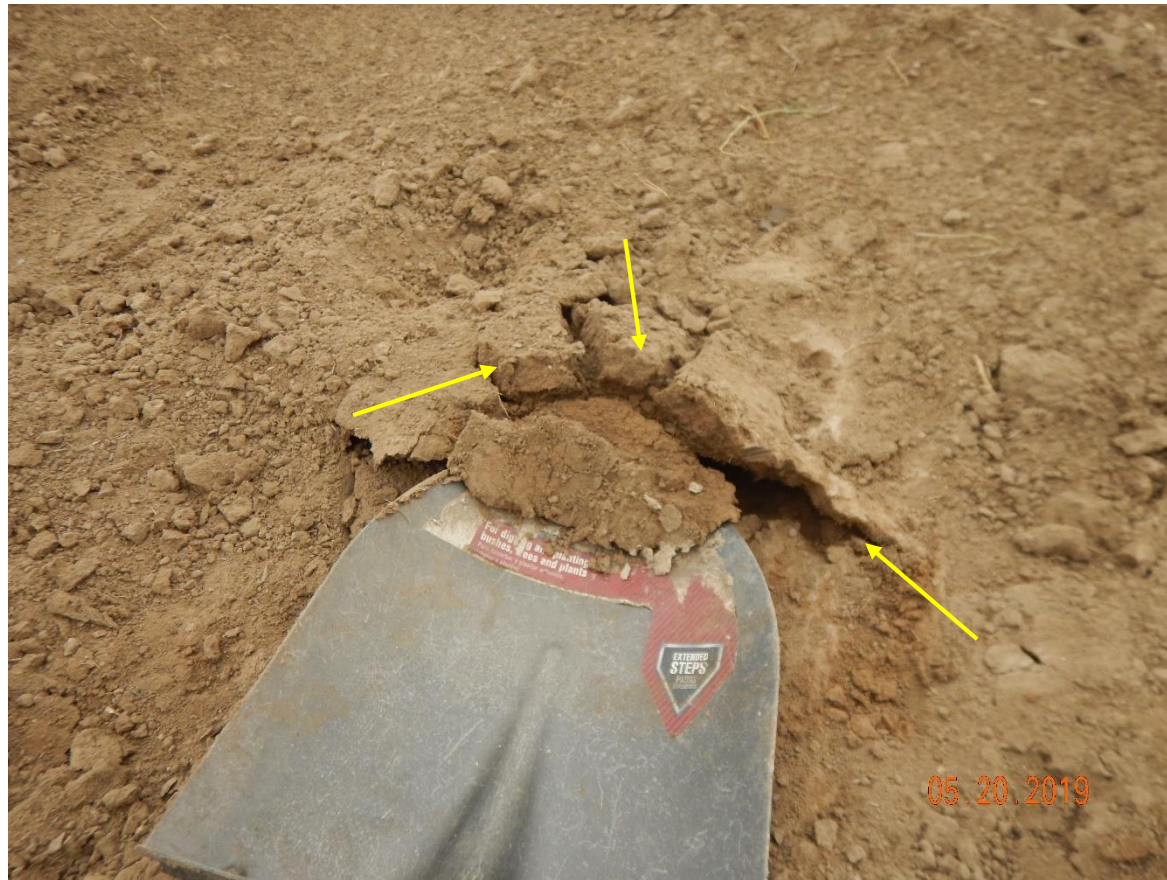
Photo 8: Continued from photo 7. Photo shows “Platy” soil structures. These structures are thin, flat plates of soil that lie horizontally and are usually found in compacted soils. Unable to find evidence that compaction alleviation has been conducted in accordance with 1003.c
