Inspection Photos
Location Name: POLY POND 42-36
API #: 05-071-07769
INSP. #:695100756

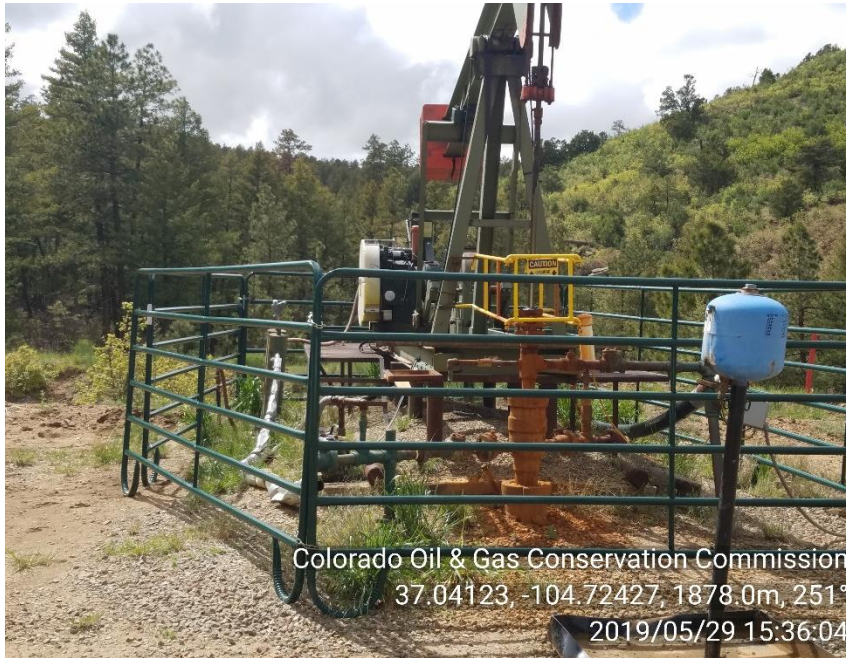
PHOTO 1: WELLHEAD/ IMPACTED SOIL AROUND WELLHEAD.
Remove and dispose impacted material in approved manner, service and maintain equipment and self inspect to prevent recurrence of conditions per 1002.f(2) and 907" CA DATE 6/29/19

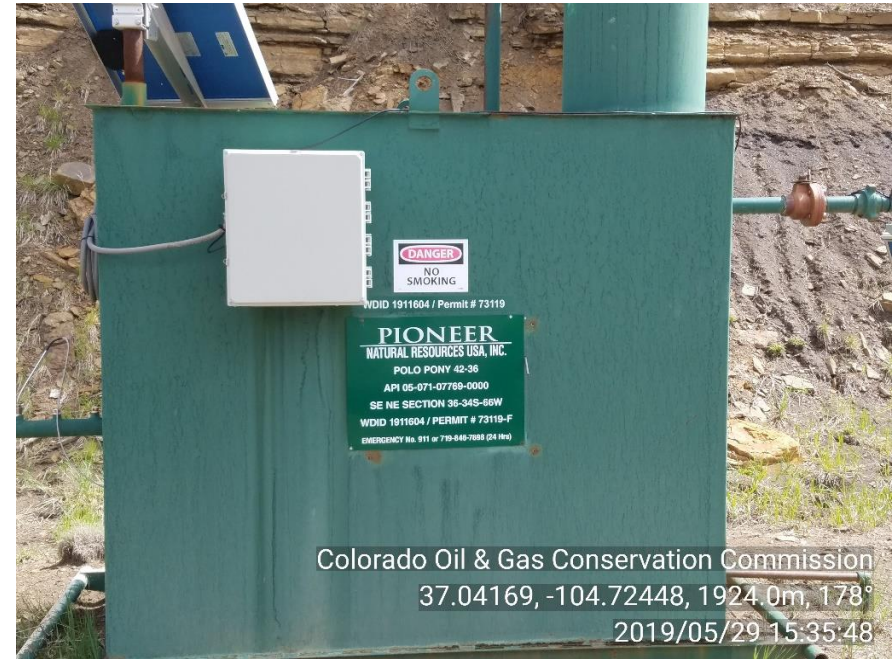
PHOTO 2: CURRENT OPERATOR NOT POSTED ON WELL SIGN.
CHANGE OPERATOR NAME TO CURRENT OPERATOR IN ACCORDANCE WITH RULE 210. CA DATE 7/29/19
