Inspection Photos

Operator: FOUNDATION ENERGY
MANAGEMENT LLC - 10112

Location ID: 455471

Inspection Doc. Number: 696200165
Weld County, CO

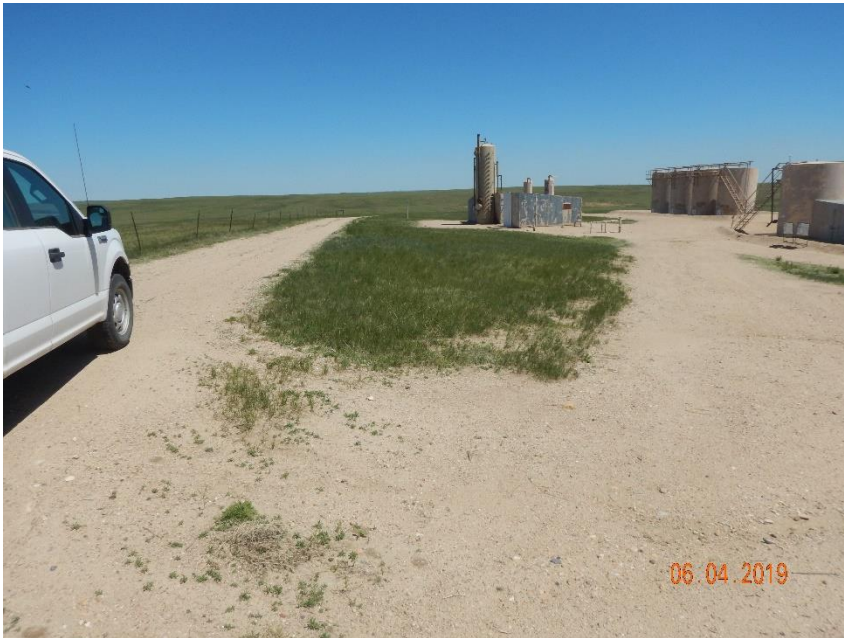
Photo 1: Photo taken from southwest end of the location, facing north. Photo provides overview of the location.

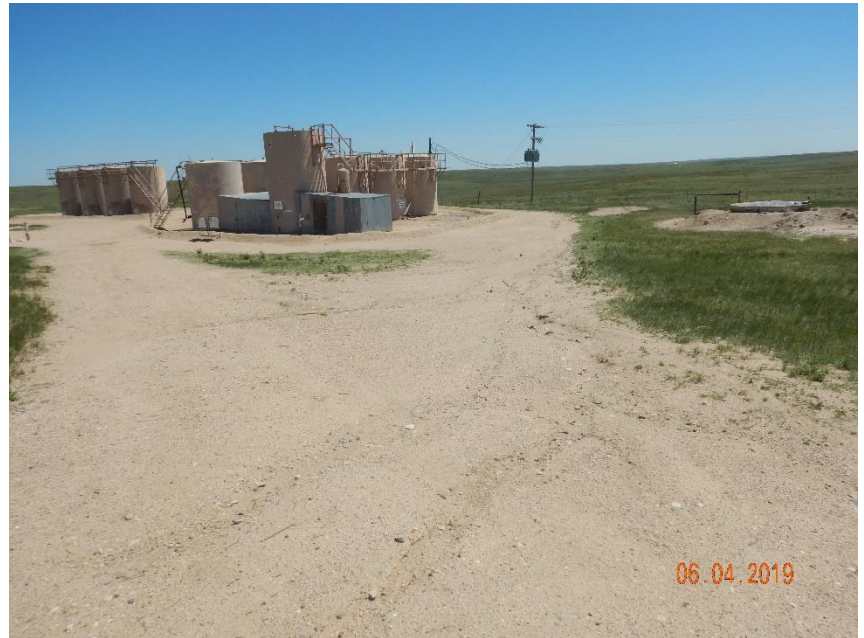
Photo 2: Photo taken from southwest end of the location, facing northeast. Photo provides overview of the location.

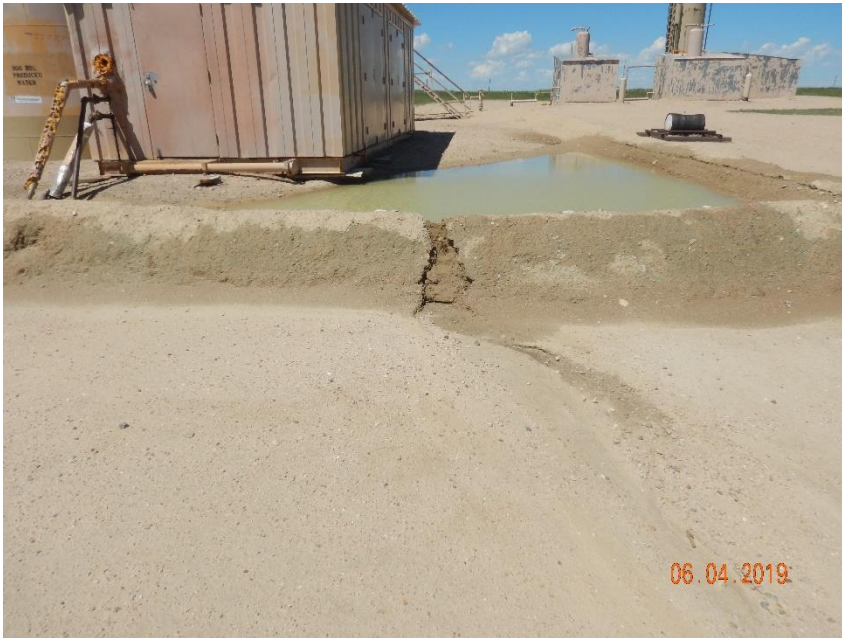
Photo 3: Photo taken from the southeast end of the location, facing west. Photo shows secondary containment is no longer in proper functioning condition in accordance with 906.d.(1)

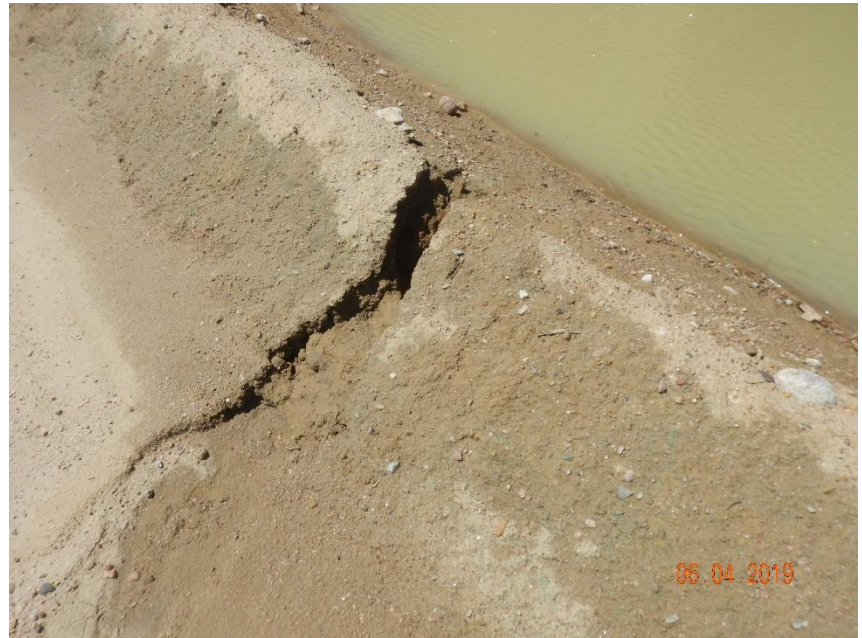
Photo 4: Continued from photo 3. Photo shows secondary containment is no longer in proper functioning condition in accordance with 906.d.(1)
