Final Reclamation Inspection

Operator: NOBLE ENERGY INC - #100322

Location ID: 309896

Location Name: RYANN STATE C #16-1

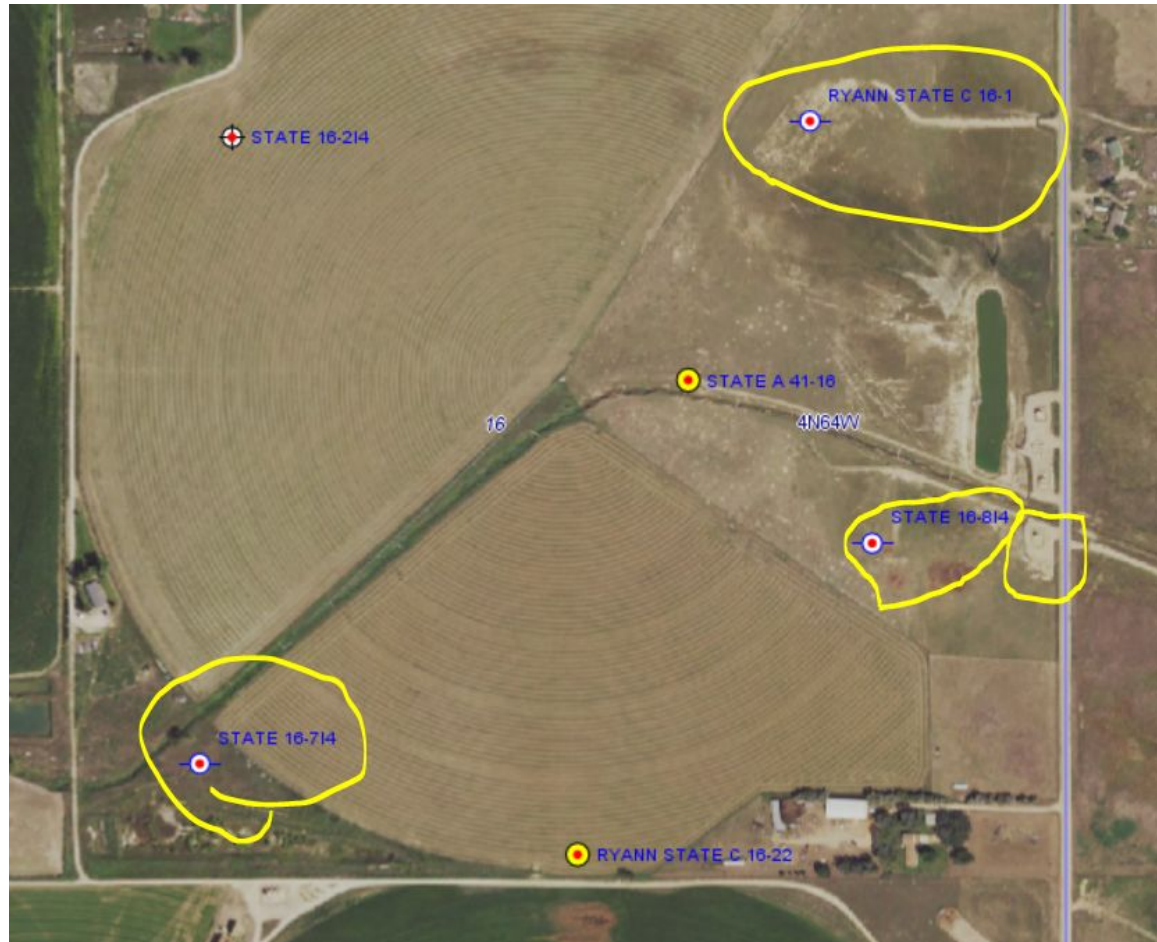
Aerial imagery taken in 2017. Aerial imagery shows four areas circled in yellow. The southern tank battery circled in yellow serviced the three circled wells.

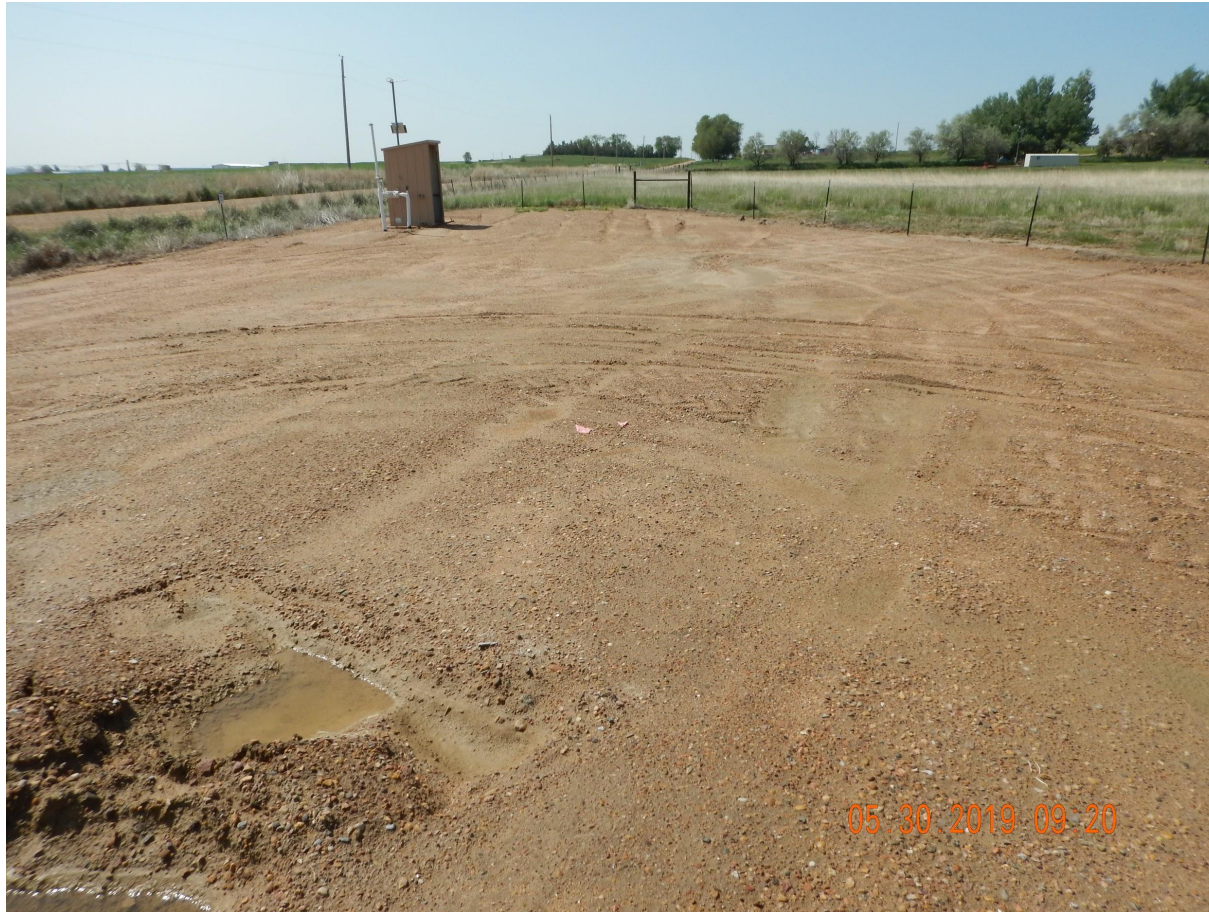
Photo 1. Photo taken from the southern tank battery, facing South. Operator indicated this southern tank battery was decommissioned on 2/13/2019. Photo illustrates it has been over 3 months and not all equipment has been removed from location. Per Rule 1004, Operator shall make every reasonable effort to perform final reclamation before the next local growing season.
