Inspection Photos
Location Name: GARCIA No. 1 (UIC)
API#: 05-055-06012
INSP. #: 695100886

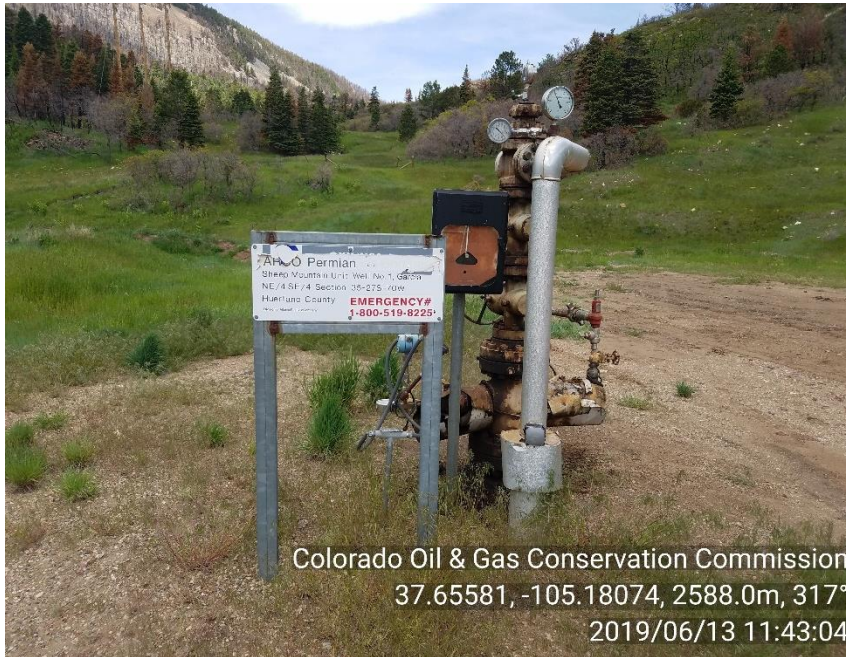
PHOTO 1: WELLHEAD/ WELLSIGN/ CURRENT OPERATOR IS NOT POSTED ON WELLSIGN 911 IS NOT POSTED AS EMERGENCY CONTACT. IF 911 SERVICES THIS AREA POST 911 AS EMERGENCY CONTACT ALSO POST CURRENT OPERATOR SIGN IN ACCORDANCE WITH 210 SERIES RULES. CA DATE 7/13/19.

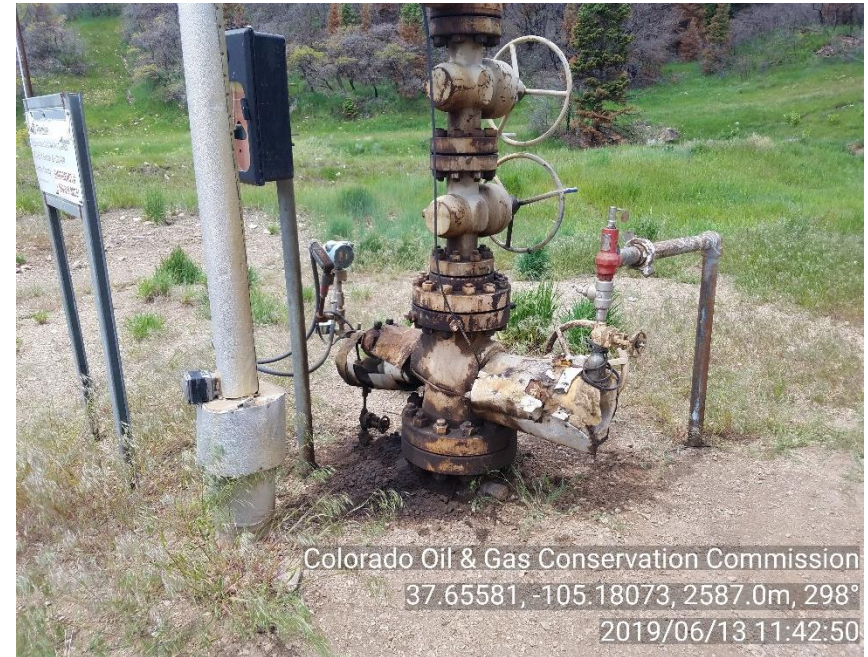
PHOTO 2: IMPACTED SOIL AROUND WELLHEAD. Remove and dispose impacted material in approved manner, service and maintain equipment and self inspect to prevent recurrence of conditions per 1002.f(2) and 907. CA DATE 7/13/19

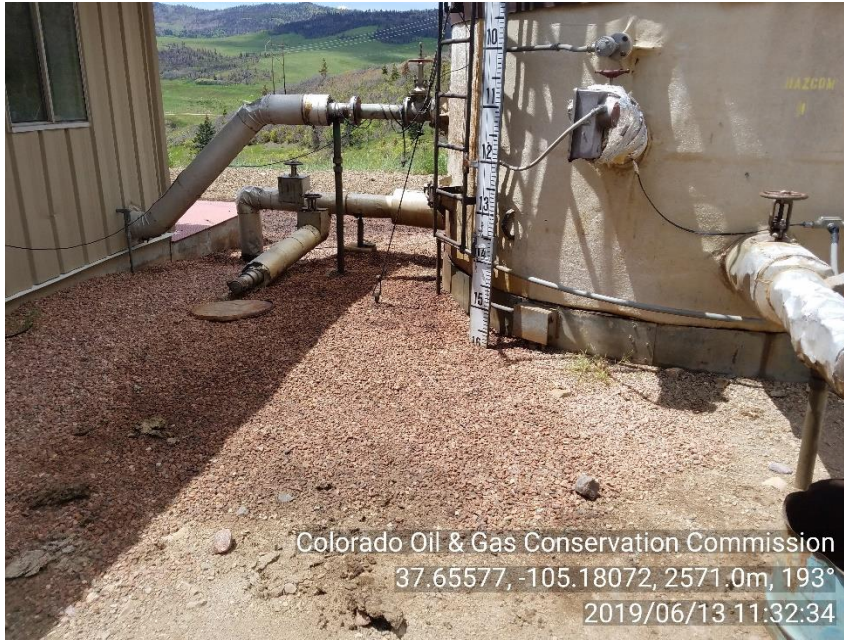
PHOTO 3: IMPACTED SOIL AROUND OIL TANK. Control and contain spills/releases and clean up per Rule 906.a.CA DATE 7/13/19

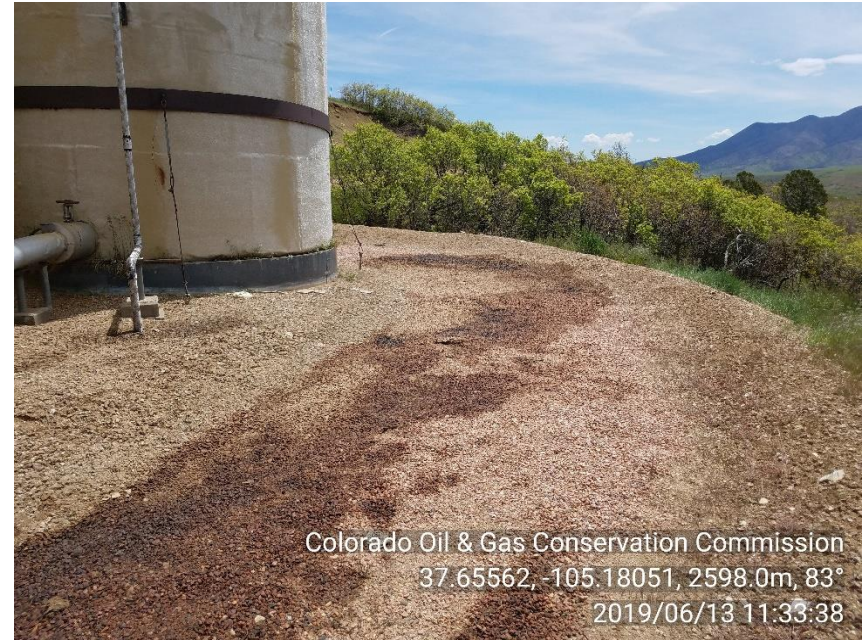
PHOTO 4: IMPACTED SOIL IN CONTAINMENT SOUTHWEST OF PRODUCED WATER TANK. Control and contain spills/releases and clean up per Rule 906.a.CA DATE 7/13/19

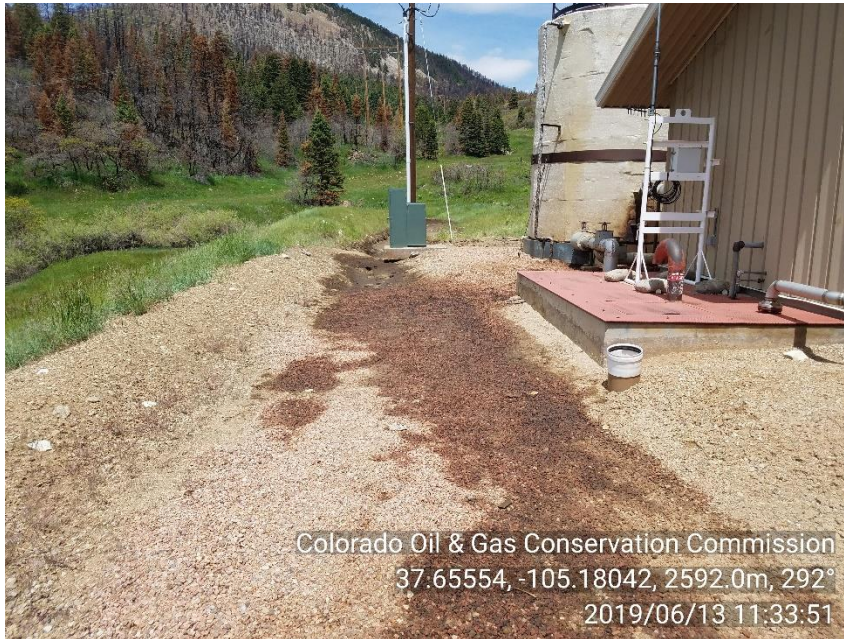
PHOTO 5: IMPACTED SOIL IN CONTAINMENT SOUTH OF OIL TANK. Control and contain spills/releases and clean up per Rule 906.a.CA DATE 7/13/19

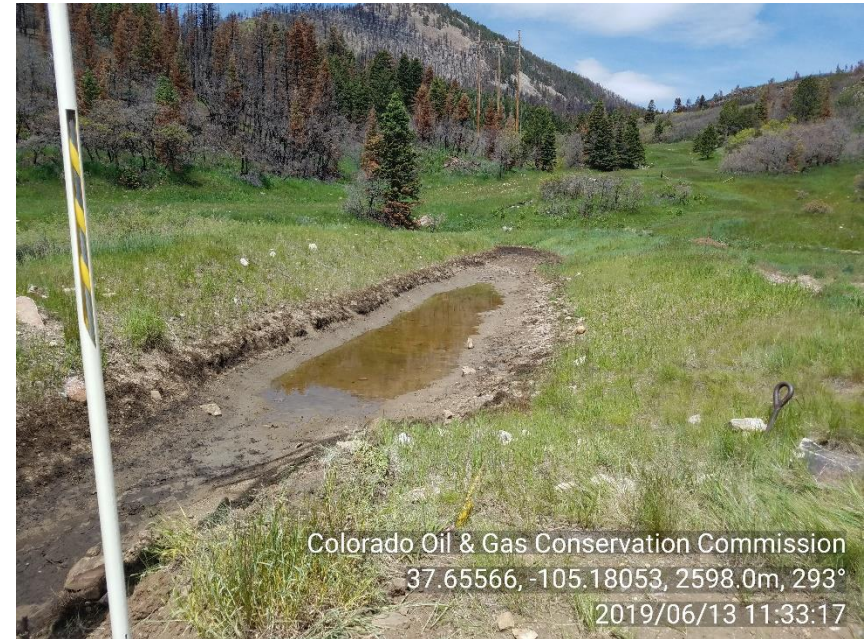
PHOTO 6: IMPACTED SOIL IN CONTAINMENT SOUTHWEST OF OIL TANK. Control and contain spills/releases and clean up per Rule 906.a.CA DATE 7/13/19

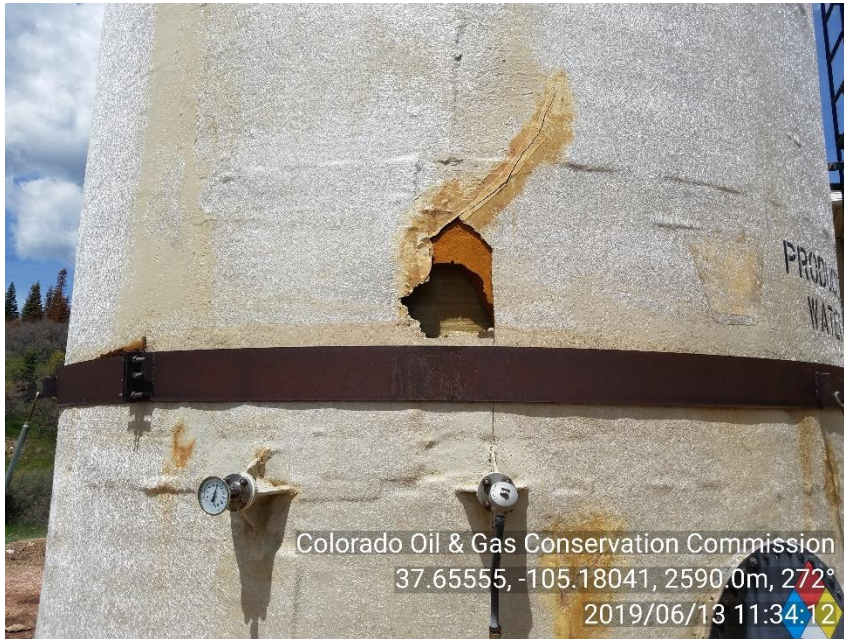
PHOTO 7: THERE IS A HOLE AND SEVERAL CRACKS IN OUTER LAYER OF THE DOUBLE WALL PRODUCED WATER TANK. COMPLY WITH 605 SERIES RULES FOR MECHANICAL CONDITIONS. CA DATE 7/13/19

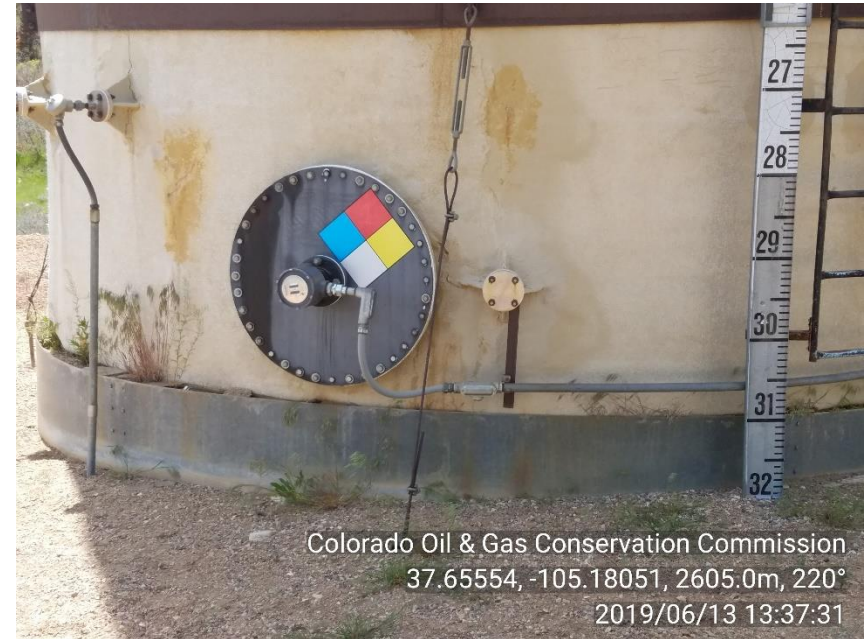
PHOTO 8: HAZARD LEVEL NUMBERS ARE FADED AND NOT LEGABLE ON LARGER PRODUCED WATER TANK (SOUTHEAST TANK). ALSO CAPACITY OF TANK IS NOT POSTED. COMPLY WITH 210 SERIES RULES. 7/13/19

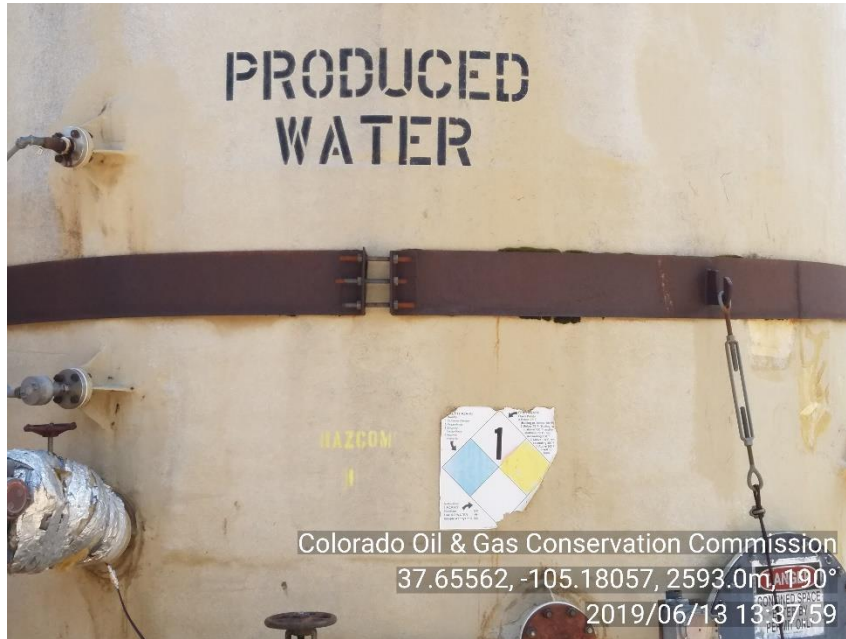
**PHOTO 9: CAZARD LEVEL NUMBERS ARE FAIDED
AND NOT LEGABLE ON LARGER PRODUCED WATER
TANK (SOUTHEAST TANK). ALSO CAPACITY OF TANK
IS NOT POSTED. COMPLY WITH 210 SERIES RULES.
7/13/19**
