Location:	Miller 6-7
Line:	Engine Fuel Return Line
Technicians:	Matthew Ingve
Date:	8/22/2018
Time	Pressure (PSI)
1:49:20 PM	1.7
1:49:50 PM	1.7
1:50:20 PM	1.7
1:50:50 PM	2.1
1:51:20 PM	20.1
1:51:50 PM	19.9
1:52:20 PM	19.9
1:52:50 PM	19.9
1:53:20 PM	20.1
1:53:50 PM	20.1
1:54:20 PM	20.1
1:54:50 PM	20.1
1:55:20 PM	20.1
1:55:50 PM	20.1
1:56:20 PM	20.1
1:56:50 PM	20.2
1:57:20 PM	20.2
1:57:50 PM	20.2
1:58:20 PM	20.1
1:58:50 PM	20.2
1:59:20 PM	20.1
1:59:50 PM	20.1
2:00:20 PM	20.2
2:00:50 PM	20.2
2:01:20 PM	20.2
2:01:50 PM	20.2
2:02:20 PM	20.2
2:02:50 PM	20.2
2:03:20 PM	20.2
2:03:50 PM	20.2
2:04:20 PM	20.2
2:04:50 PM	20.2
2:05:20 PM	20.2
2:05:50 PM	20.2
2:06:20 PM	20.2
2:06:50 PM	20.2
2:07:20 PM	20.2
2:07:50 PM	20.2
2:08:20 PM	20.2
2:08:50 PM	20.2
2:09:20 PM	20.2
2:09:50 PM	20.2

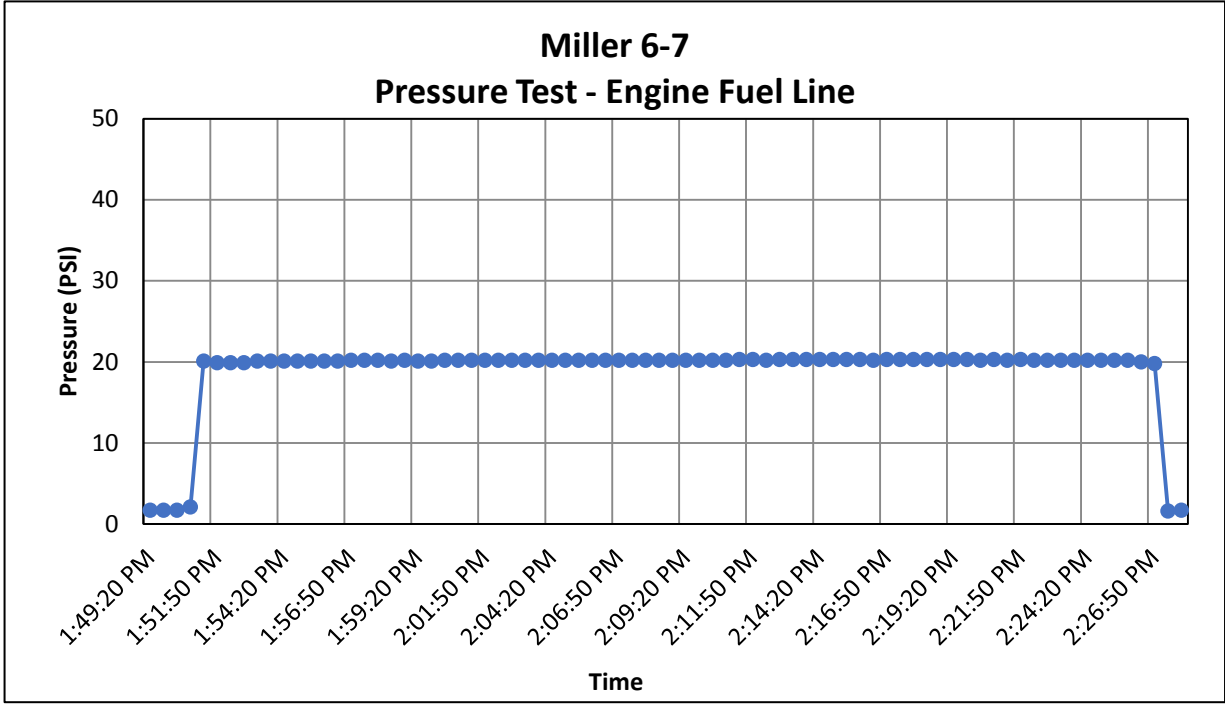
2:10:20 PM	20.2
2:10:50 PM	20.2
2:11:20 PM	20.3
2:11:50 PM	20.3
2:12:20 PM	20.2
2:12:50 PM	20.3
2:13:20 PM	20.3
2:13:50 PM	20.3
2:14:20 PM	20.3
2:14:50 PM	20.3
2:15:20 PM	20.3
2:15:50 PM	20.3
2:16:20 PM	20.2
2:16:50 PM	20.3
2:17:20 PM	20.3
2:17:50 PM	20.3
2:18:20 PM	20.3
2:18:50 PM	20.3
2:19:20 PM	20.3
2:19:50 PM	20.3
2:20:20 PM	20.2
2:20:50 PM	20.3
2:21:20 PM	20.2
2:21:50 PM	20.3
2:22:20 PM	20.2
2:22:50 PM	20.2
2:23:20 PM	20.2
2:23:50 PM	20.2
2:24:20 PM	20.2
2:24:50 PM	20.2
2:25:20 PM	20.2
2:25:50 PM	20.2
2:26:20 PM	20
2:26:50 PM	19.8
2:27:20 PM	1.6
2:27:50 PM	1.7

% loss over 30 minutes	0.50%	Less than 10%	Yes
% loss in last 5 minutes	0.49%	Less than 1%	Yes

Pass/Fail

Pass
