# Final Reclamation Inspection

Operator: SRC ENERGY INC- #10311

Location ID: 319284

Inspection Document #: 697500612

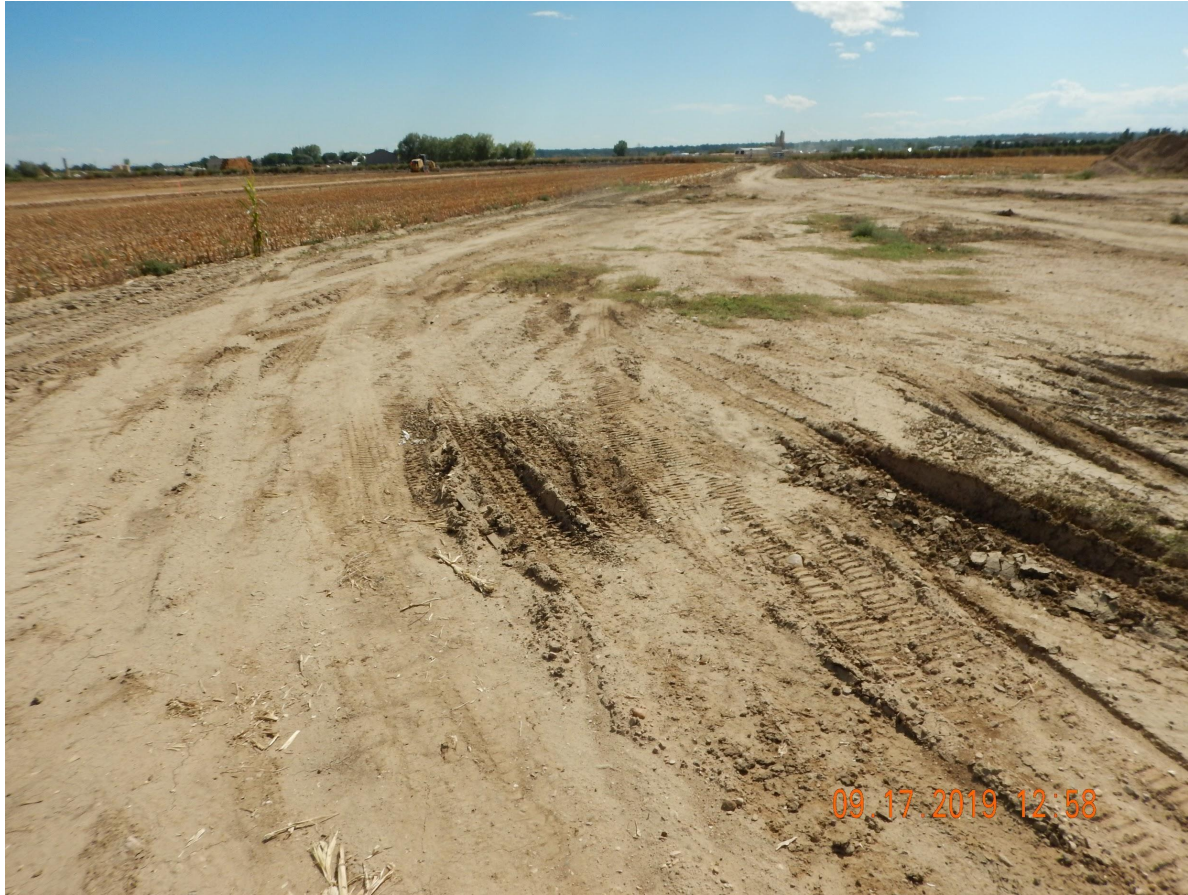
**Photo 1.** Photo taken from the well/production facility location, facing South.  
Photo illustrates the Operator has failed to reclaim the location per Rule 1004.

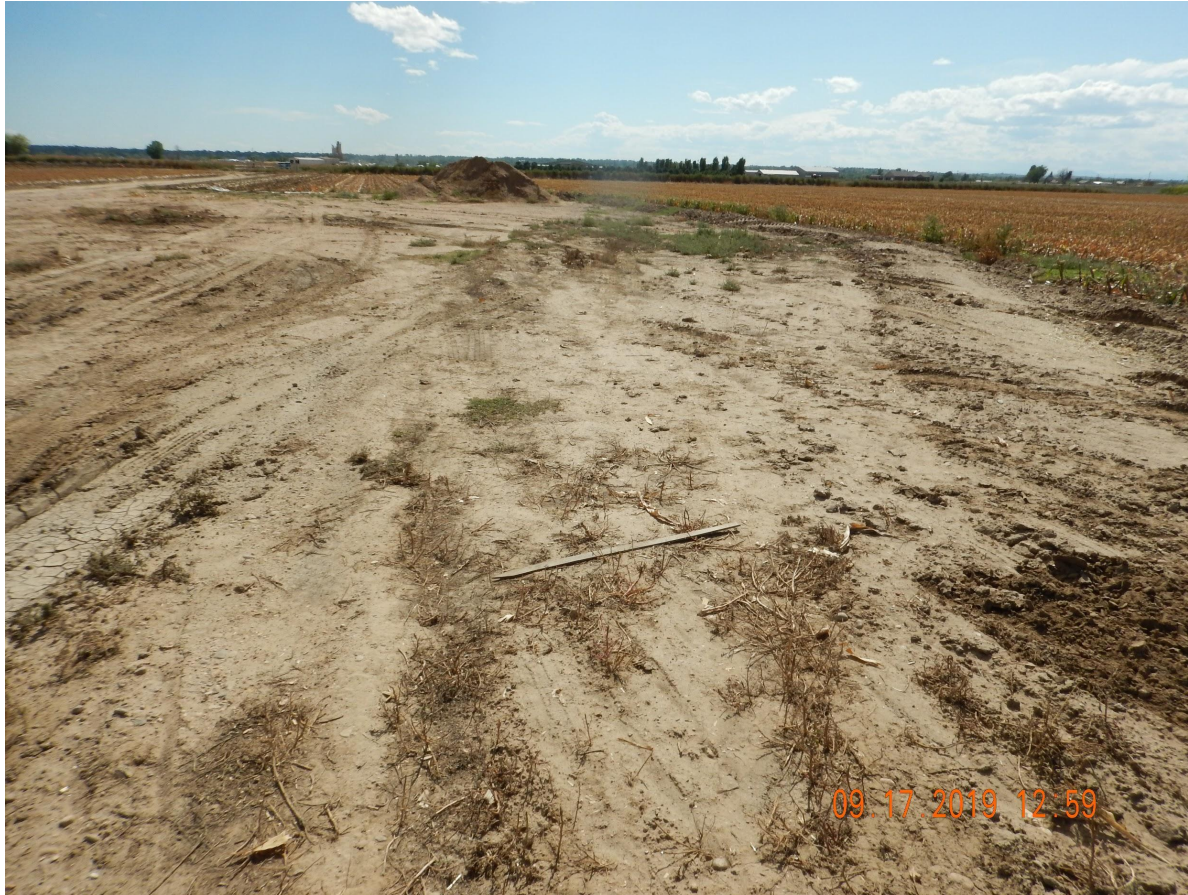
**Photo 2.** Photo taken from the well/production facility location, facing South. See comments under Photo 1.

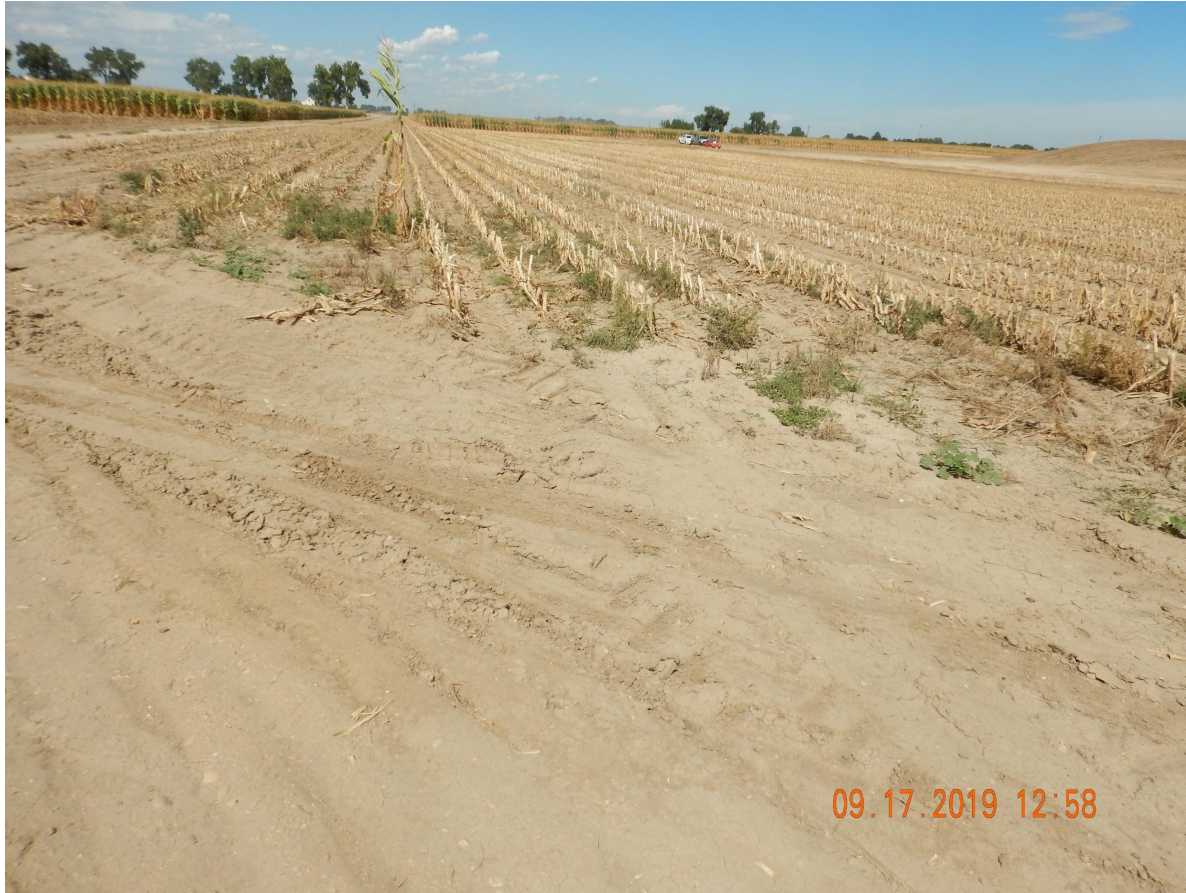
**Photo 3.** Photo taken from the well/production facility location, facing North. See comments under Photo 1.

Operator indicated this well/production facility location is planned to be used as part of the new Chalk Seeley access road. However, the Operator has only constructed a portion of the new access road- see Photo 4.

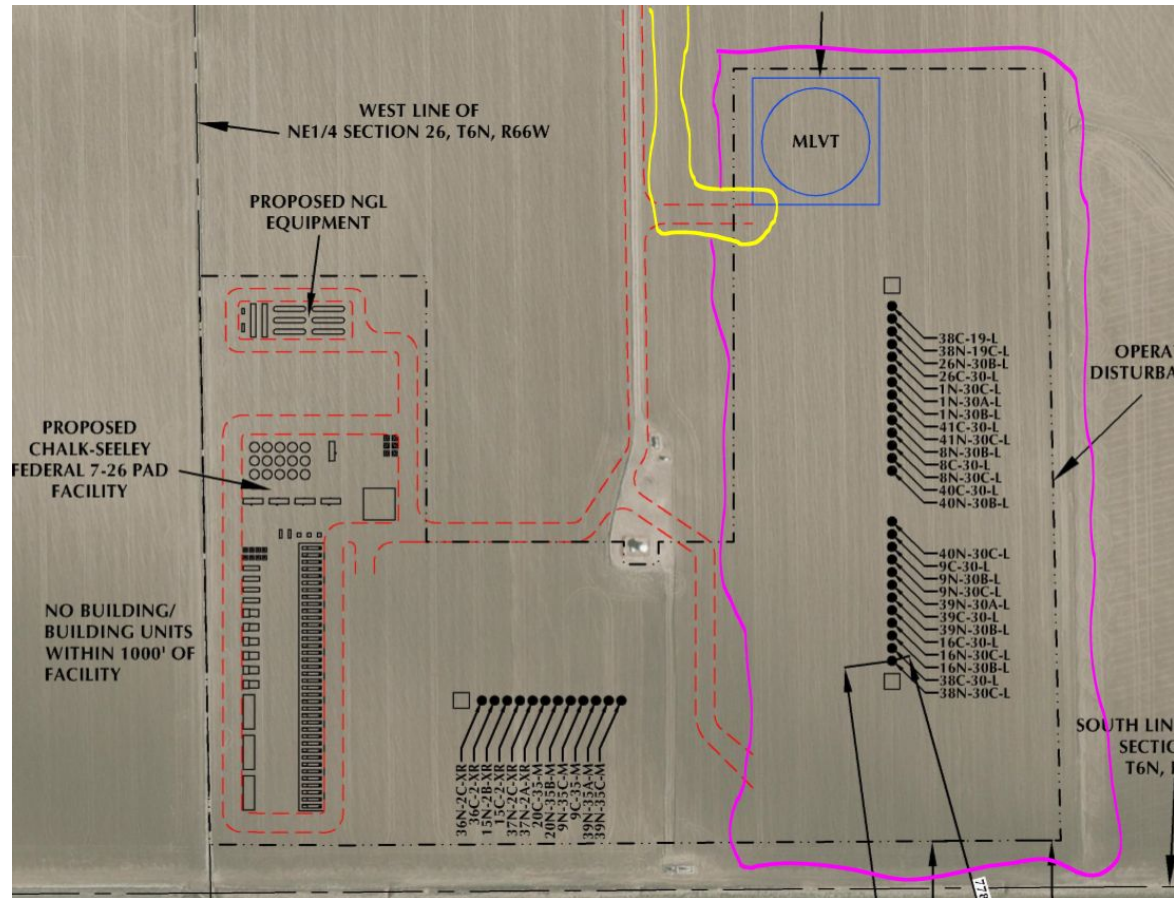
**Photo 4.** Photo taken from the Chalk Seeley facility drawing. Photo illustrates the current disturbance from the Chalk Seeley construction (yellow= new access road that has been recently constructed for the Chalk Seeley location; fushia= eastern well pad has been recently constructed). As of 9/17/2019, the central and western location have not been constructed.
