CB-4 CO2 Well Location Photos
API #05-083-06730 / Facility ID #454999
FIR #693900886 / CA #131437 & #131438
Form 4 #402202431 / FIRR #402202524

Response to CA #131437

Response to CA #131438

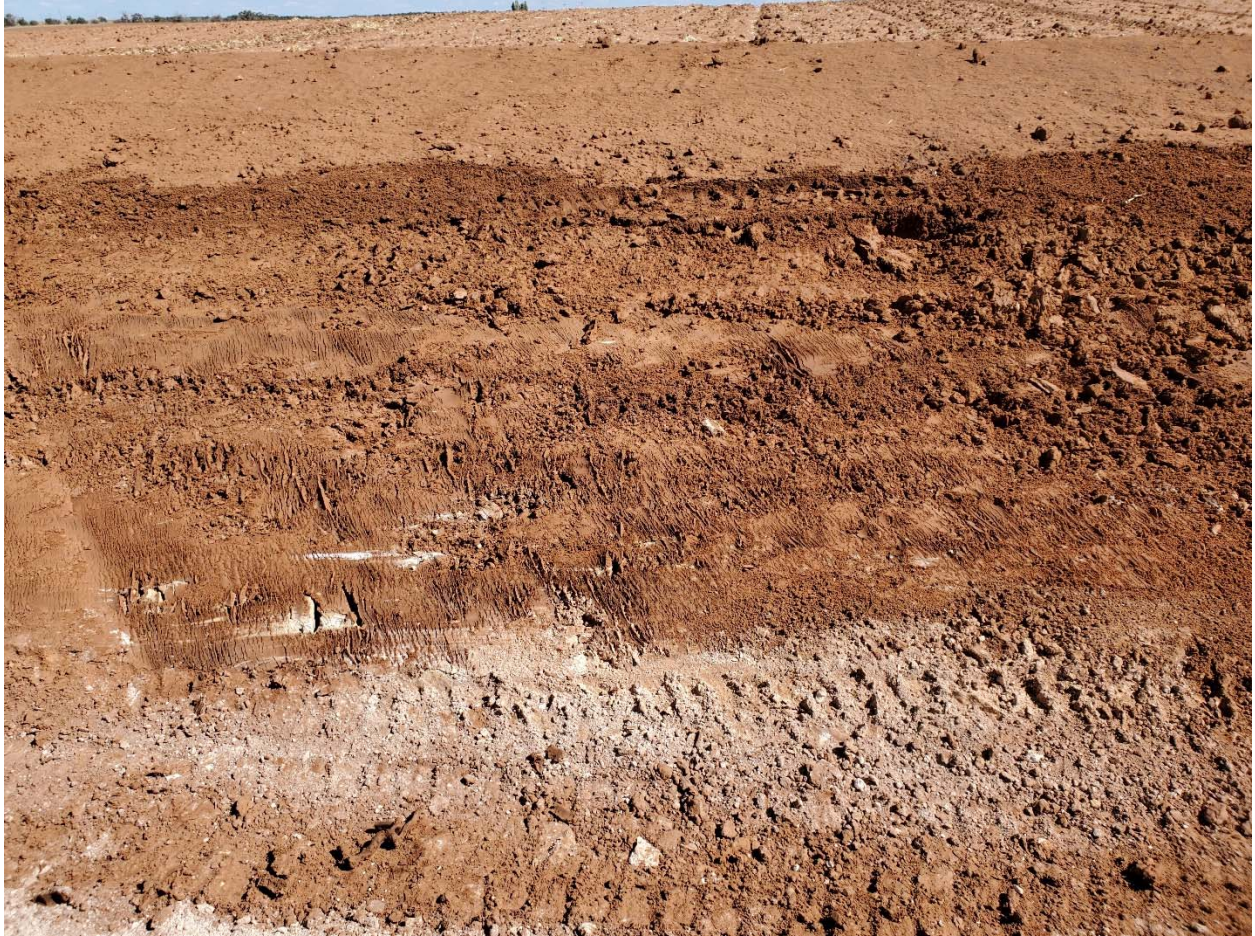
- a. The depth of the topsoil horizon discovered at the CB-4 well pad ranged from three (3) to eight (8) inches, which is in general agreement with the NRCS Map Unit Description, as shown in the photograph below:

CB-4 soil profile shown in a shallow cut slope (no scale).

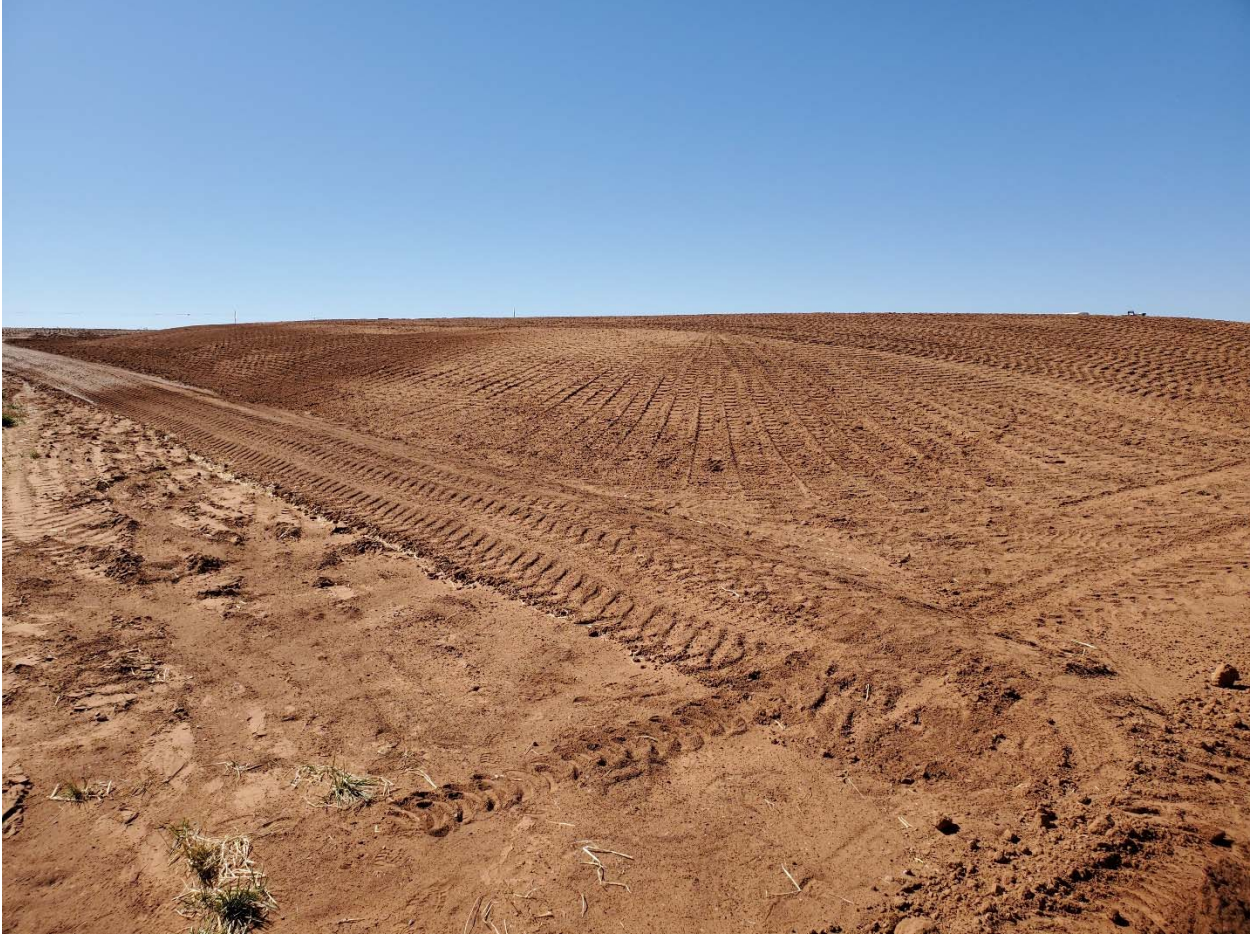
Topsoil stockpile on east side of CB-4 location.

- 3) *Estimate of cubic yards of topsoil to be excavated, to ensure that all topsoil is removed and properly stockpiled:*
- a. Based upon the average discovered topsoil depth of 5.5 inches, the 350-foot by 400-foot well pad area is estimated to generate approximately 2,377 cubic yards (c.y.) of topsoil. The actual volume of topsoil removed from the project area, based on in-place measurements of topsoil stockpiles, is 2,735 c.y. The volume of topsoil actually removed from the project area was 15 percent greater than the estimated volume. The entire topsoil horizon has been removed and stockpiled. The photographs included below show that the topsoil horizon was removed and placed in stockpiles.

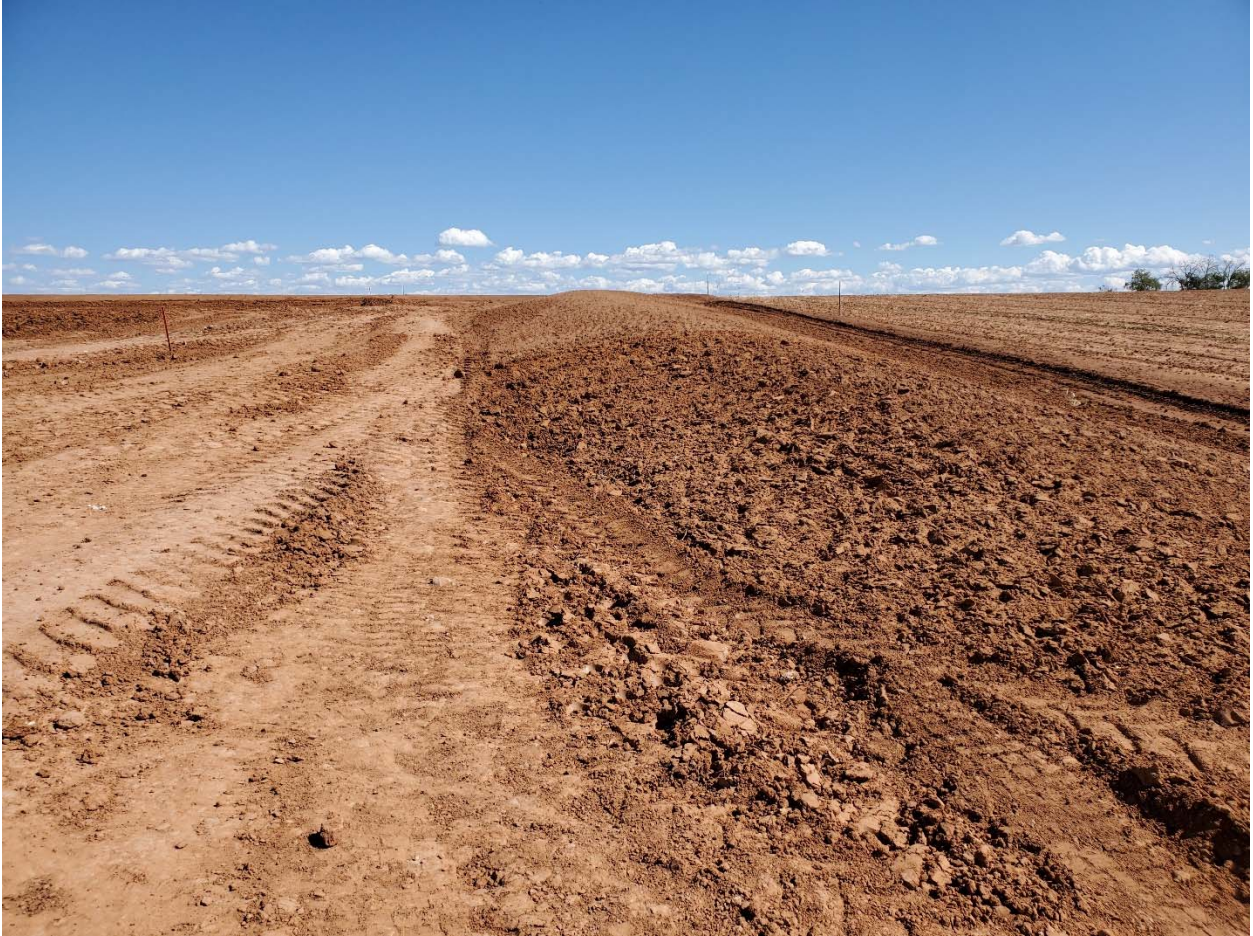
Topsoil stockpile on south side of CB-4 location.

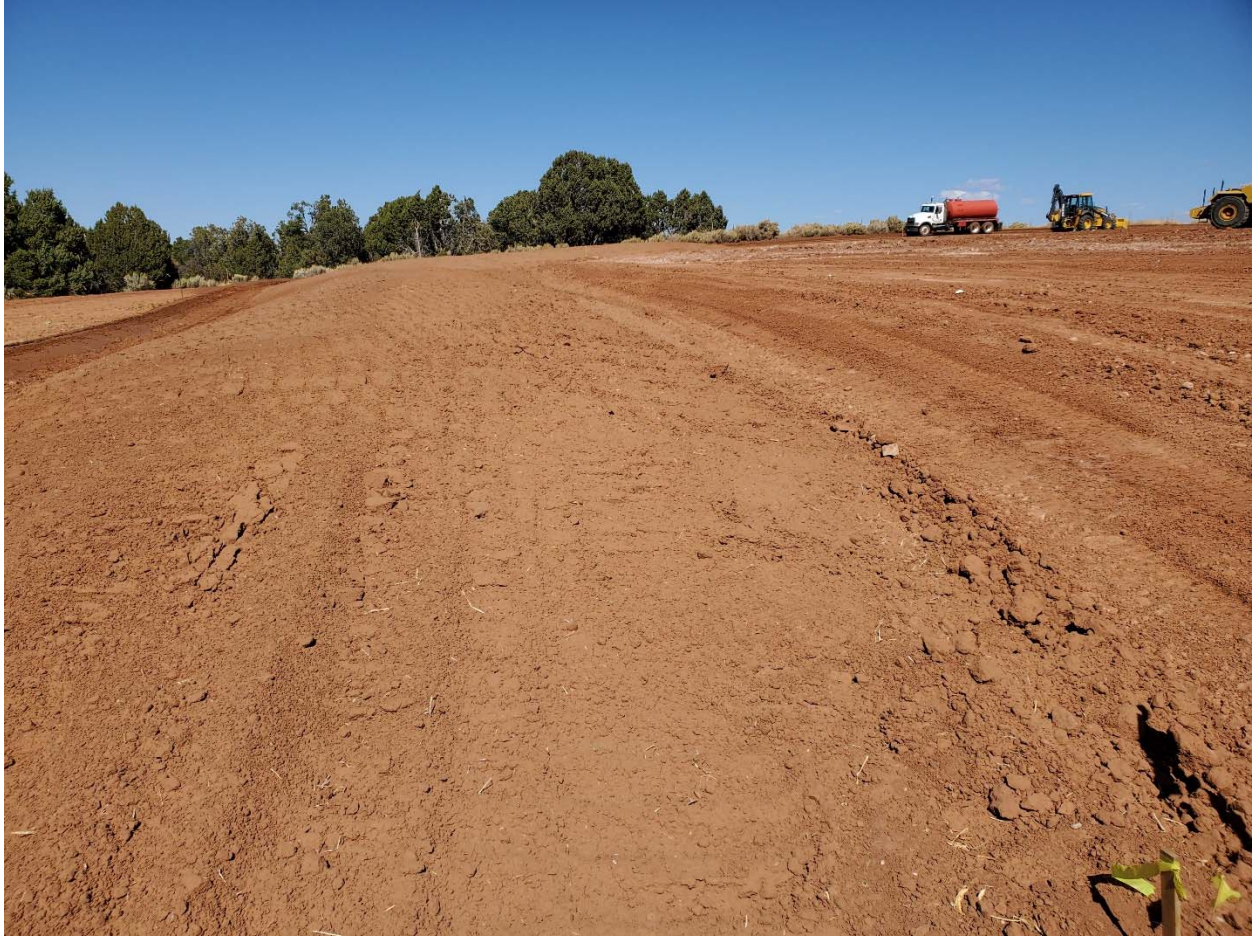
Topsoil stockpile on west side of CB-4 location.

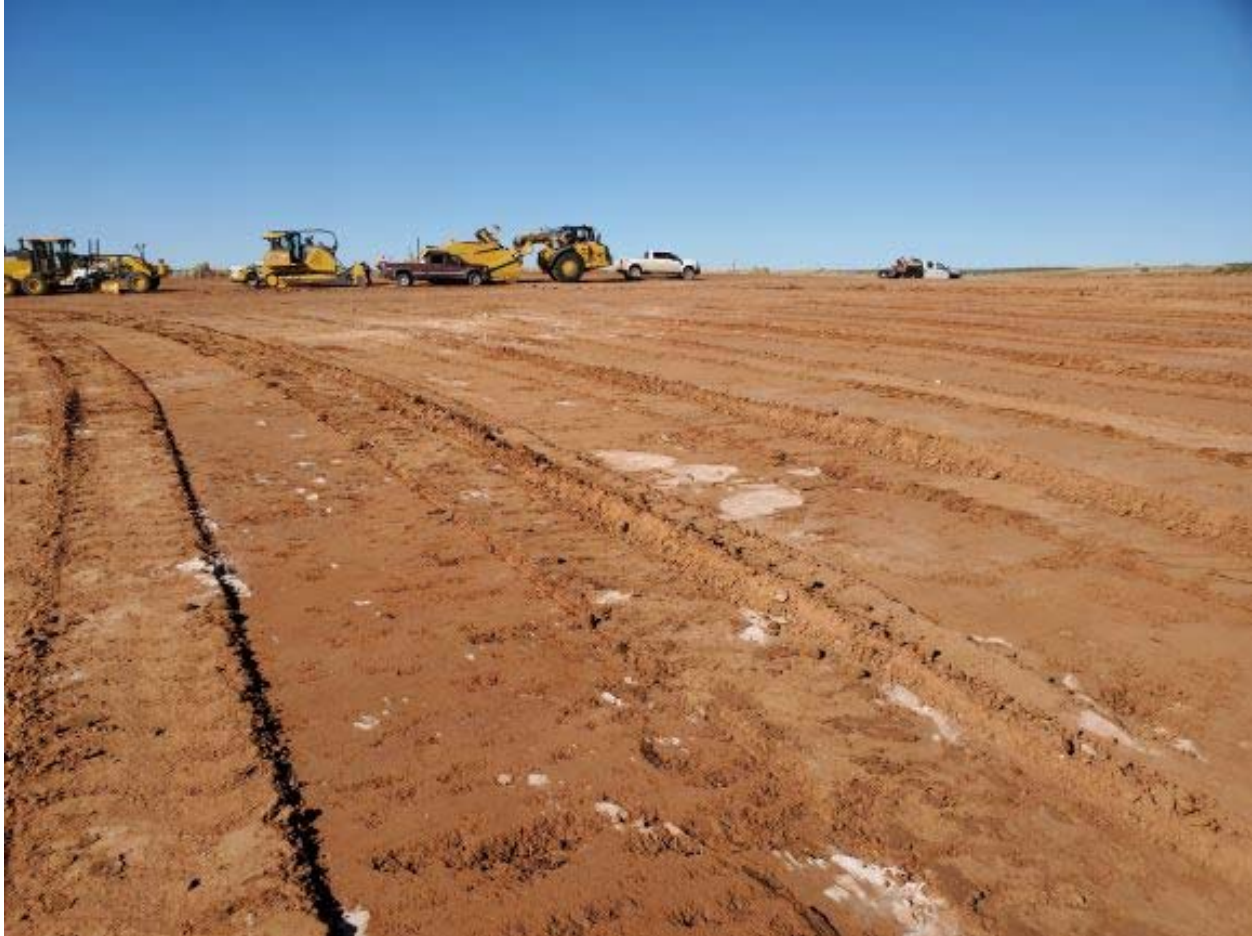
Topsoil horizon removed from CB-4 location.

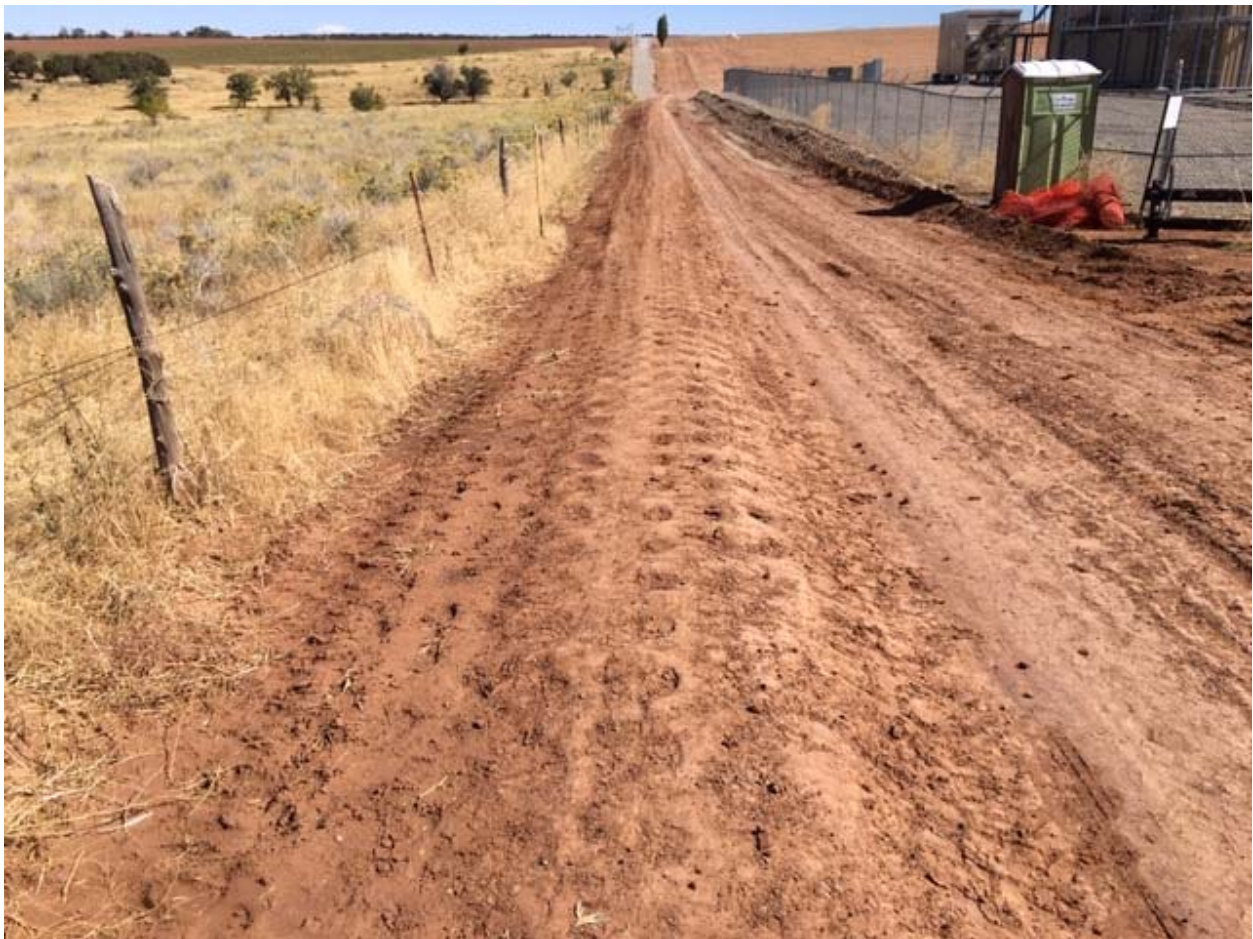
Compacted soil berm (CB-4 access road).

Although Form 42 (Doc #402185577) stated that construction of the CB-4 location would begin on 9/26/2019, mobilization of equipment and actual construction activities at the project location did not begin until 9/30/2019. Kinder Morgan's contractor did ensure that compacted perimeter berms were put in place prior to construction and there have been no precipitation events since construction began. Although Catherine Roy observed evidence of loose soil on the perimeter berms and ditches during her inspection, the perimeter controls were in place awaiting stabilization (drum compactor rolling and hydro-mulch/tackifier application). Additional stabilization of the soil on the perimeter berms and ditches has been completed as of 10/10/2019 as shown in the photographs below.

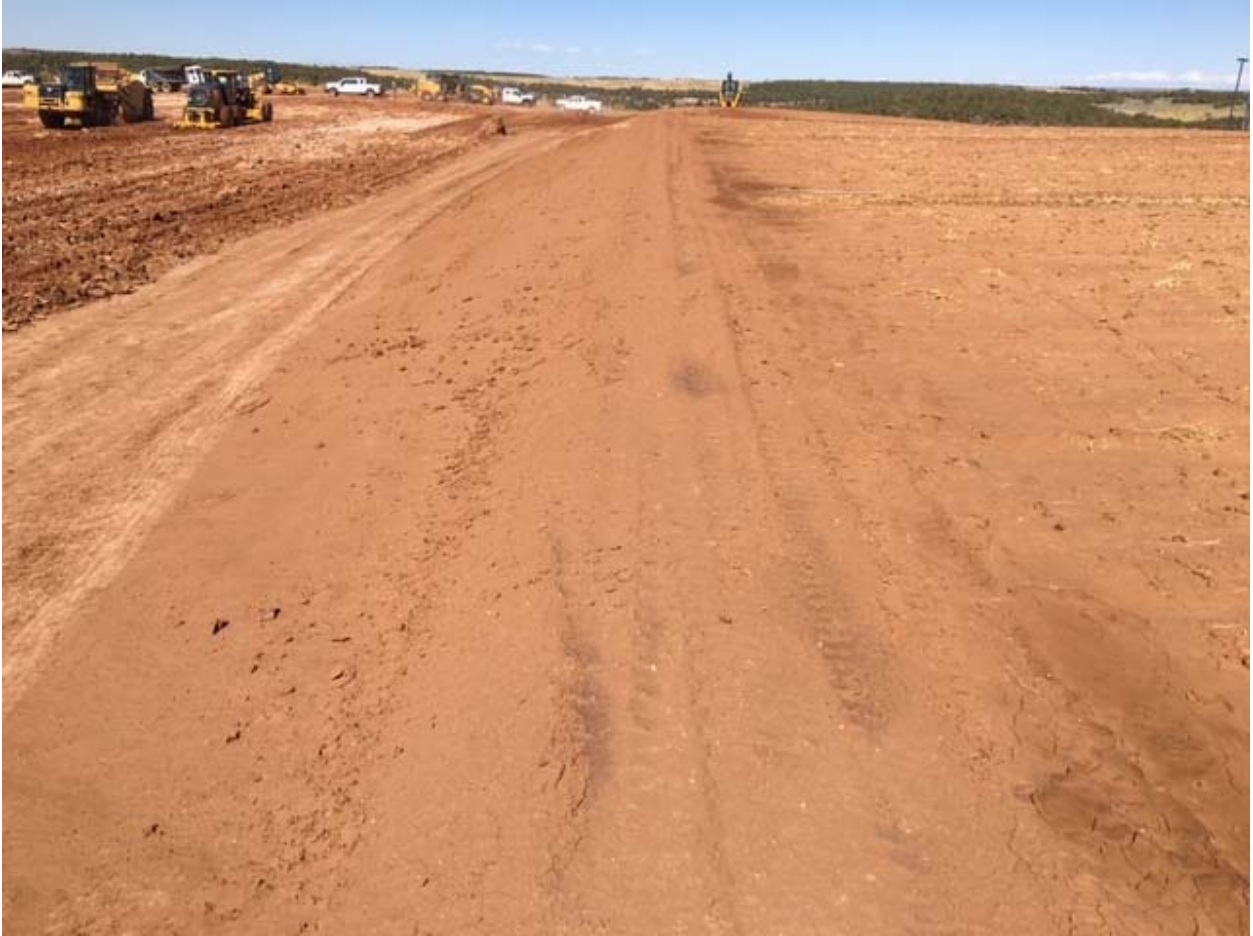
Compacted soil berm (east side of CB-4 location).

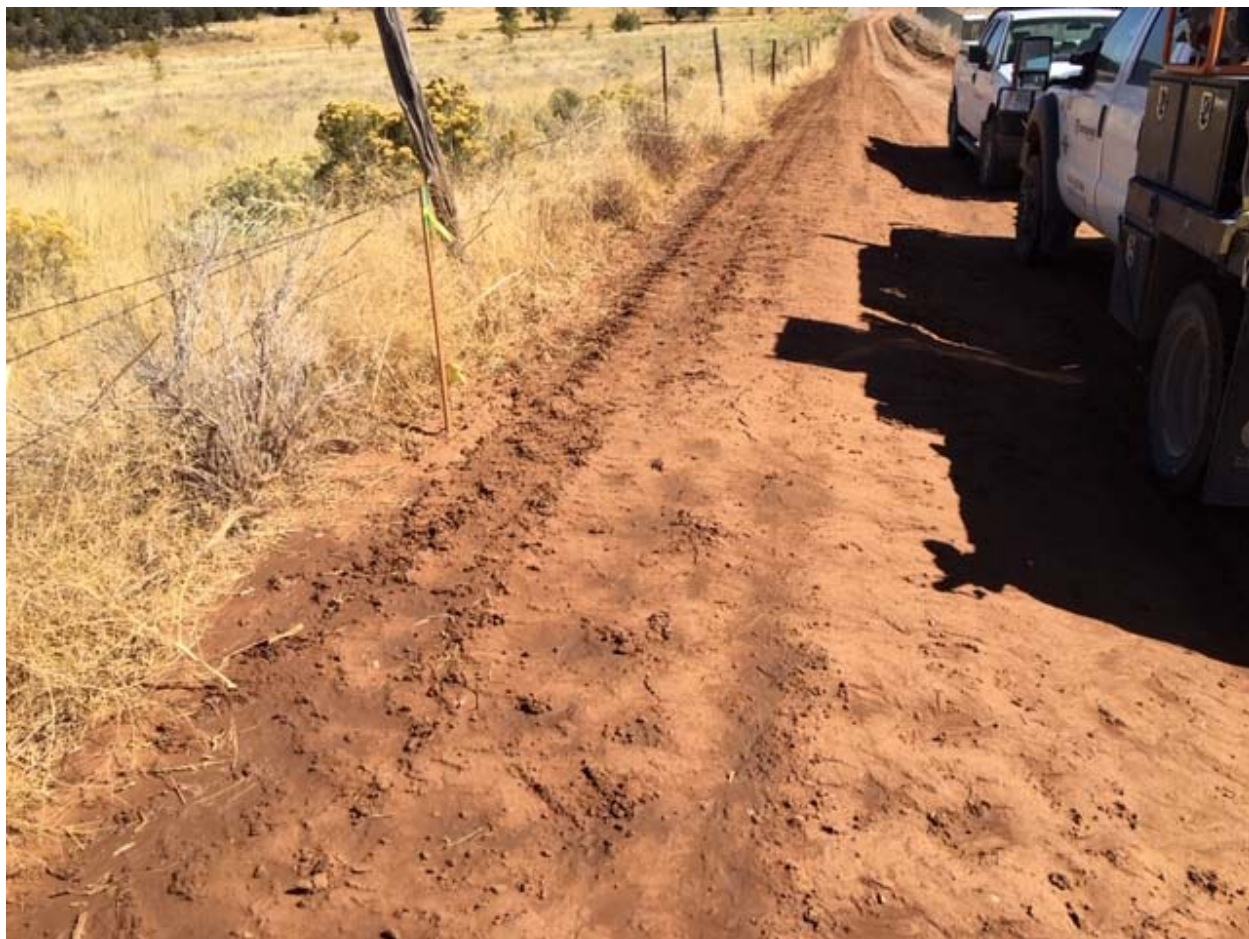
Compacted soil berm (north side of CB-4 location).

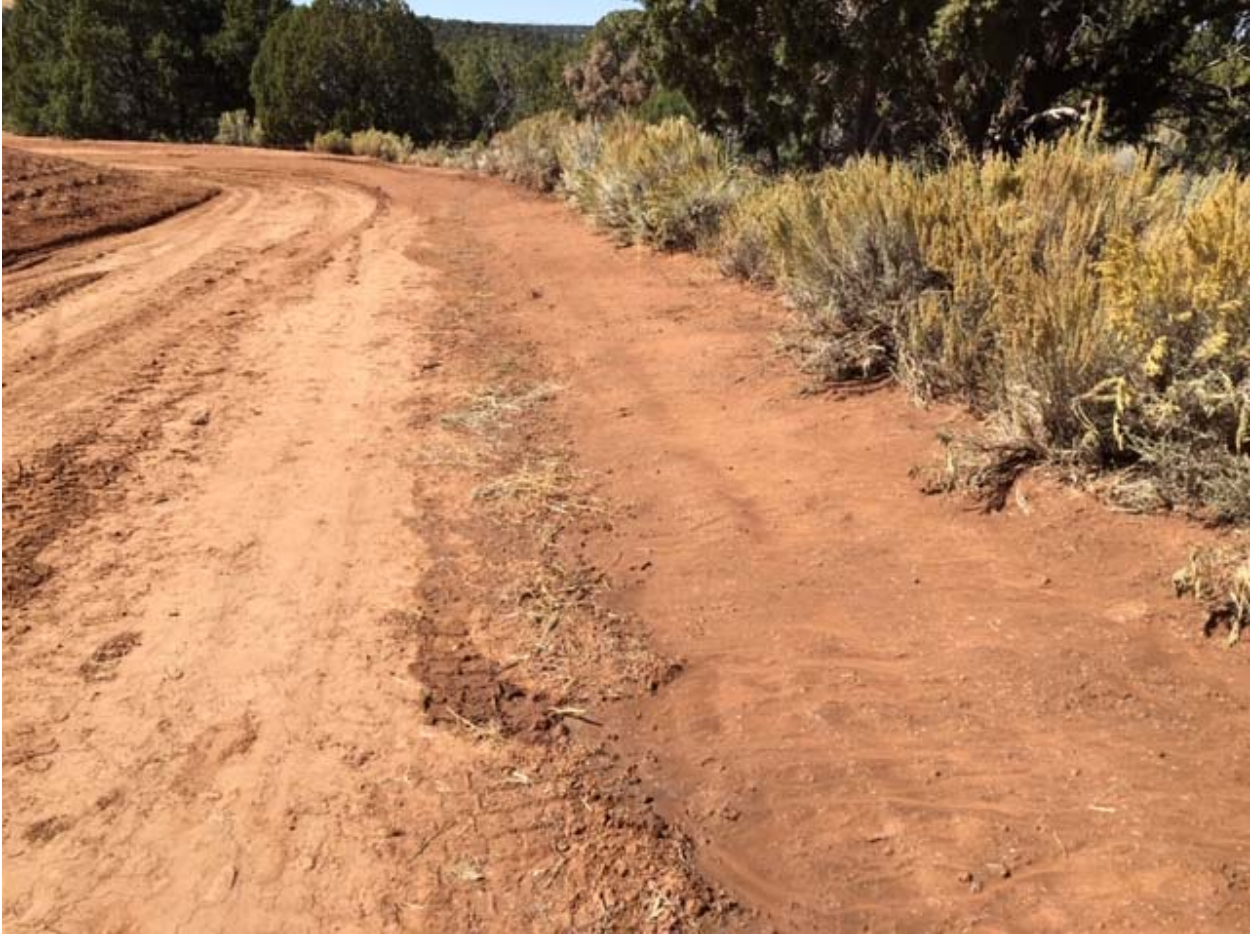
Compacted soil berm (northwest corner of CB-4 location).

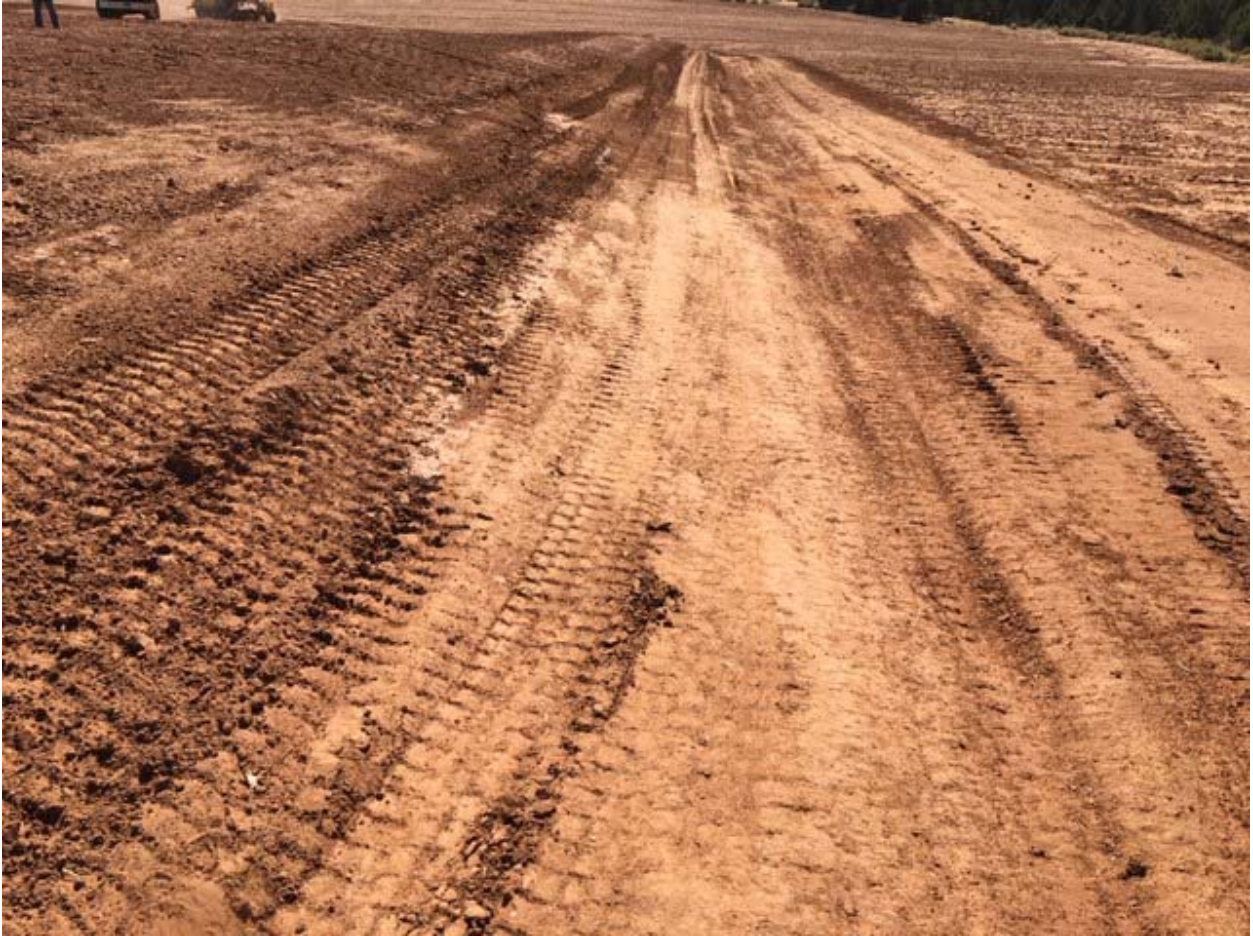
Compacted soil berm and trench (south side of CB-4 location).

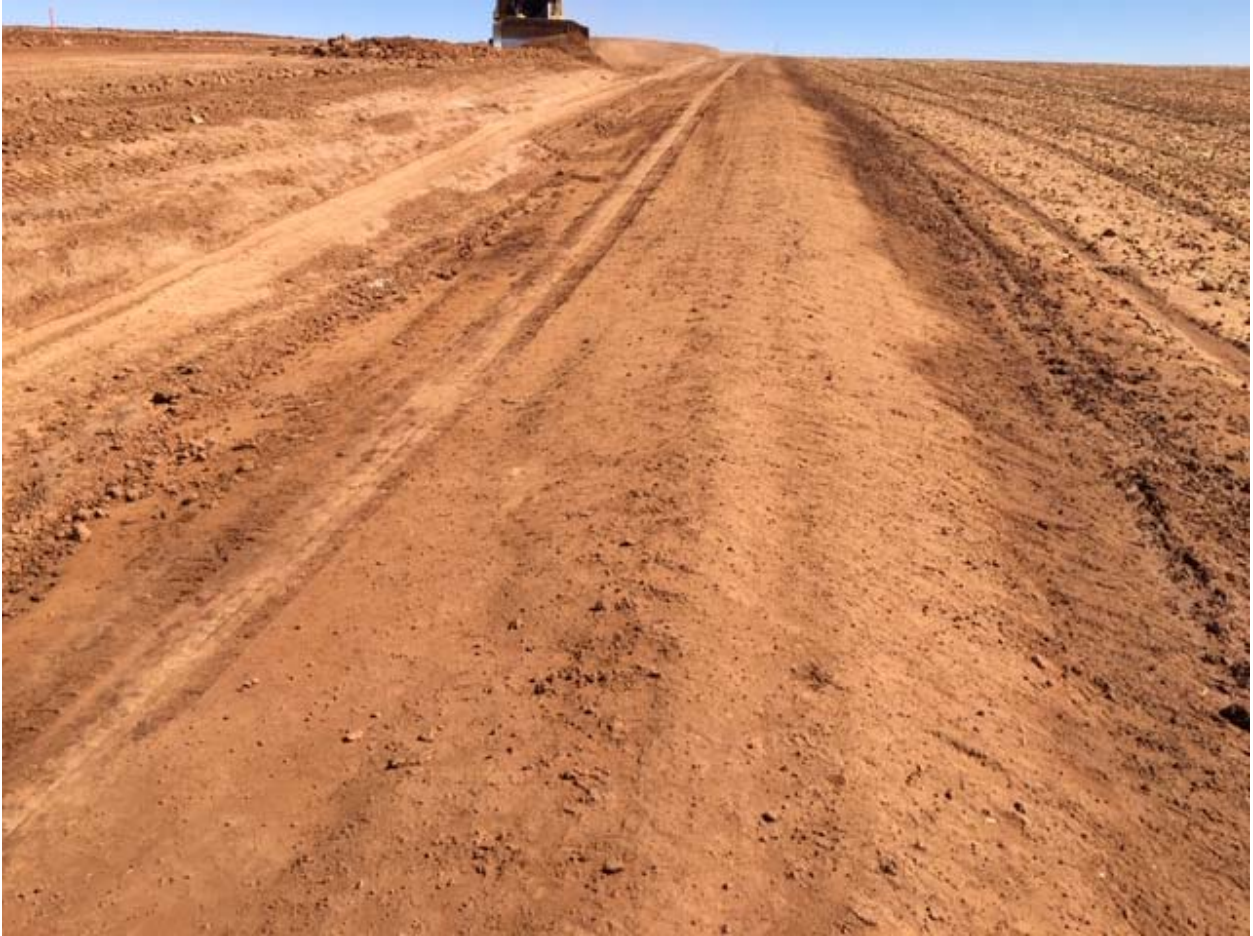
Compacted soil berm (west side of CB-4 location).
