**Inspection Photos**  
**Location Name: LEROY 33-3 FOLLOWUP**  
**API#: 05-071-07714**  
**INSP. #: 695101518**

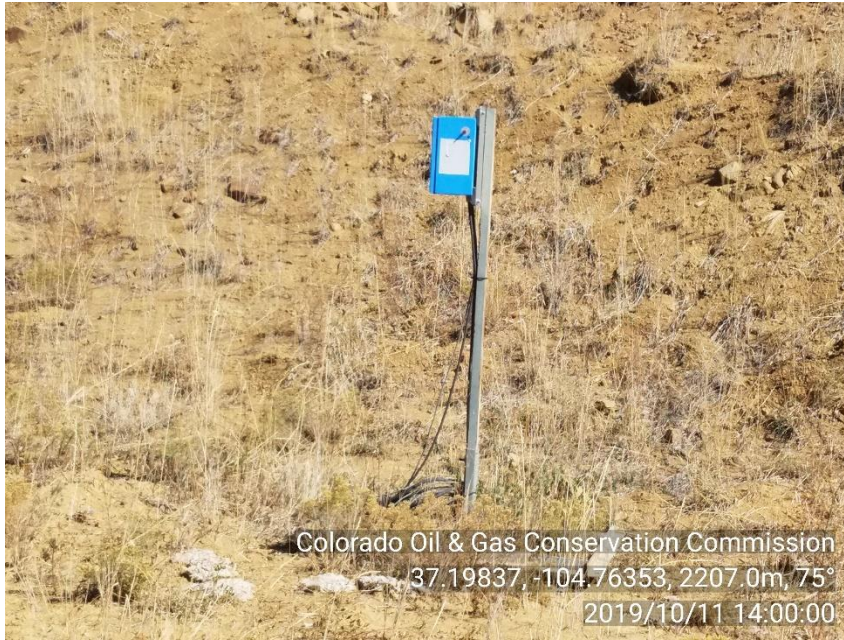
**PHOTO 3: UNUSED EQUIPMENT STORED ON LOCATION.**  
**REMOVE ALL UNUSED EQUIPMENT FROM LOCATION.**  
**COMPLY WITH RULE 603.f. CA DATE 11-11-19**

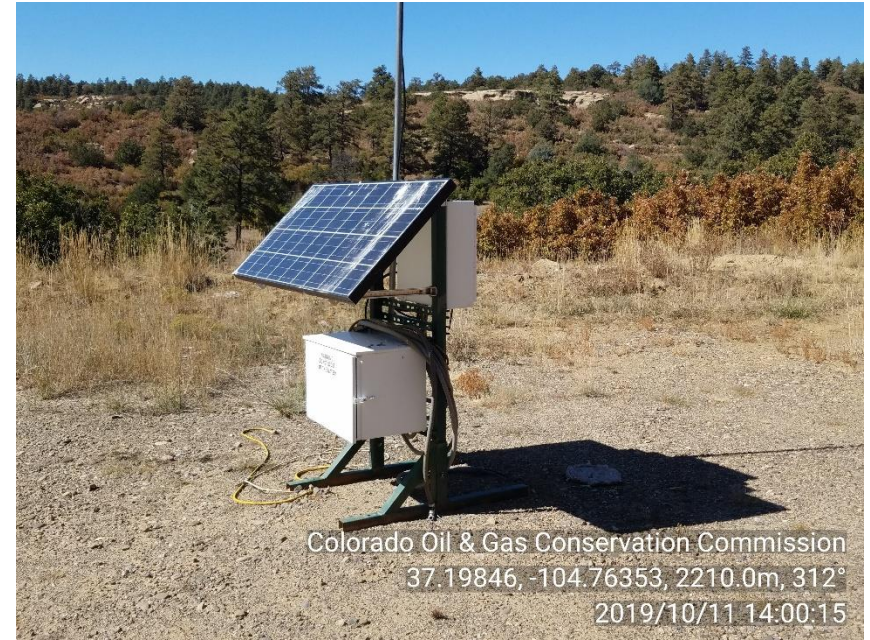
**PHOTO 4: MORE UNUSED EQUIPMENT.**
