Inspection Photos

API: 05-009-06014

Operator: JONES ENERGY

Inspection Date: 10/8/2019

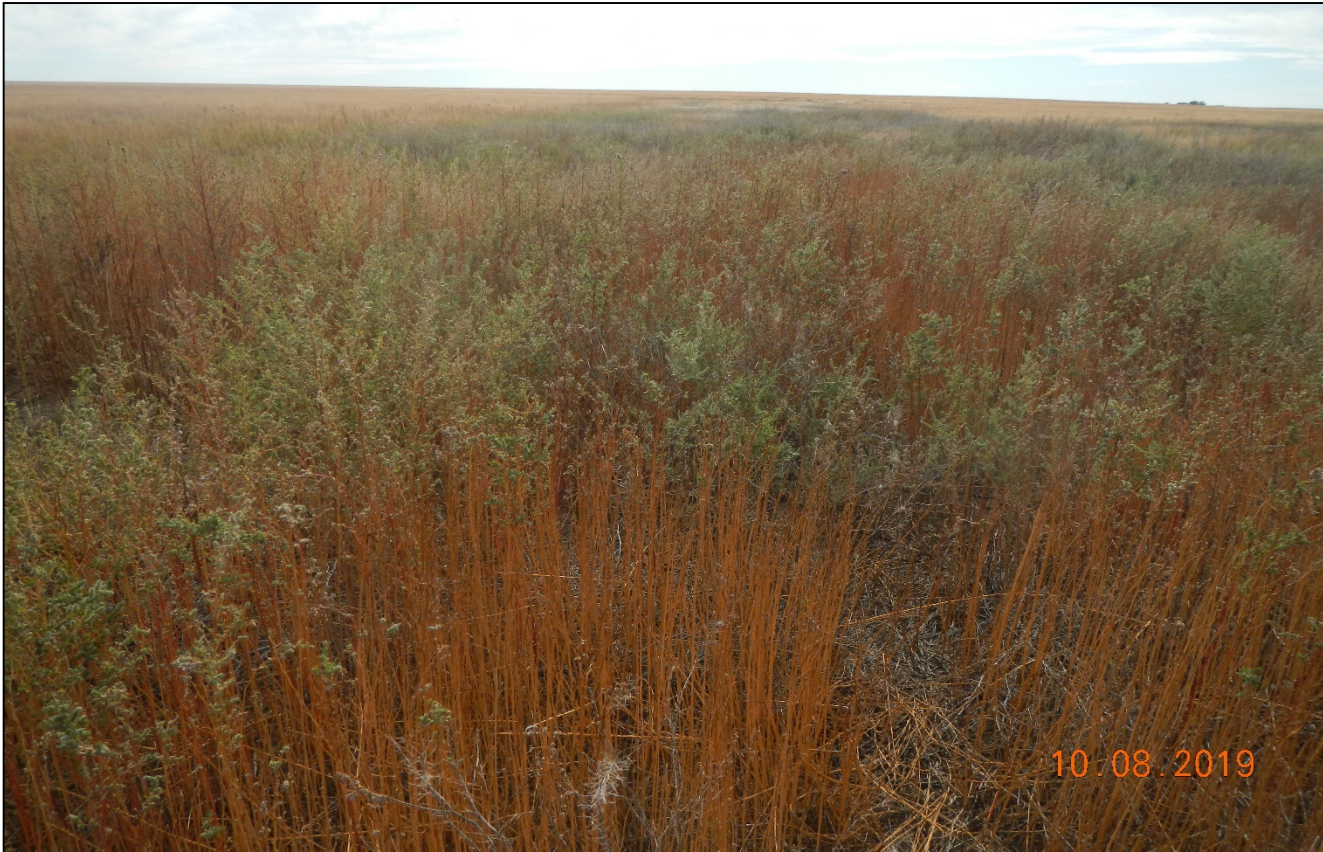
Photo 1. Facing southwest at the beginning of the access road. There is undesirable weed growth (Kochia sp.) along the road. The weeds are 2 ft. high in this area. No desirable vegetation is establishing. Weeds need to be controlled.

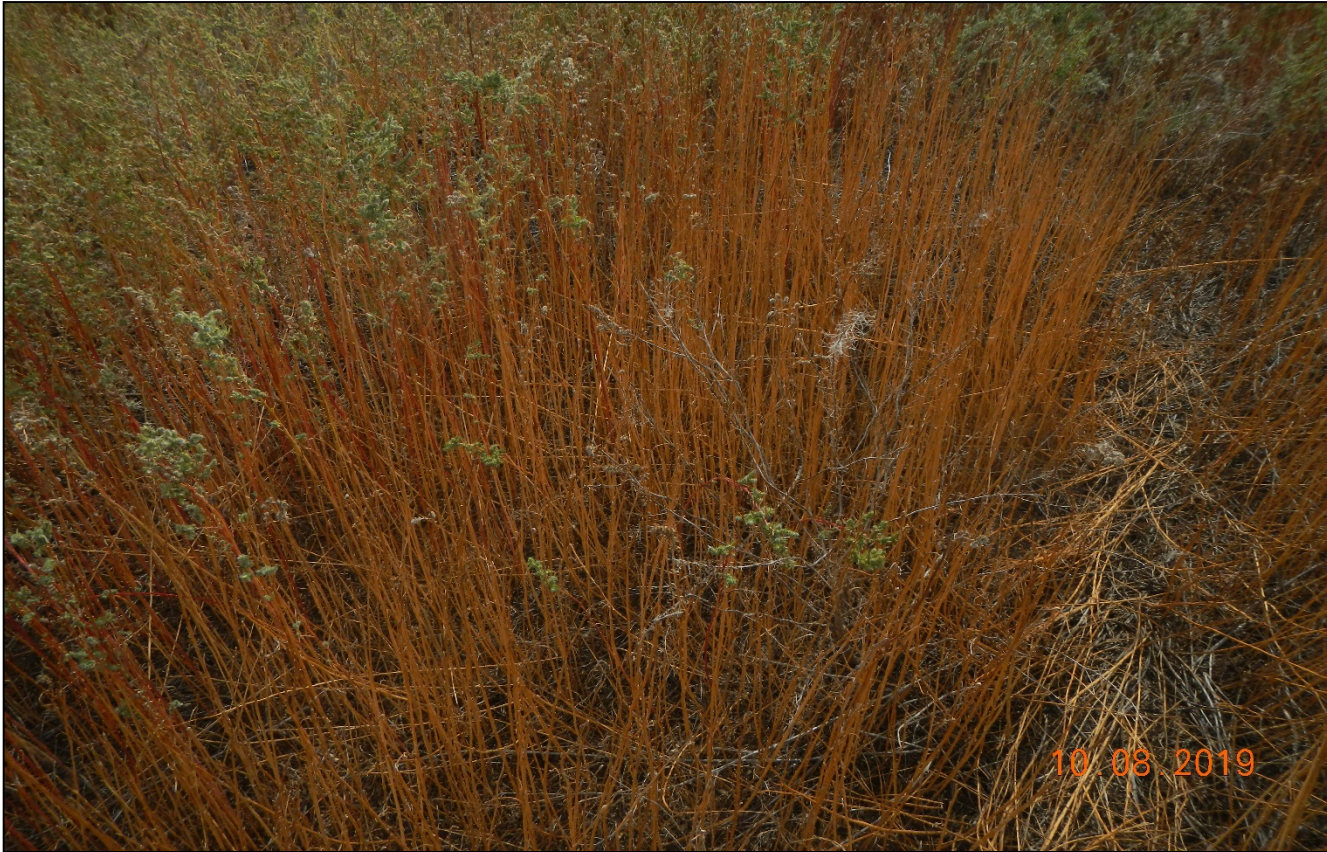
Photo 2. There is undesirable weed growth (Kochia sp.) along the road. The weeds are 2 ft. high in this area. No desirable vegetation is establishing. Weeds need to be controlled.

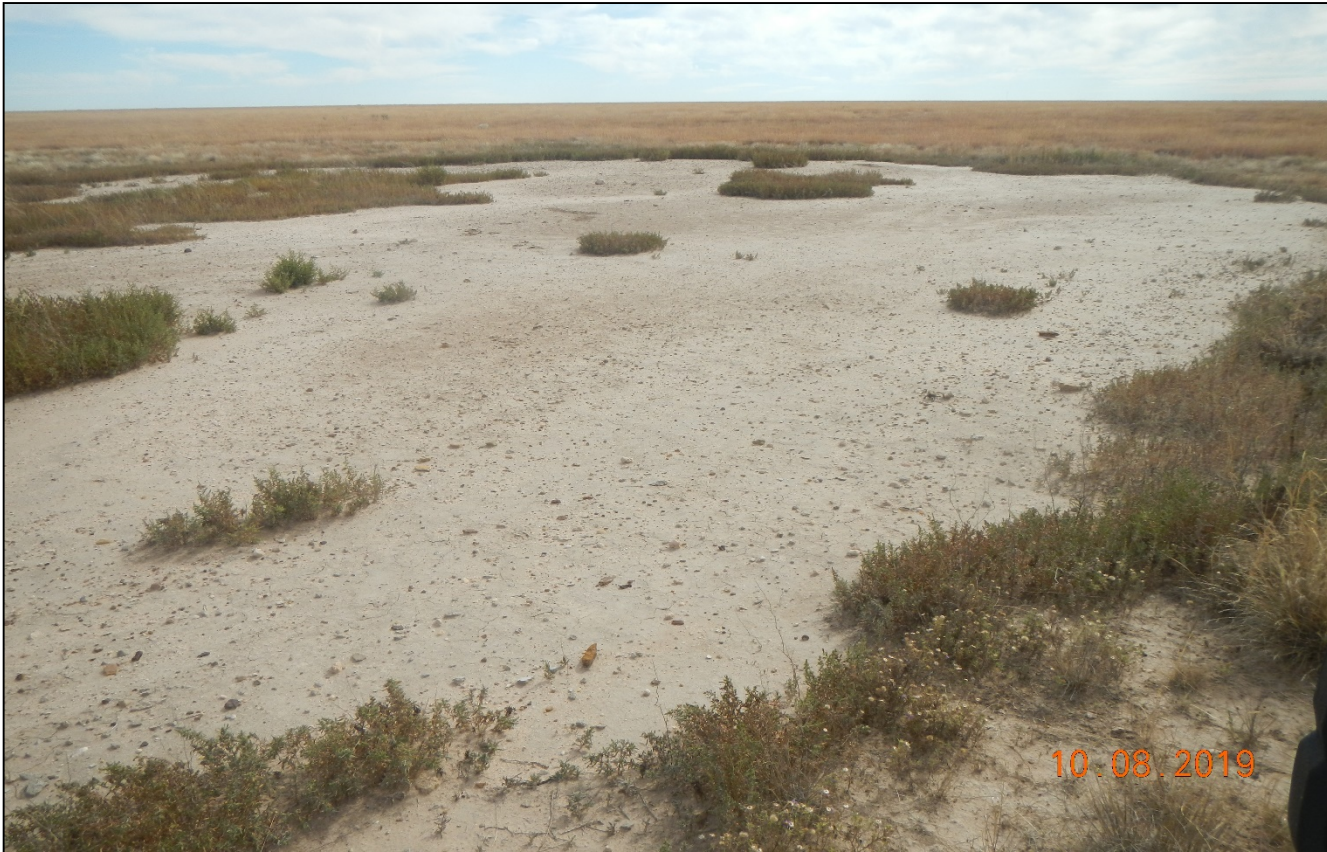
Photo 3. Facing south toward the location. This area is bare of vegetation. Does not appear any work was performed since the previous inspection. No germination in this area was observed.

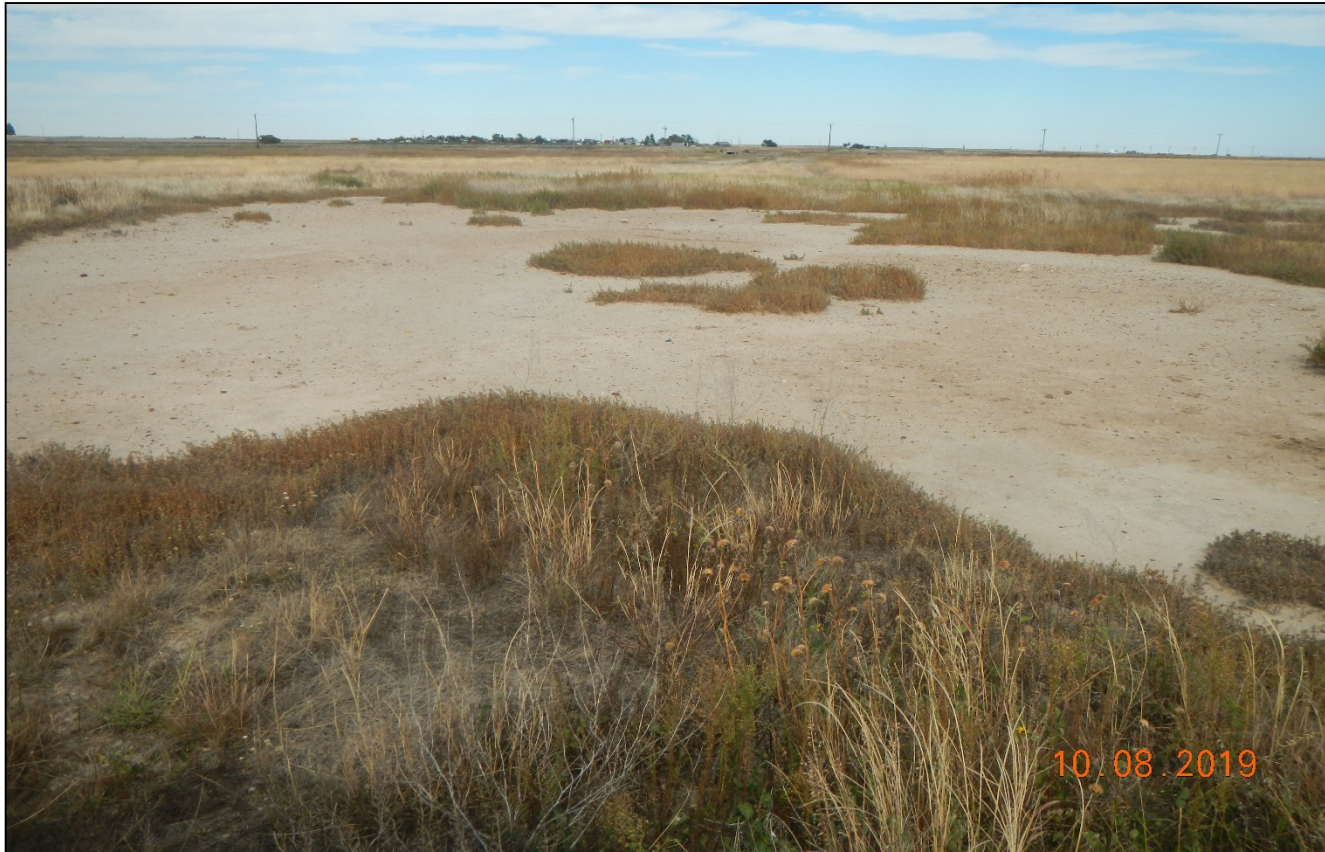
Photo 4. Facing northeast toward the location. This area is bare of vegetation. Does not appear any work was performed since the previous inspection. No germination in this area was observed.

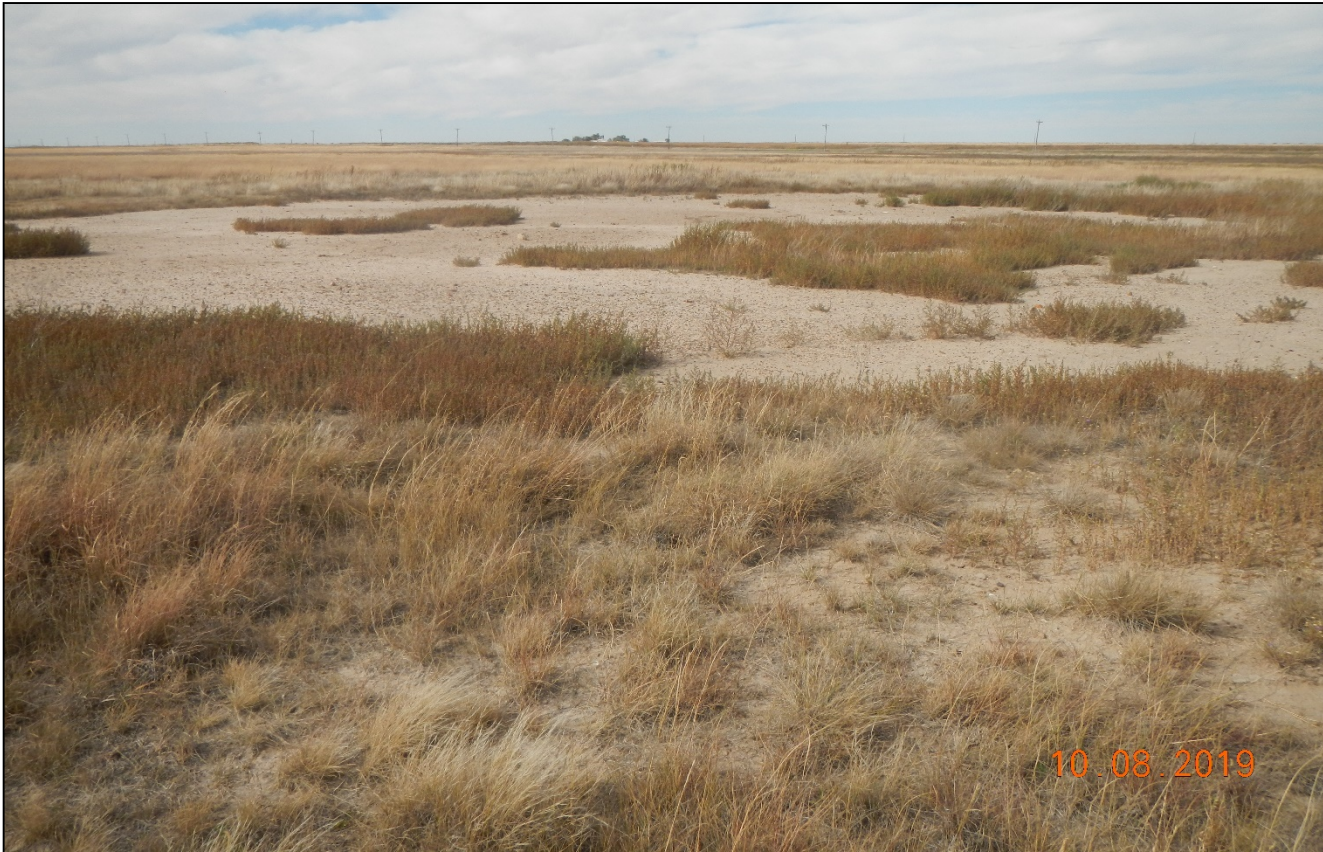
Photo 5. Facing northwest toward the location. This area is bare of vegetation. Does not appear any work was performed since the previous inspection. No germination in this area was observed.

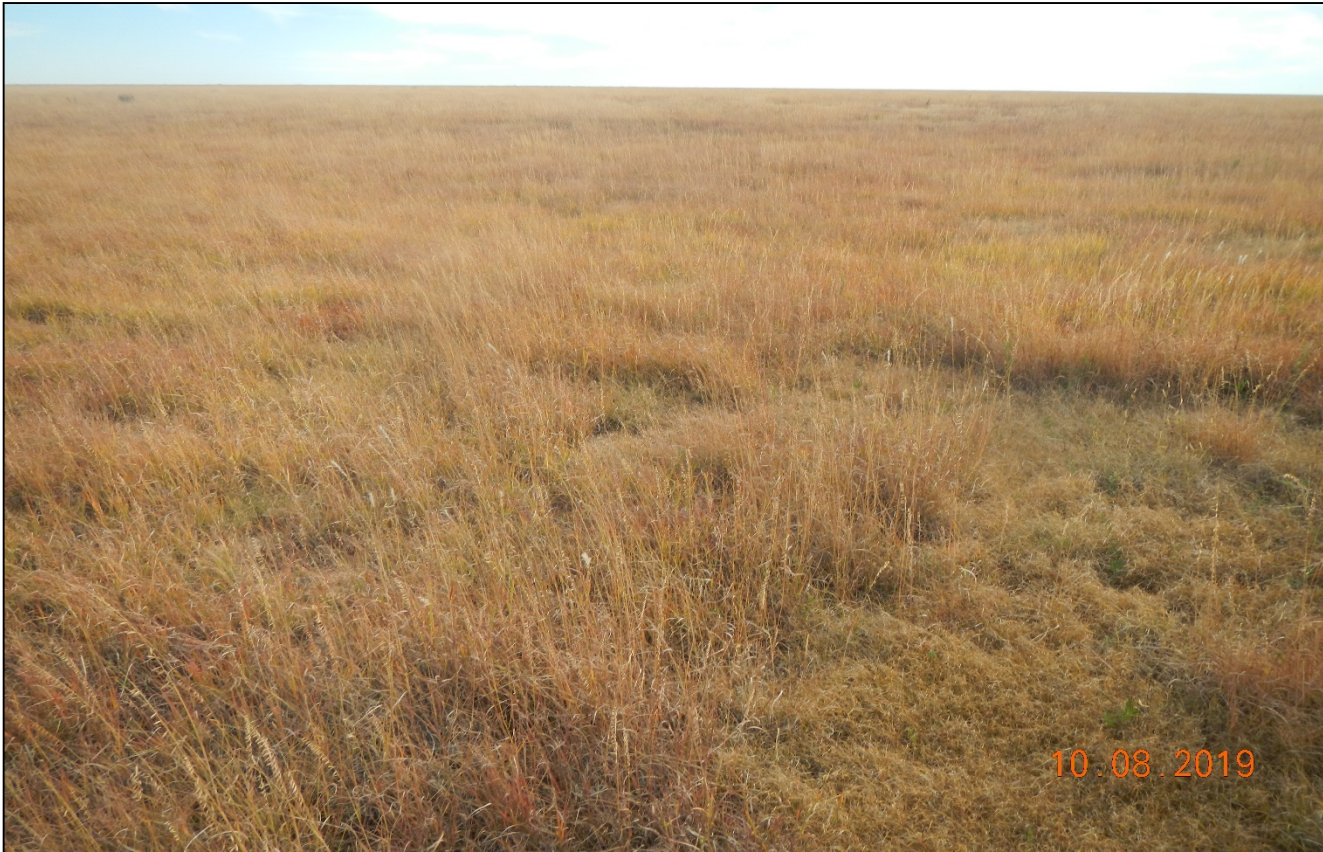
Photo 6. Facing north toward the surrounding undisturbed reference area.
