Inspection Photos

API: 05-071-08611

Operator: EVERGREEN NATURAL RESOURCES

Inspection Date: 10/18/2019

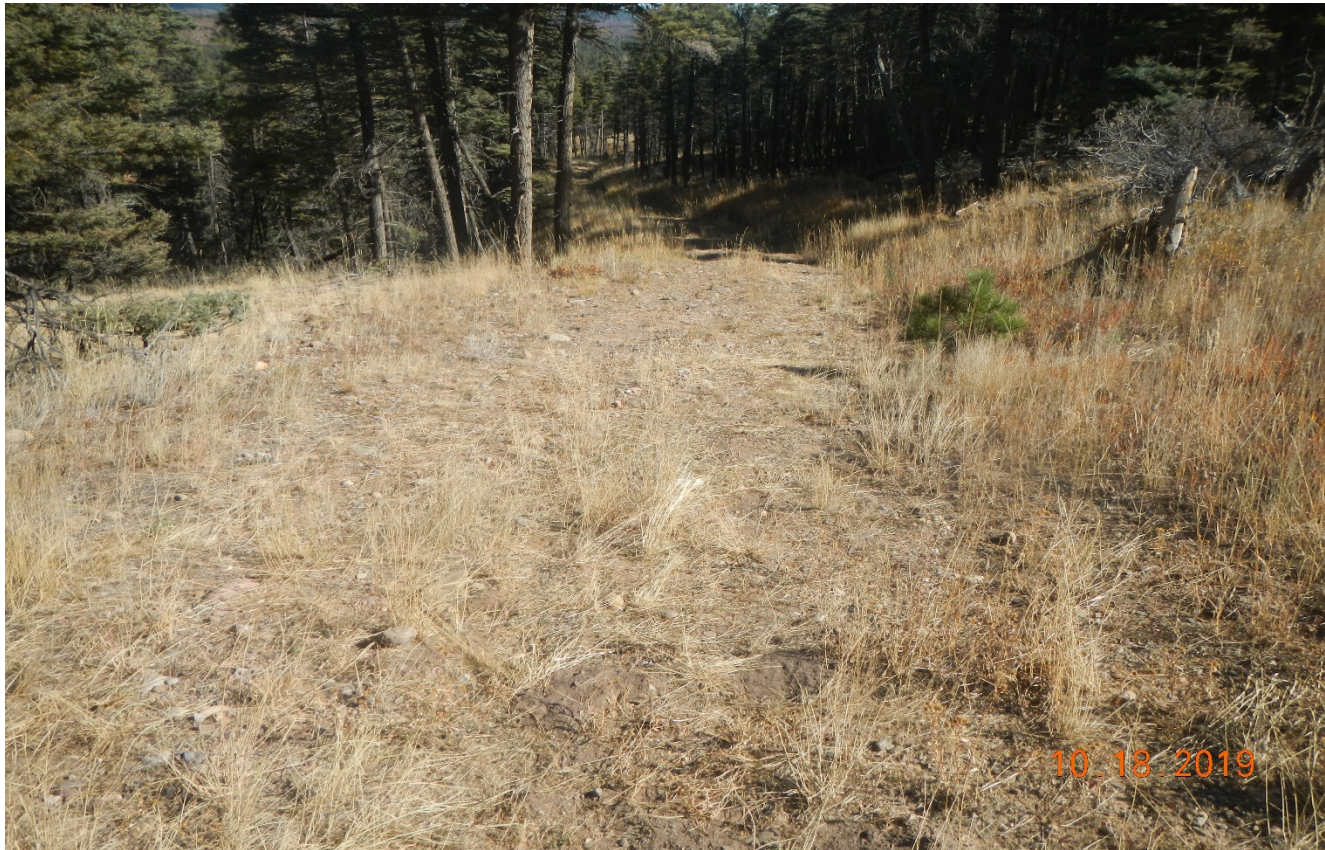
Photo 1. Facing northeast at the beginning of the access road.

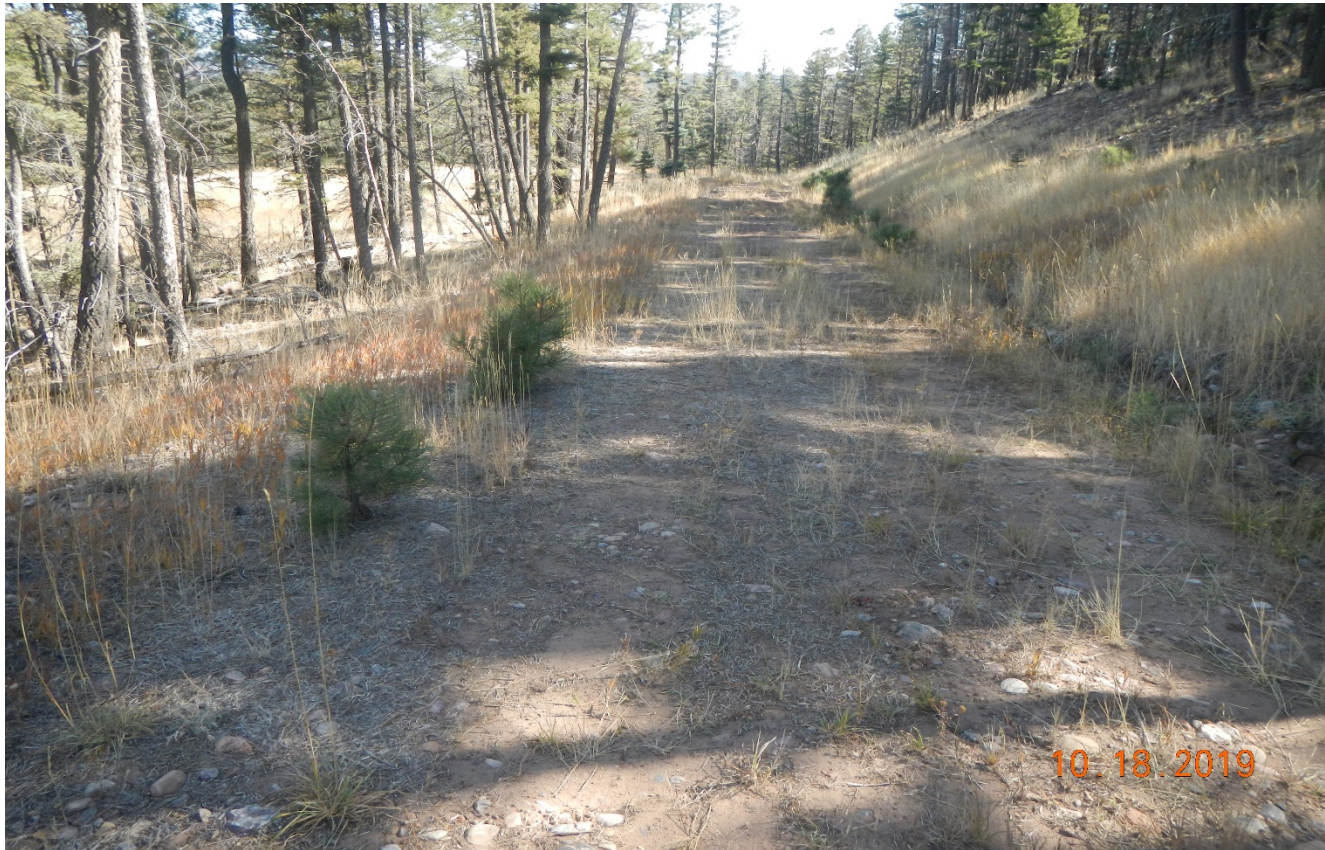
Photo 2. Facing northeast along the access road. Vegetation is well established along the road and culverts are maintained..

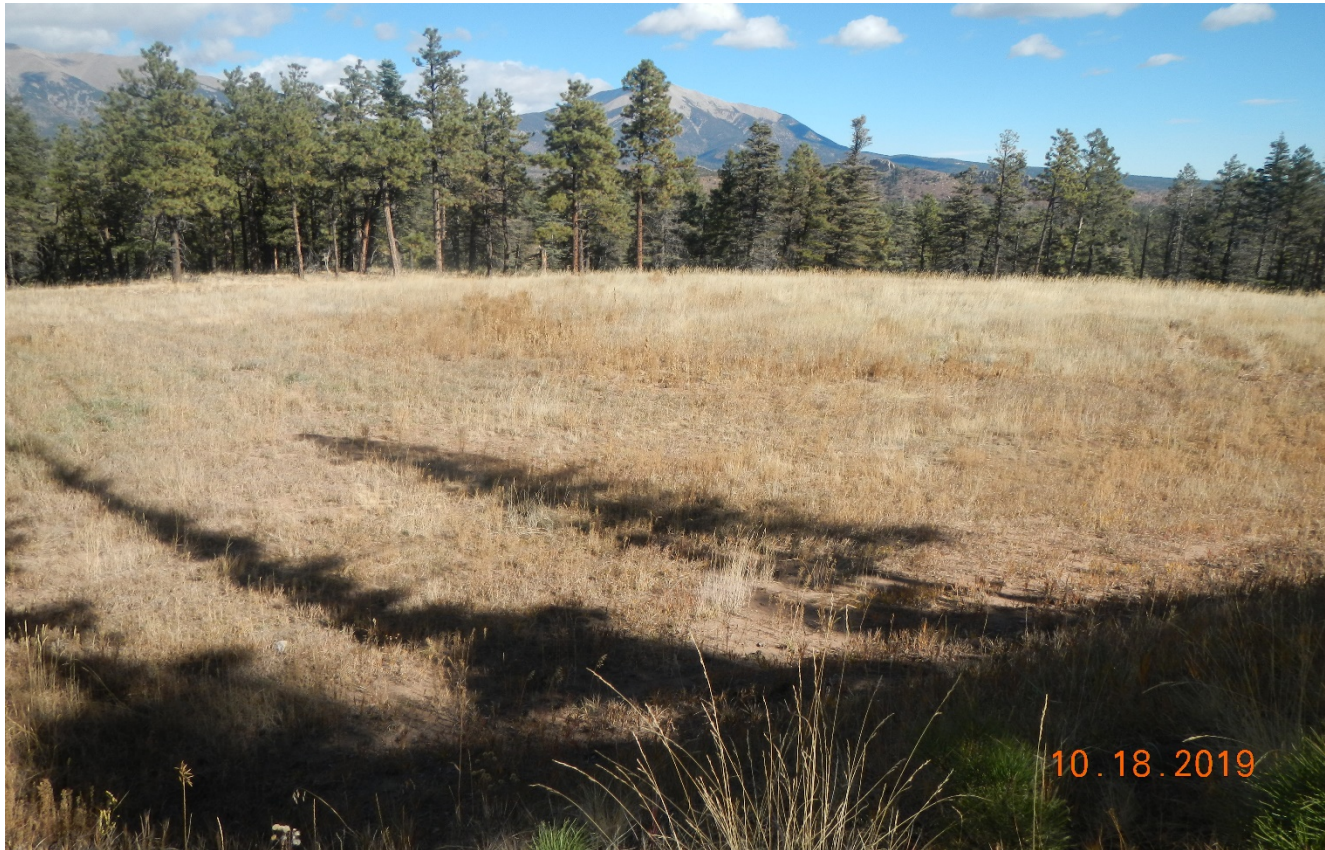
Photo 3. Facing northeast toward the location. Vegetation has established at the location which consists of Dac glo, Pas smi, Bro ine, among other species.

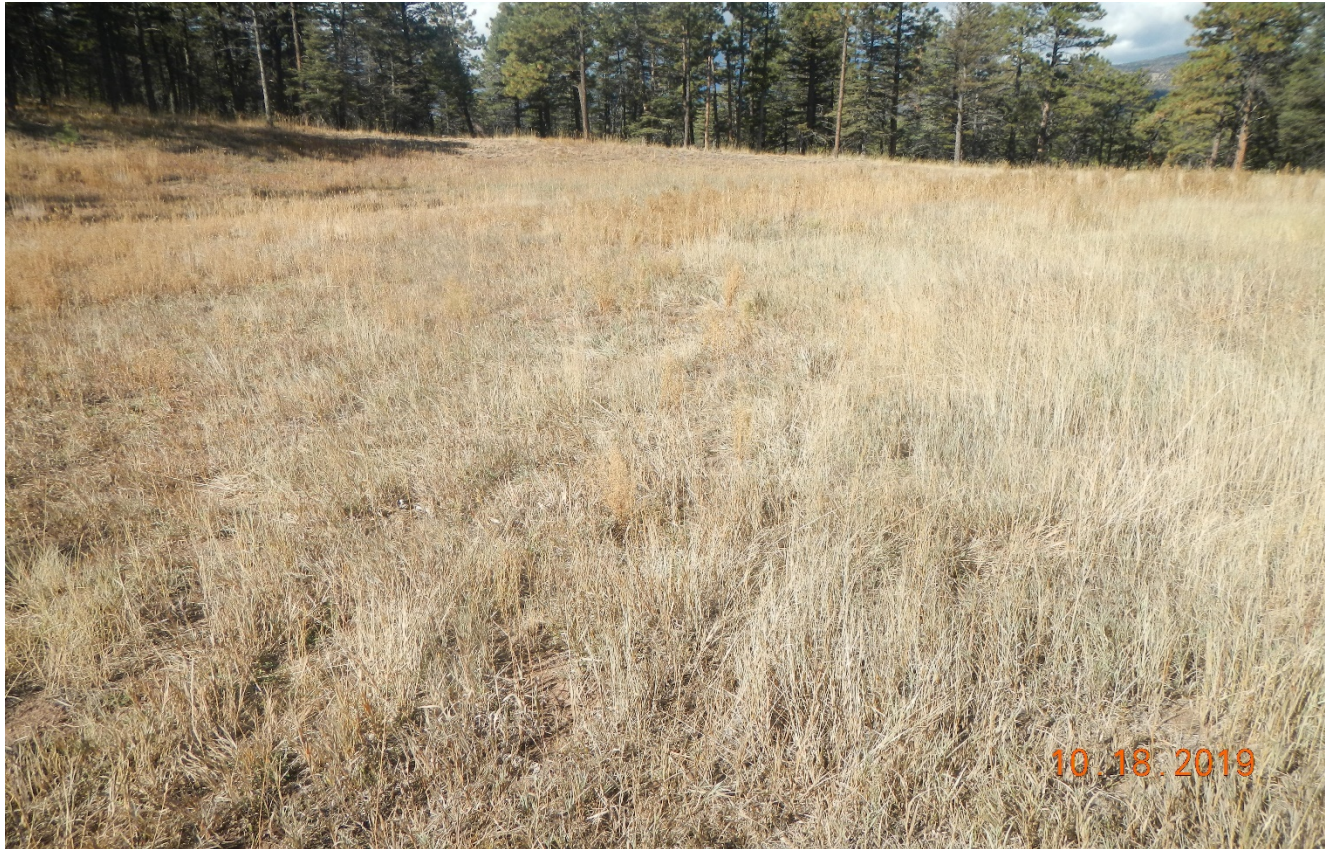
Photo 4. Facing northwest toward the location. Vegetation has established at the location which consists of Dac glo, Pas smi, Bro ine, among other species

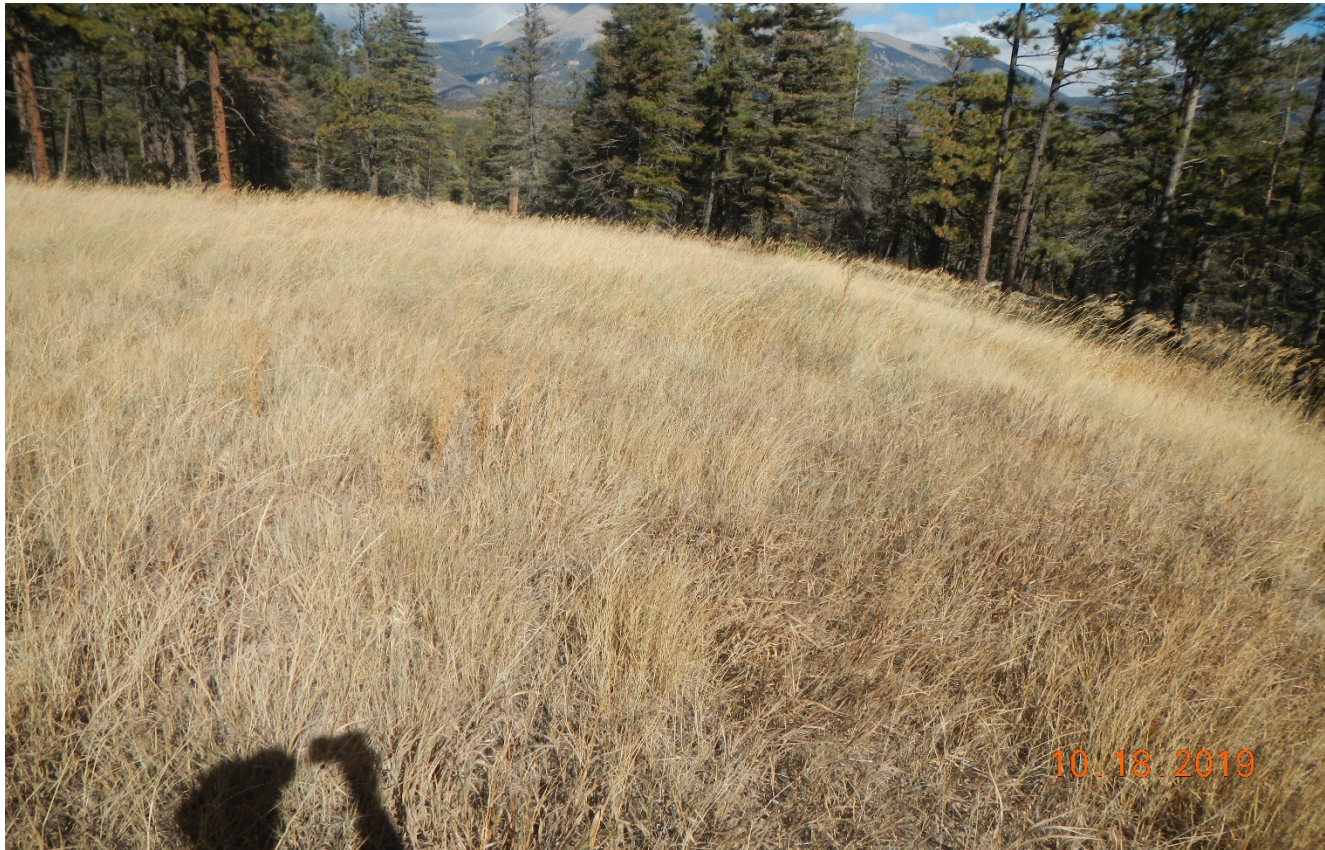
Photo 5. Facing north toward the fill slope which is stabilized with vegetation.

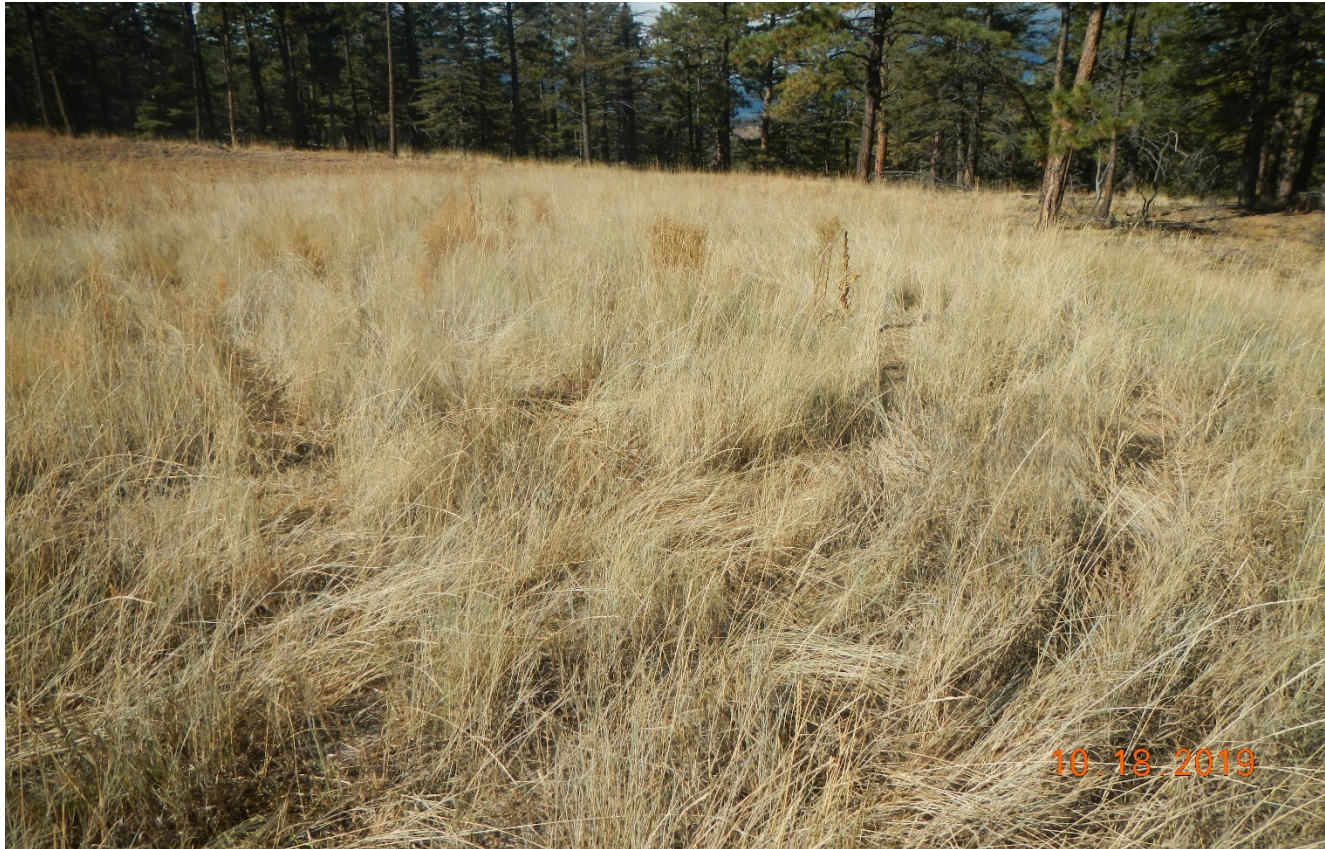
Photo 6. Facing west toward the location. Vegetation has established at the location which consists of *Dac glo*, *Pas smi*, *Bro ine*, among other species.

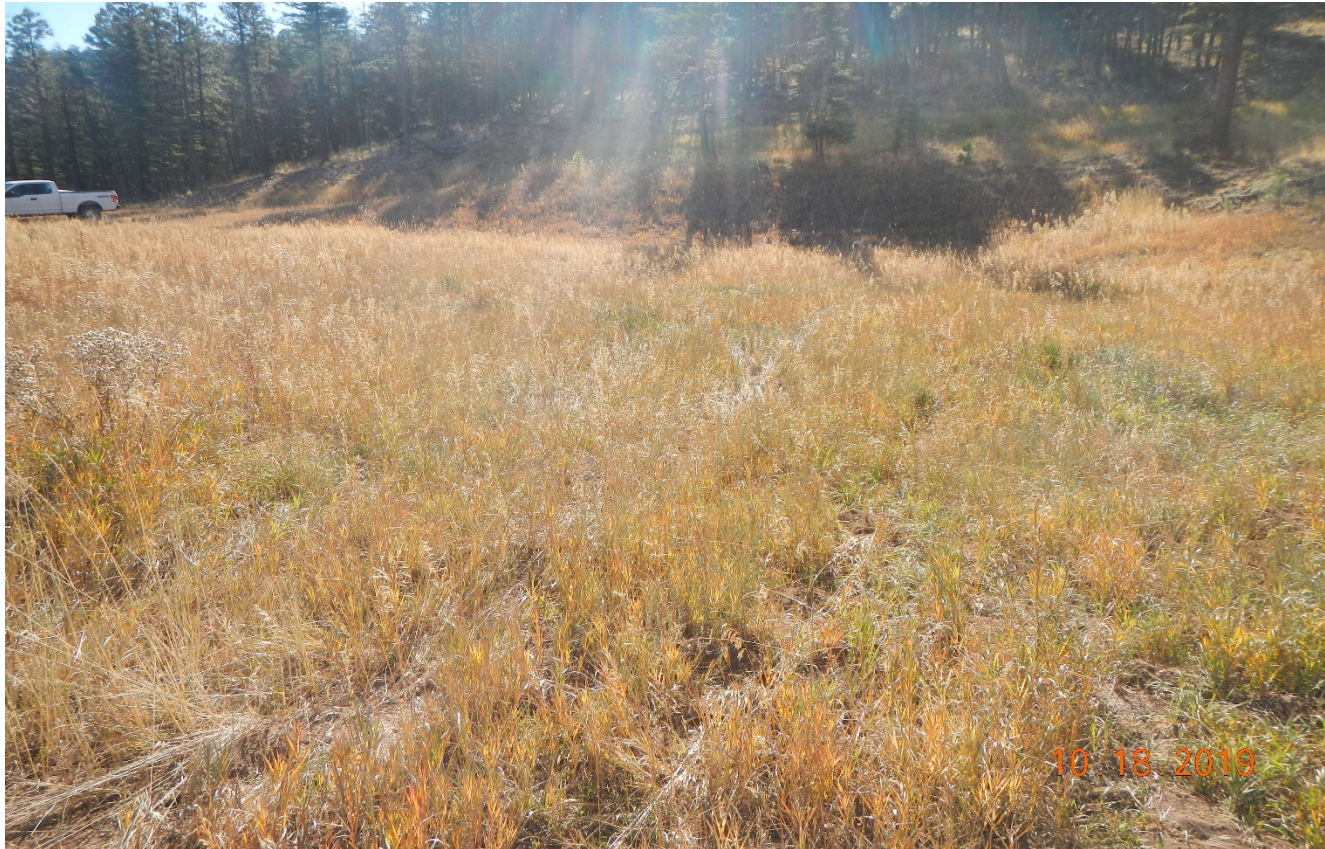
Photo 7. Facing southeast toward the location. Vegetation has established at the location which consists of *Dac glo*, *Pas smi*, *Bro ine*, among other species.
