**Response to FIR: Document 699100309**

COGCC conducted an inspection of the Spike State CC 30-24 (Location ID 309858) on October 8, 2019. During that inspection, COGCC made the following observations:

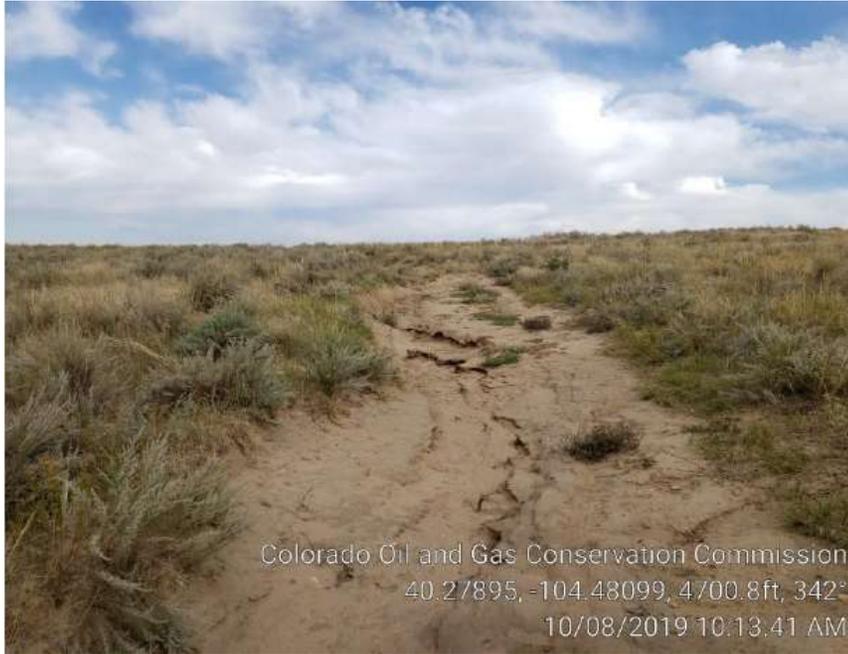
**COGCC – 10/08/19**

COGCC Comment: *Location is not accessible during normal business hours.*

COGCC Photo 2. Inaccessible lease road.

COGCC Corrective Action: *Repair and maintain lease road to comply with rule 204.*

Noble Response: Noble determined road inaccessibility was due to erosion. Noble has repaired the road and successfully restored accessibility. Erosion was backfilled, and the road was recompact. Photos of the repaired areas are presented in the attached log. Noble looks to continually improve their location maintenance program, and we welcome further discussion regarding these repairs.

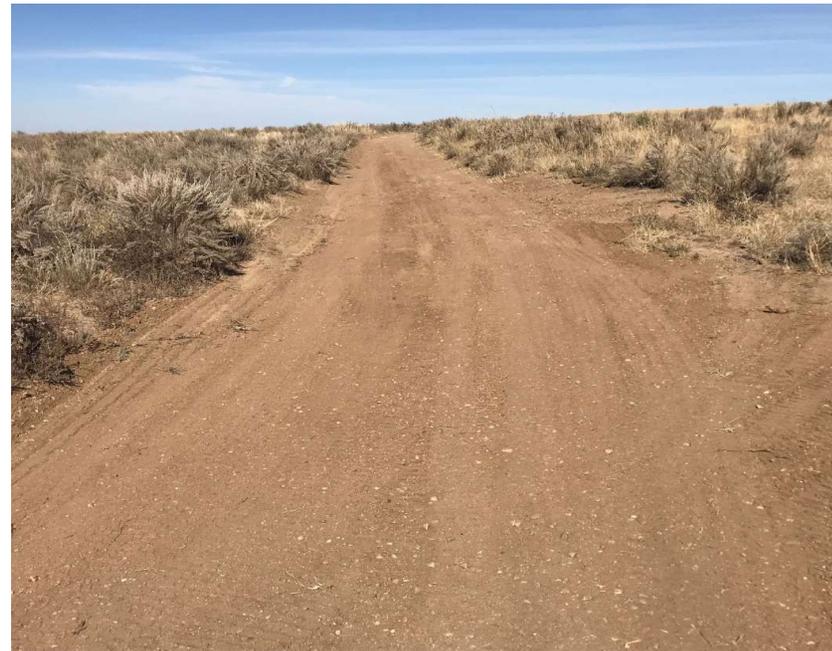
**Noble Energy – 10/15/19**

Photo NBL1. Erosion back-filled and compacted roadbed.

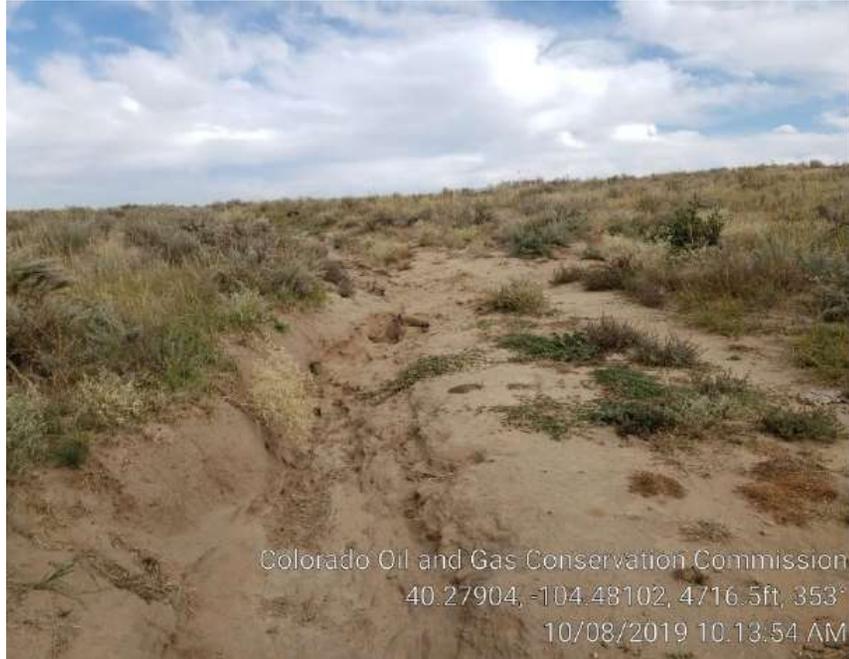
COGCC – 10/08/19

COGCC Photo 3. Inaccessible lease road

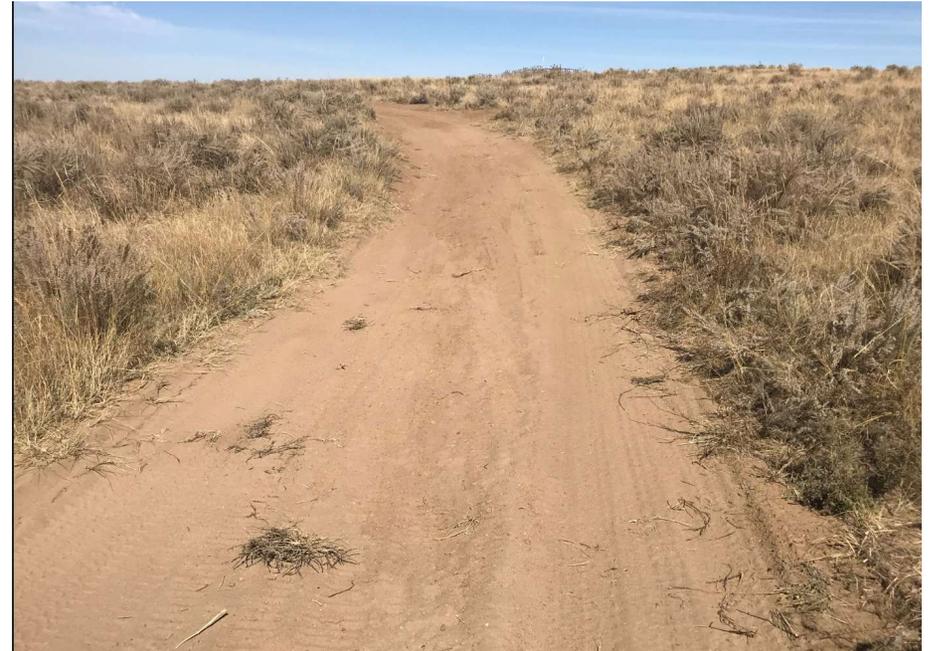
Noble Energy – 10/15/19

Photo NBL2. Erosion back-filled and compacted roadbed.

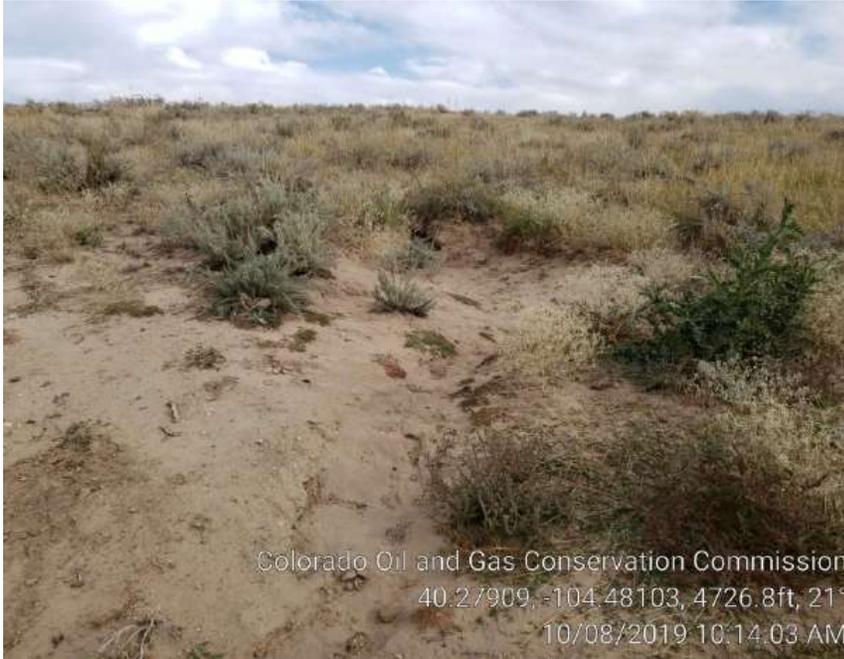
COGCC – 10/08/19

COGCC Photo 4. Inaccessible lease road

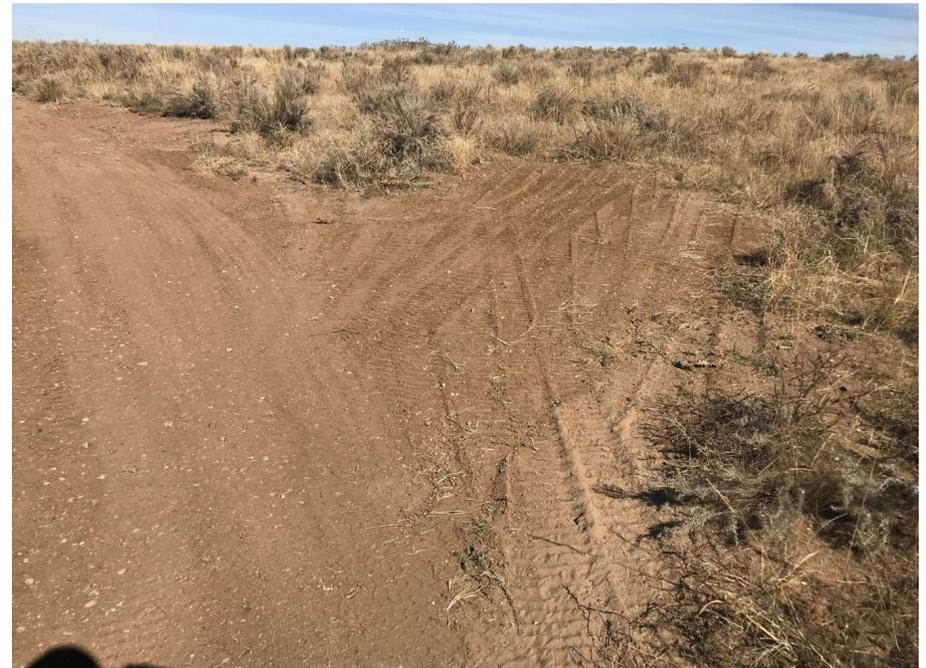
Noble Energy – 10/15/19

Photo NBL3. Erosion back-filled and compacted roadbed.

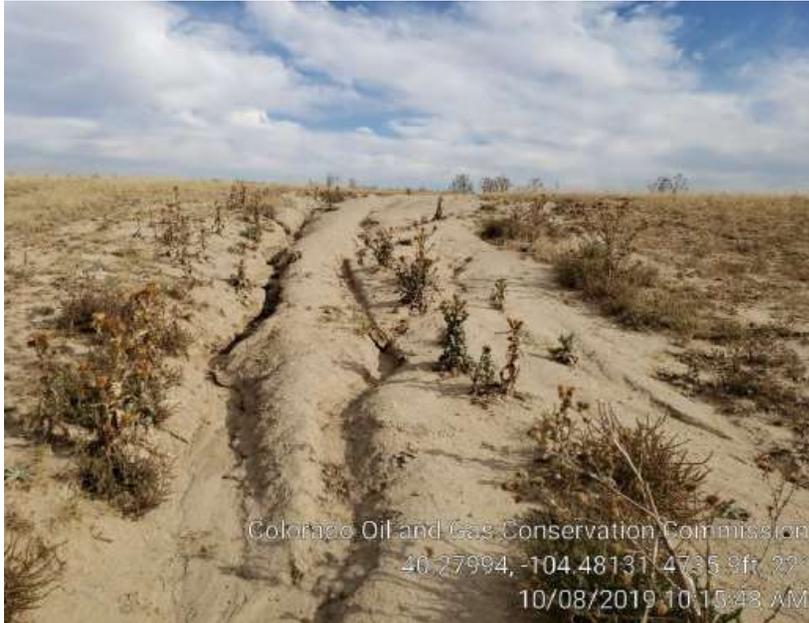
**COGCC – 10/08/19**

COGCC Photo 7. Inaccessible lease road

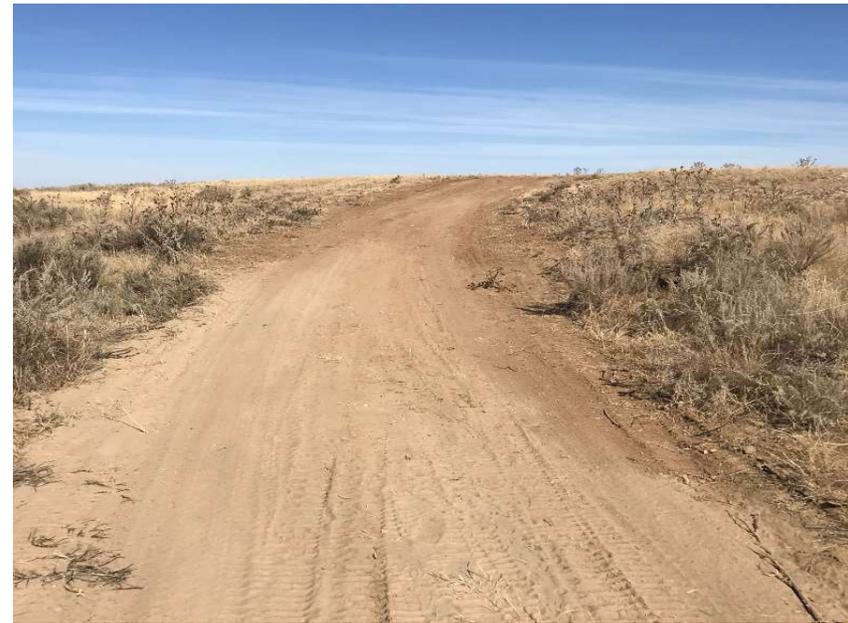
**Noble Energy – 10/15/19**

Photo NBL4. Filtrexx installed outside fence. Erosion repaired, and sloped compacted and tracked.

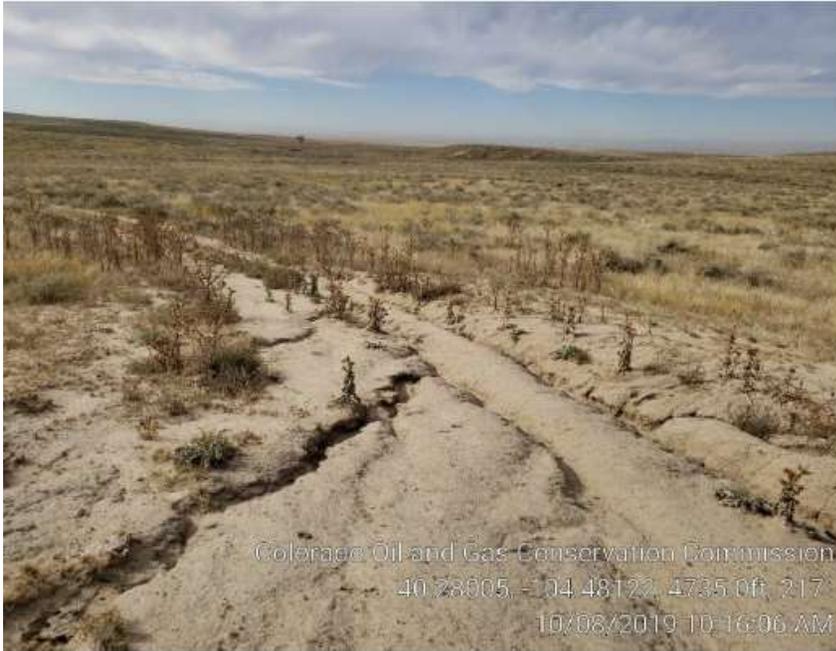
COGCC – 10/08/19

COGCC Photo 8. Inaccessible lease road

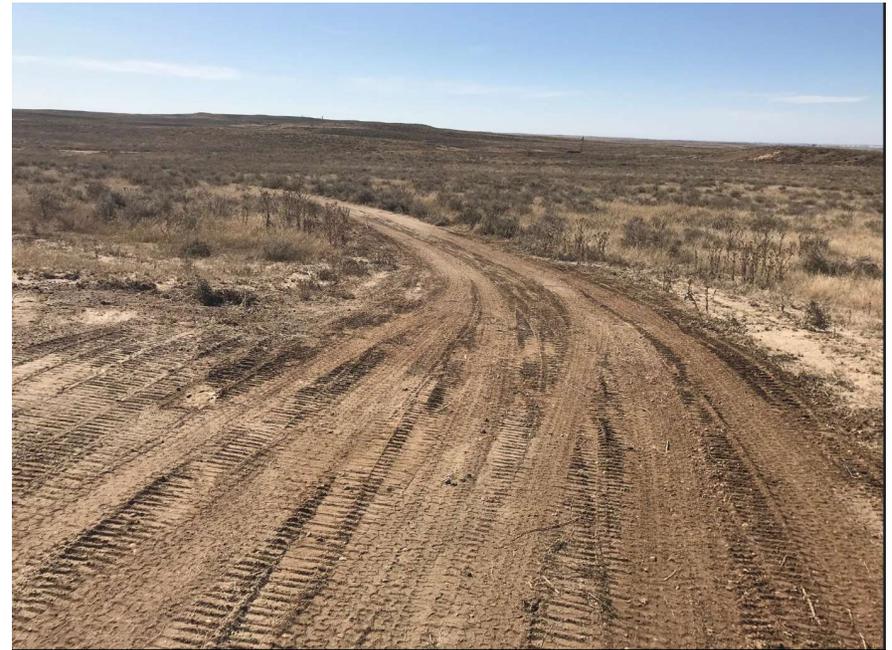
Noble Energy – 10/15/19

Photo NBL5. Erosion back-filled and compacted roadbed.
