Final Reclamation Inspection

Operator: GREAT WESTERN OPERATING COMPANY LLC- #10110

API: 05-123-05482

Inspection Photos
Location Name: UPRR #13
API: 05-123-05482

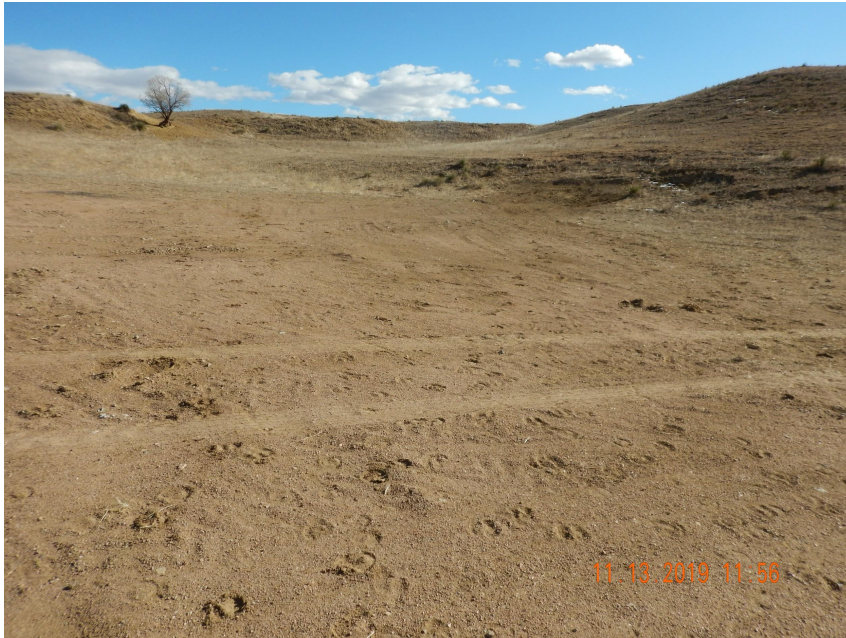
Photo 1. Photo taken from the well location, facing East. Photo illustrates equipment has been removed from location. Operator shall comply with Rule 1004.a regarding the timing requirement to complete all final reclamation activities.

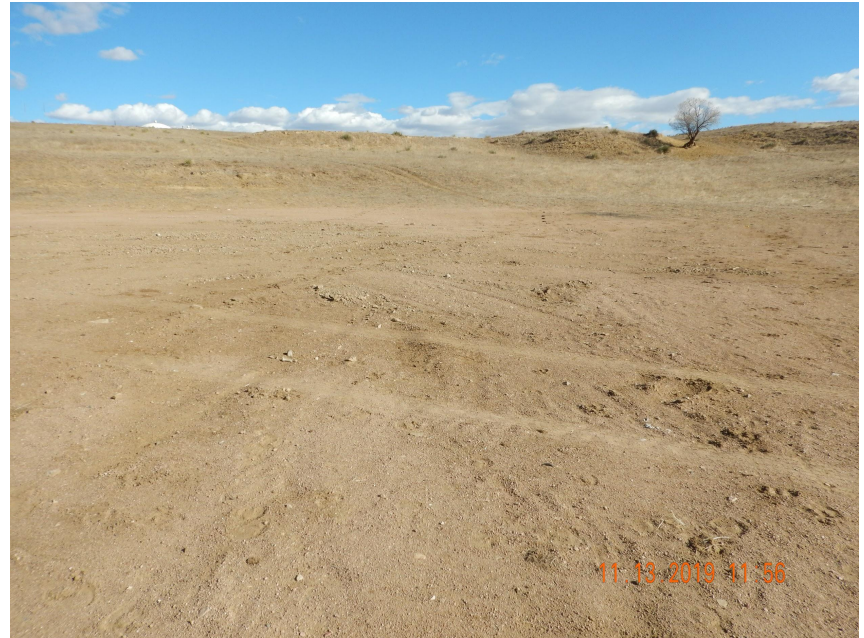
Photo 2. Photo taken from the well location, facing North. See comments under Photo 1.
