**Inspection Photos**  
**Location Name: T.Y.L. 42-27**  
**API#: 05-071-08104**  
**INSP. #: 695101764**

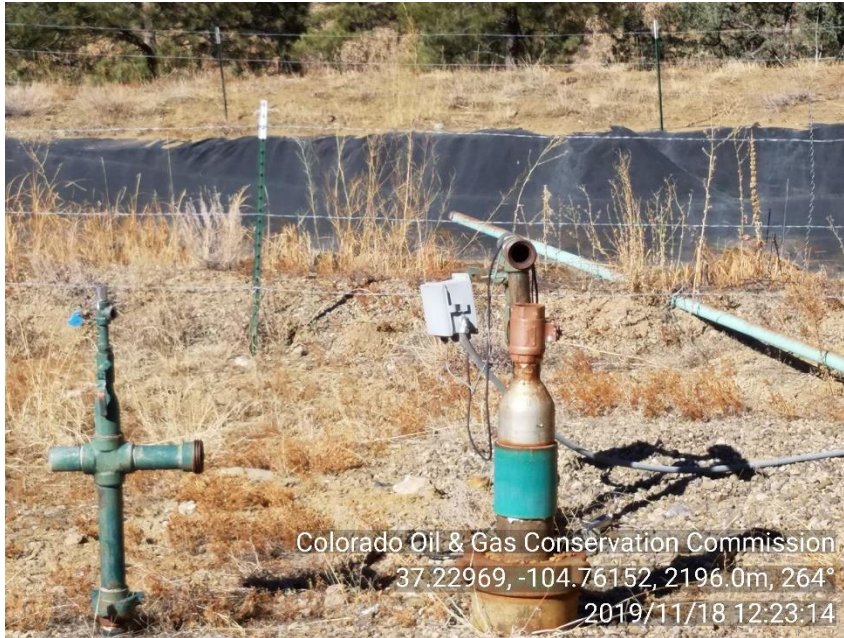
**PHOTO 3: UNUSED EQUIPMENT (TWO 2" RISER'S). REMOVE  
UNUSED EQUIPMENT ASS PER NTO AND RULE 603.f. CA DATE  
02-18-19.**
