## Inspection Photos

Location Name: SCARECROW 22-2 FOLLOWUP CA DATE 2-15-20

API#: 05-071-09335

INSP. #: 695102012

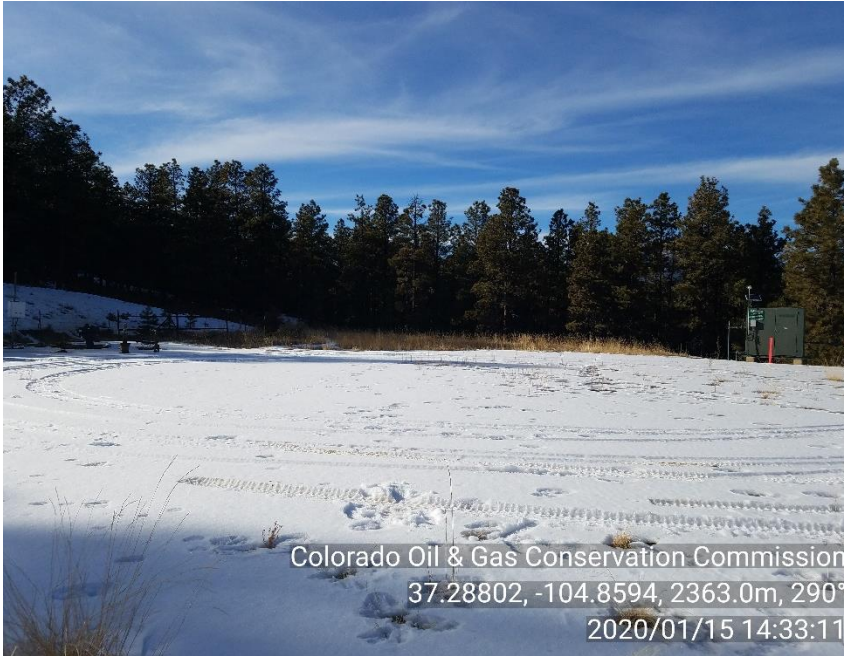
**PHOTO 1: LOCATION**

Colorado Oil & Gas Conservation Commission  
37.28802, -104.8594, 2363.0m, 290°  
2020/01/15 14:33:11

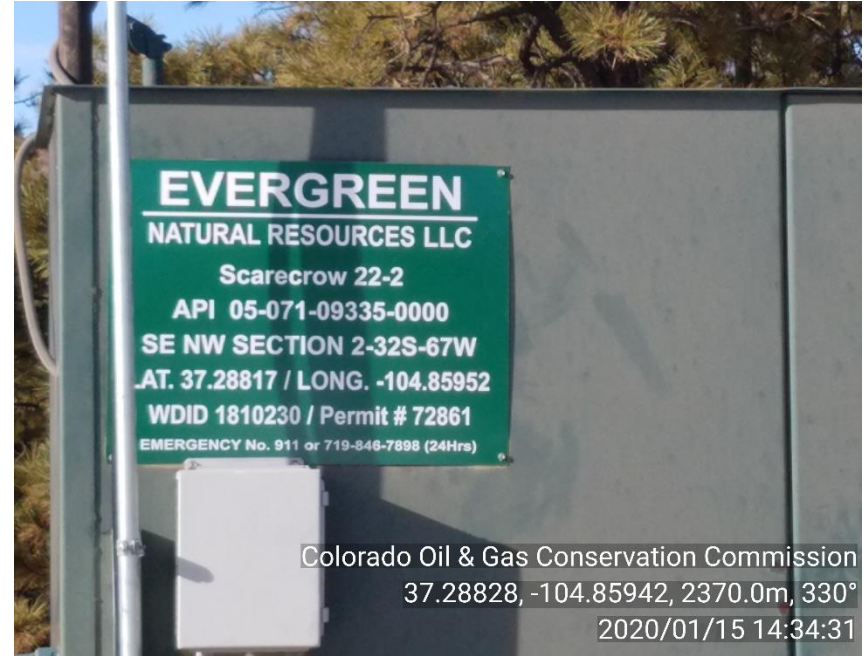
**PHOTO 2: WELL SIGN**

Colorado Oil & Gas Conservation Commission  
37.28828, -104.85942, 2370.0m, 330°  
2020/01/15 14:34:31

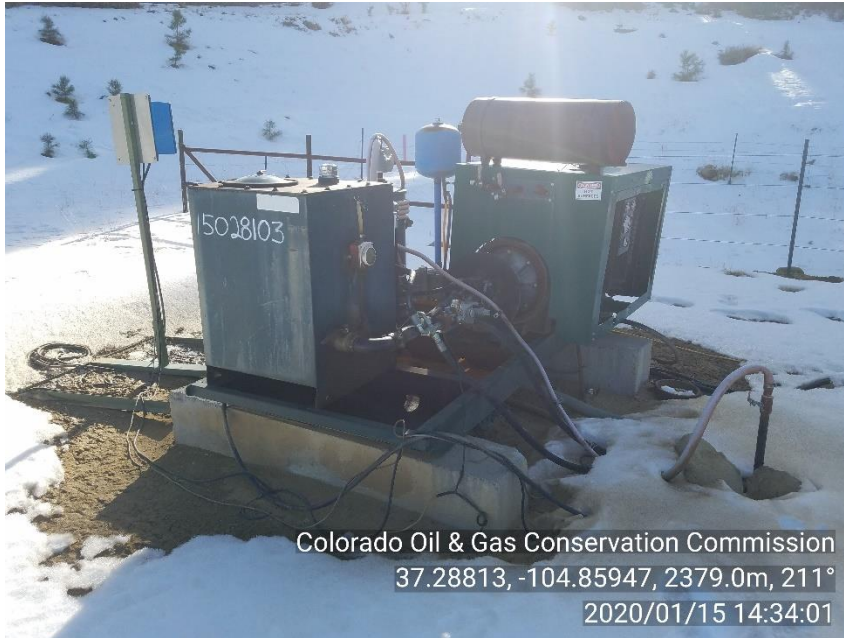
**PHOTO 3: PRODUCTION EQUIPMENT STORED ON LOCATION IS NOT IN USE (THIS IS SECOND NOTICE). REMOVE UNUSED EQUIPMENT PER RULE 603.f. CA DATE 2-15-20**

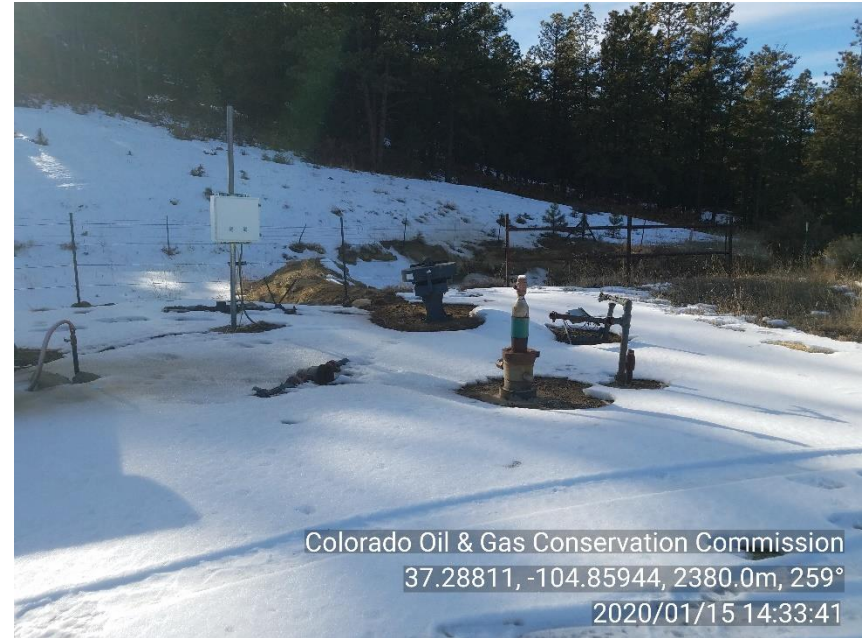
**PHOTO 4: PRODUCTION EQUIPMENT STORED ON LOCATION IS NOT IN USE ALSO RISERS NOT IN USE OR LO/TO ARE CONSIDERED UNUSED EQUIPMENT (THIS IS SECOND NOTICE). REMOVE UNUSED EQUIPMENT, LO/TO RISERS OR REMOVE THEM PER RULE 603.f. CA DATE 2-15-20.**
