# Inspection Photos

Operator: EQUITY OIL CO - 27900

Location ID: 398968

Rio Blanco County, CO

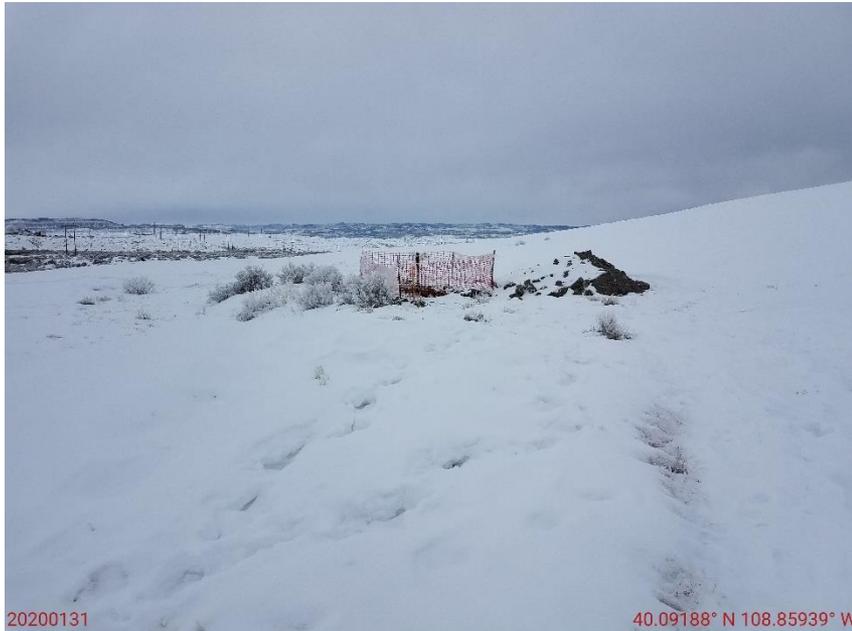
**Photo 1:** Photo taken from the west end of the Location, facing east. Previous inspections documented a leak from the casing. Operator appears to have conducted work at the well location. Surface disturbance observed at well site and on areas leading to well site used by vehicles for access. Reclamation activities will be required once leak has been controlled.

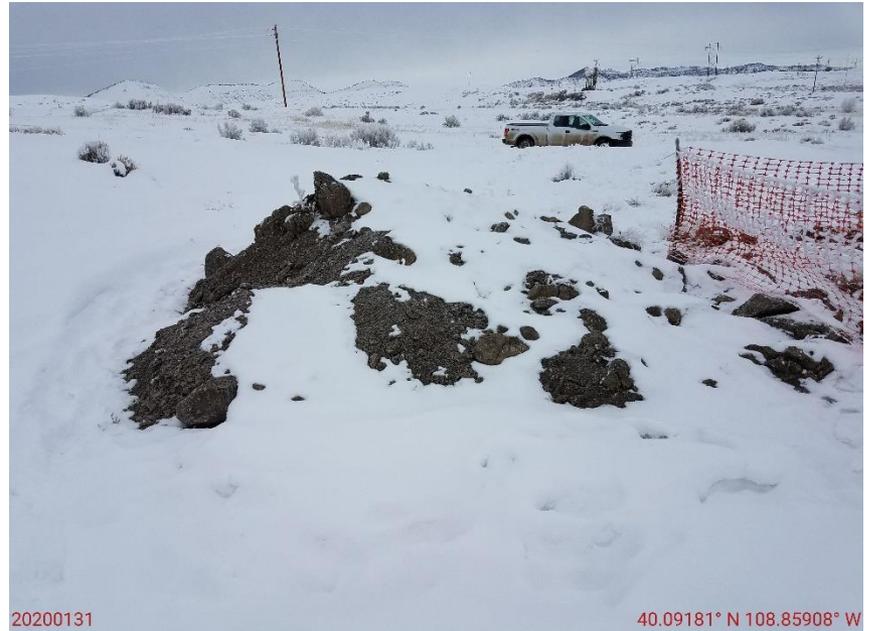
**Photo 2:** Photo taken from the Location, facing west. Photo shows soil stockpile excavated from around the well.
